# SKAGAFJORDUR ARCHAEOLOGICAL SETTLEMENT SURVEY

## ARTIFACT CONSERVATION REPORT

SITE Stora Seyla 104  
 AREA C  
 CONTEXT # 101  
 FIND # 1  
 FIND DATE 3 July 2008  
 FINDING ARCHAEOLOGIST KEG

OBJECT DESCRIPTIVE TITLE Coin/medallion  
 MATERIAL Probably silver/ copper alloy  
 DISTINGUISHING MARKS Cross within a circle with a 4 pointed star at the center. Indistinct lettering around the outside of the circle. Indistinct head and shoulders and possible lettering on the opposite side.  
 LENGTH 1.811 cm wide at widest point  
 WIDTH 1.718 cm wide at narrowest point  
 THICKNESS 0.13 cm thick at least corroded point  
 WEIGHT 1.1g before cleaning

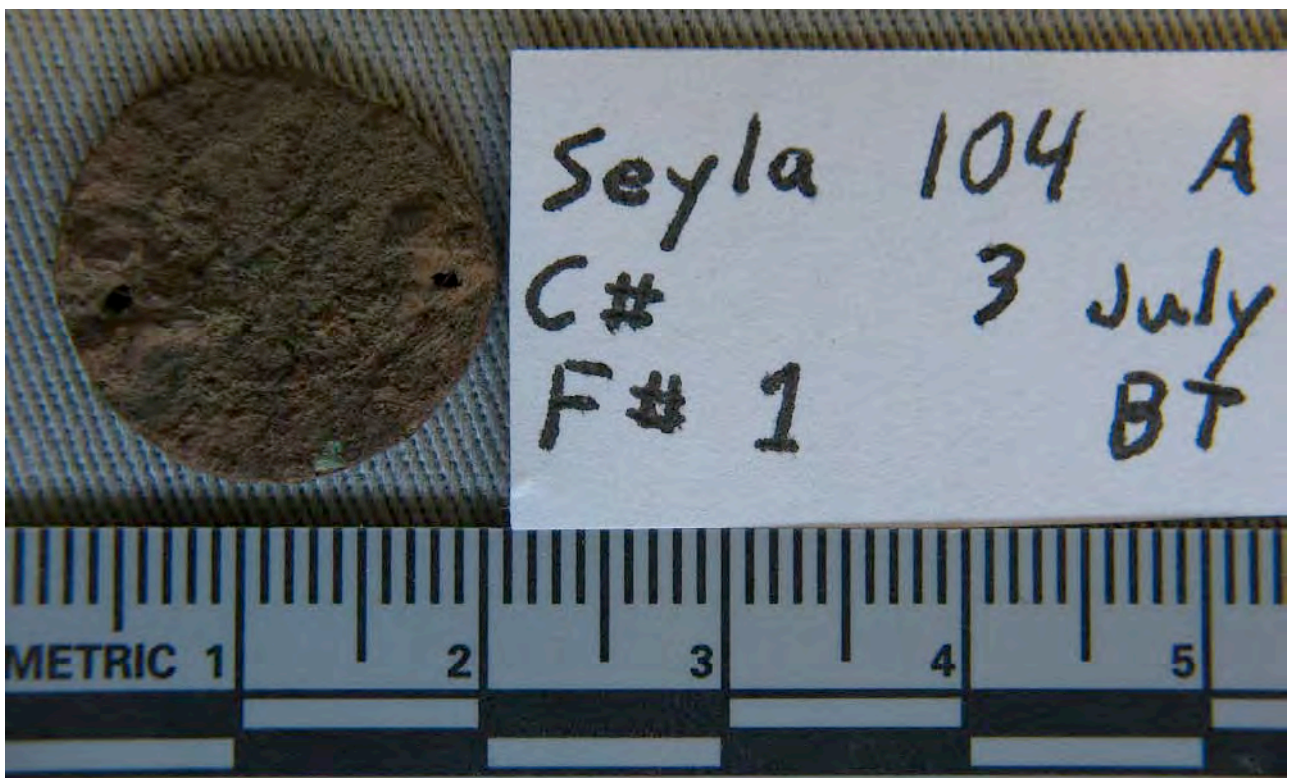
SASS104(C(c\_(F1.cross.BT1 – cross side of the coin, sunlight illumination, before treatment, cm. scale.

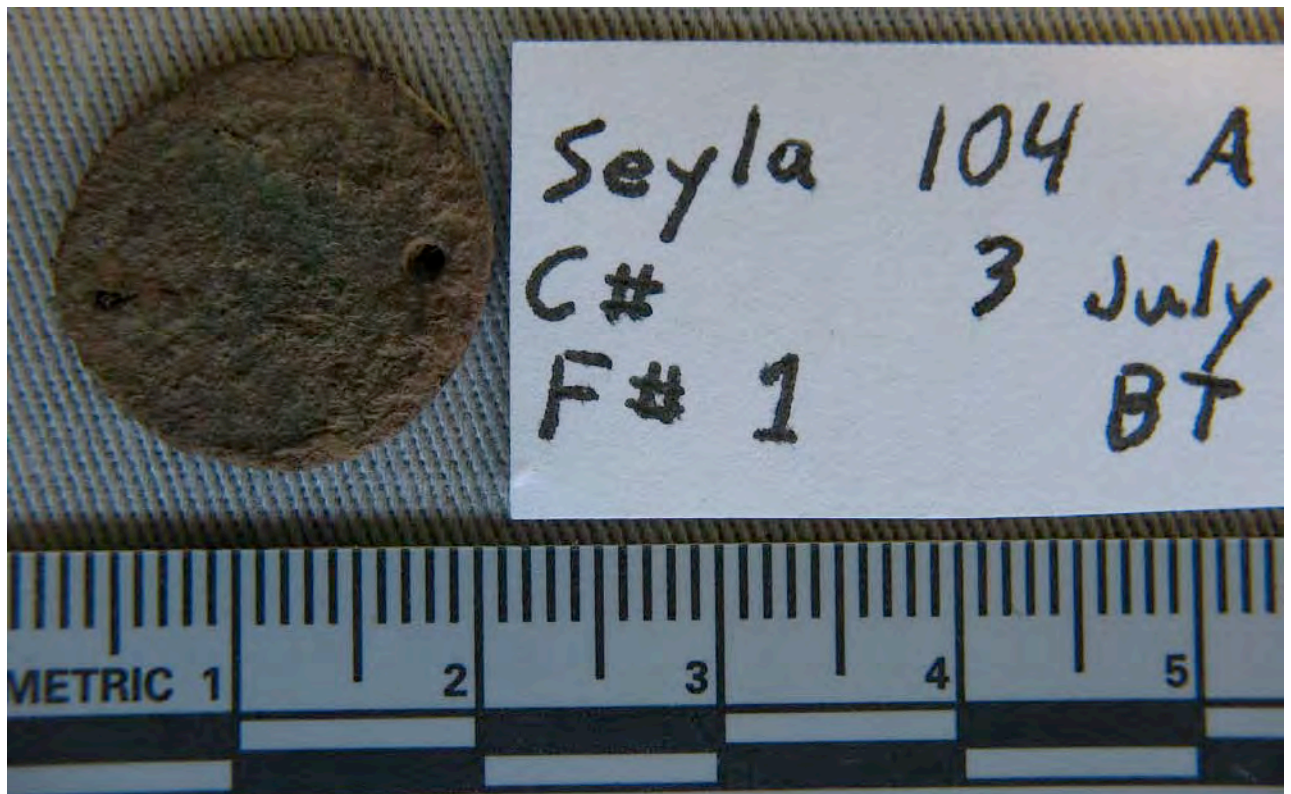
SASS104(C(c\_(F1.face.BT1 – face side of the coin, sunlight illumination, before treatment, cm. scale.

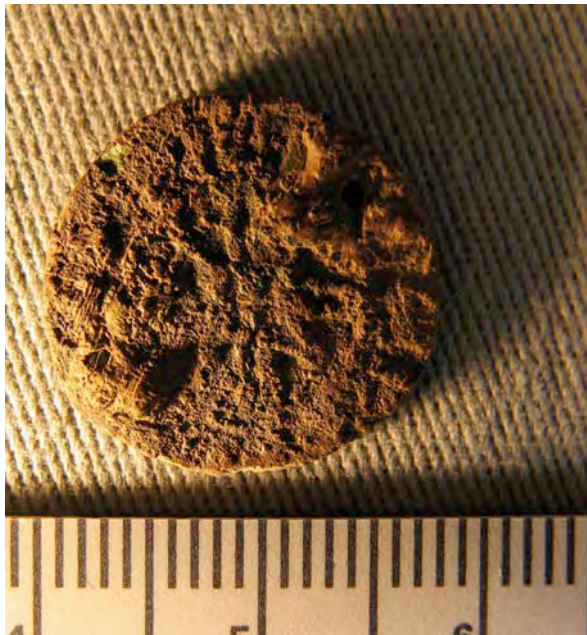
SASS104(C(c\_(F1.cross.BT3  
Cross side of the coin under raking illumination.

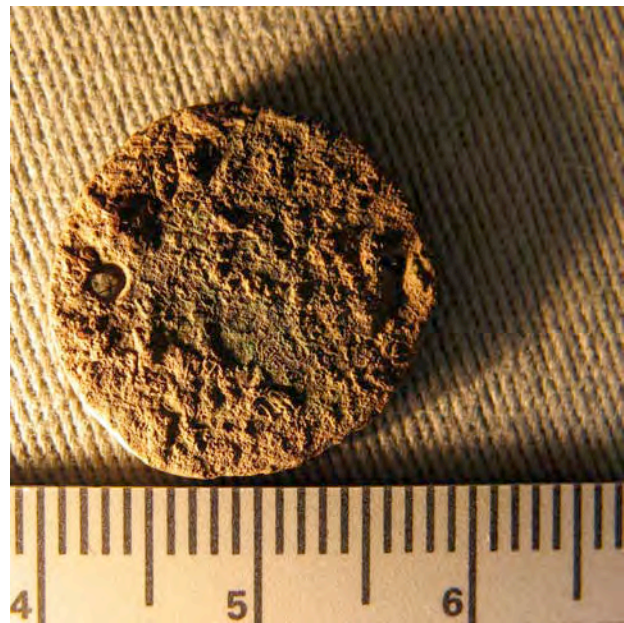
SASS104(C(c\_(F1.face.BT3  
Face side of the coin under raking illumination.

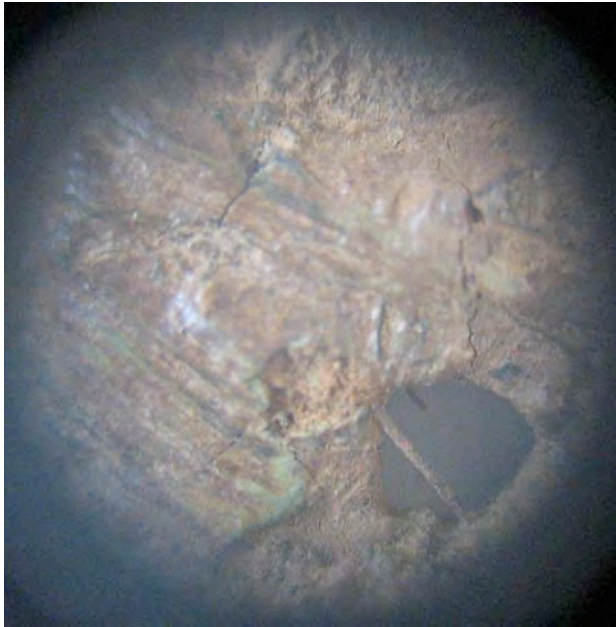
SASS104(C(c\_(F1.cross.BTpmic1  
Photo-micrograph of corrosion around the larger hole  
in the cross side of the coin. 20X magnification.

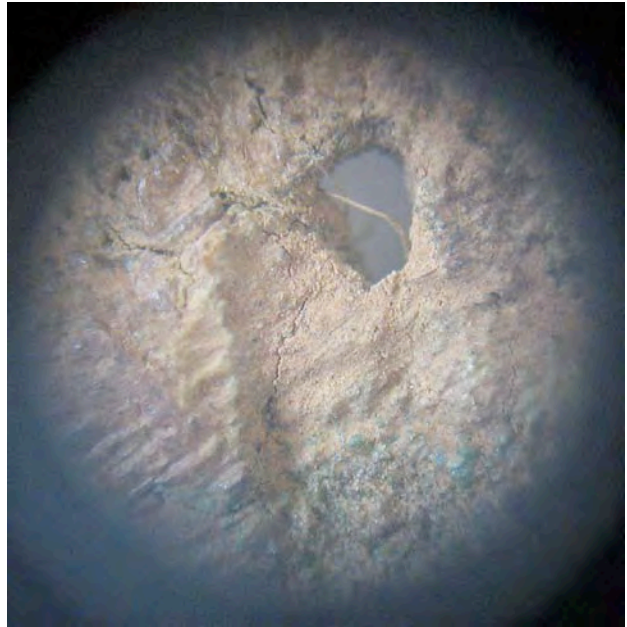
SASS104(C(c\_(F1.cross.BTpmic2  
Photo-micrograph of corrosion around the smaller hole  
in the cross side of the coin. 20X magnification.

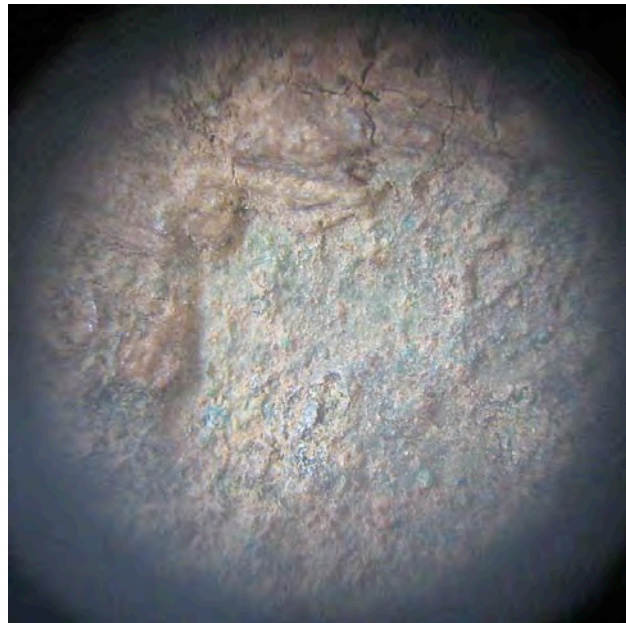
SASS104(C(c\_(F1.face.BTpmic1  
Photo-micrograph of corrosion around surface details on  
the face side of the coin. 20X magnification.

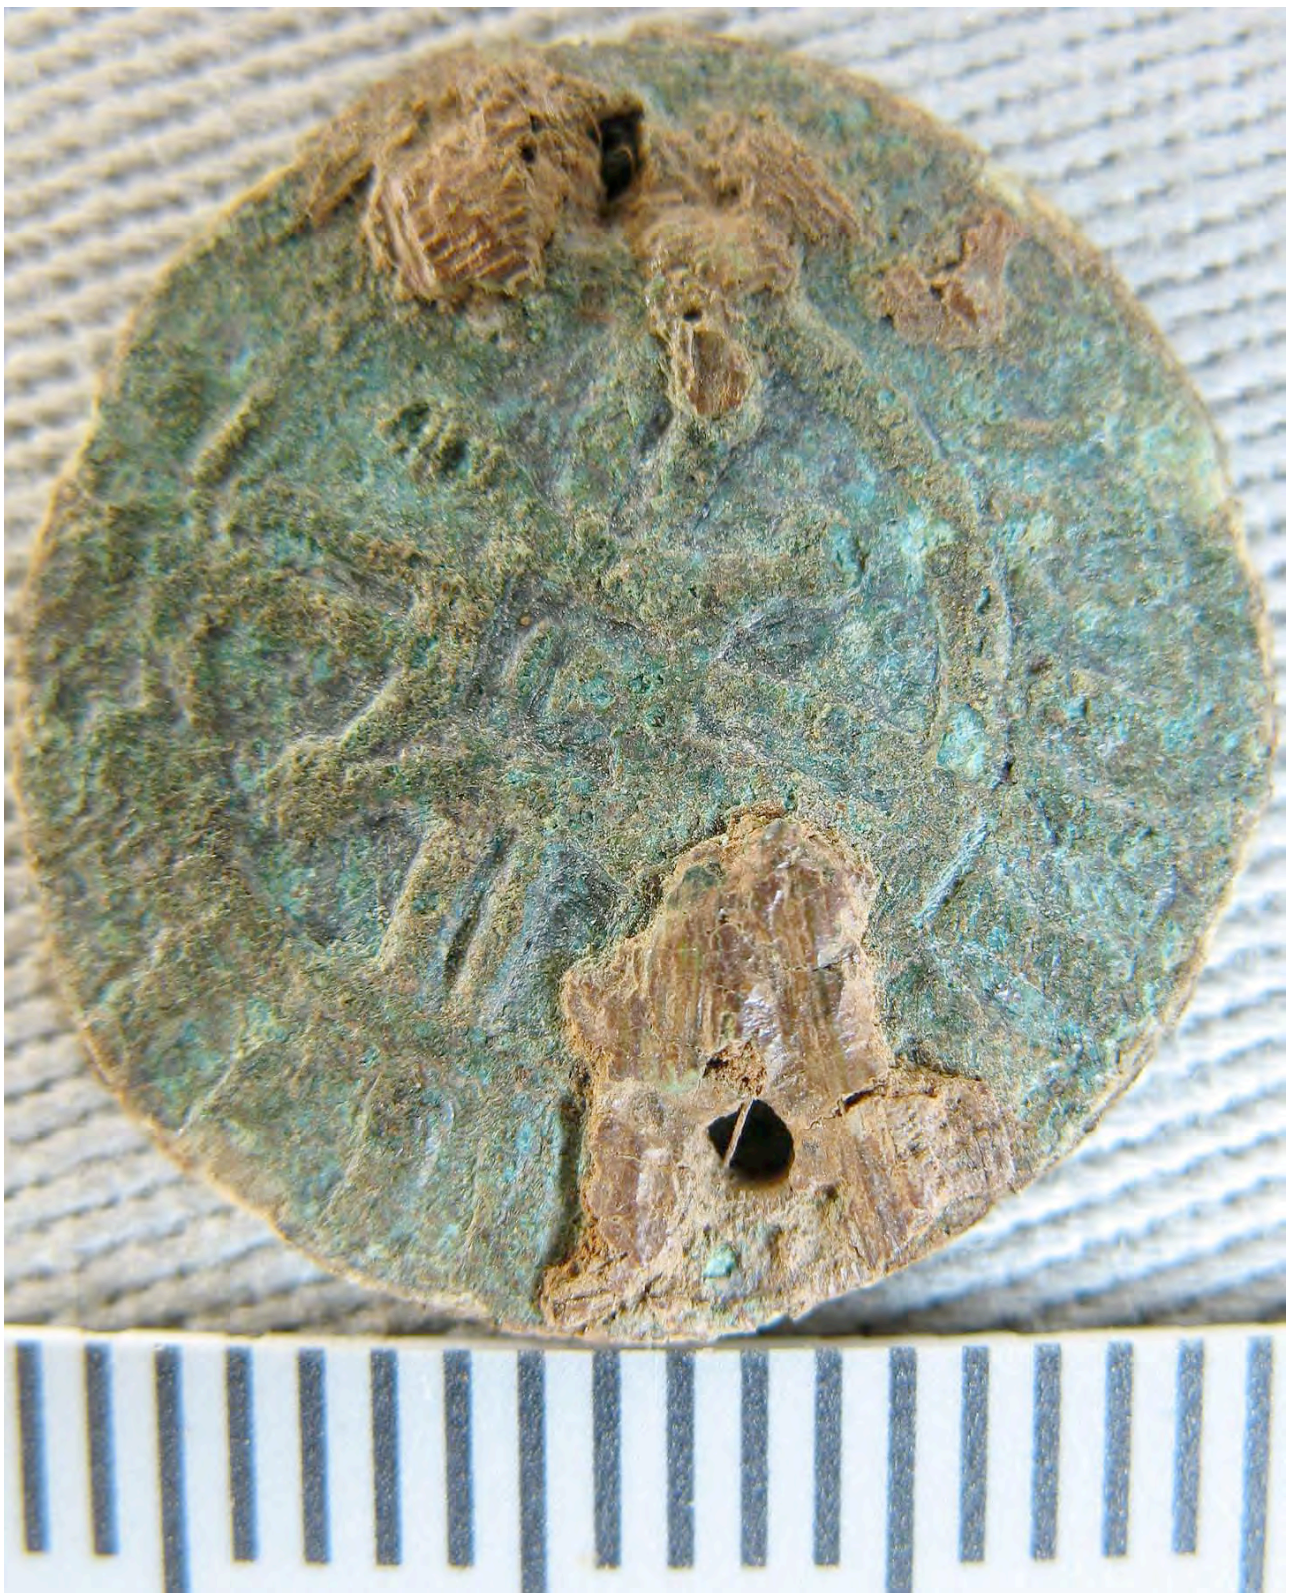
SASS104(C(c\_(F1.cross.DT2

Cross side of the coin after mechanical cleaning showing cross motif, lettering around the edge, and preserved fiber impressions in accreted dirt.

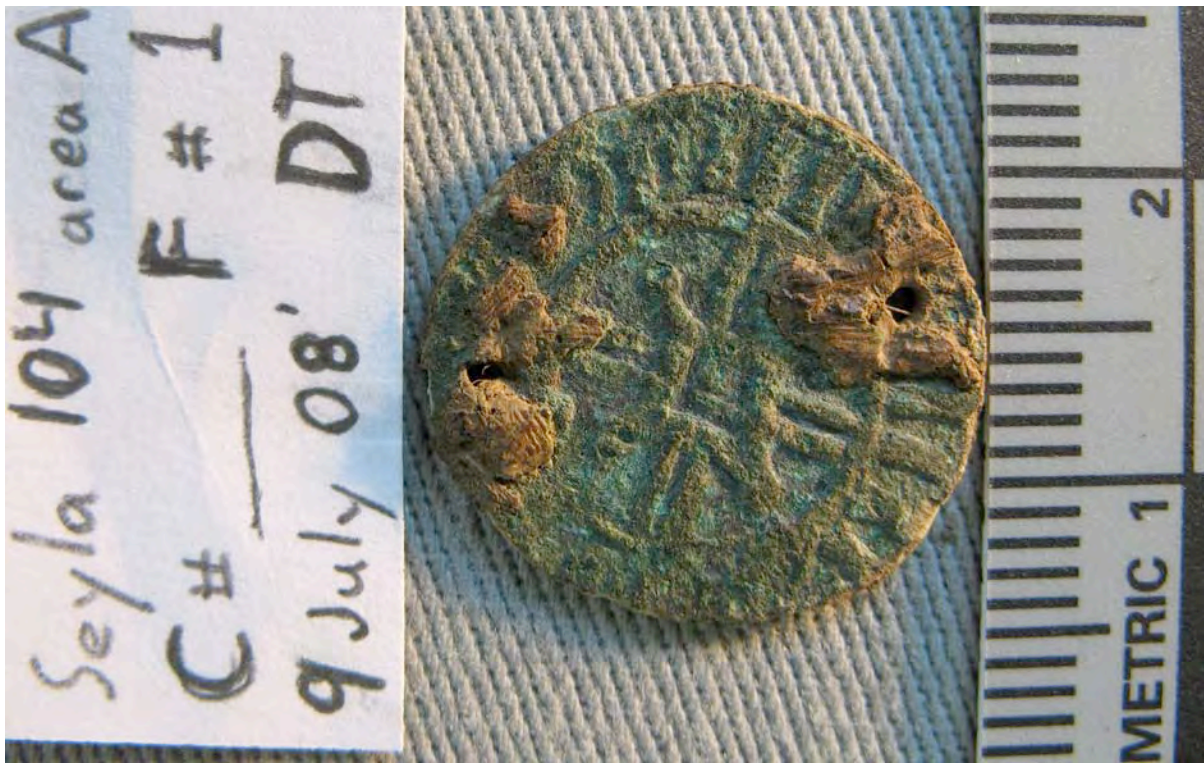
SASS104(Cc\_(F1.cross.DT1

Cross side of the coin after mechanical cleaning

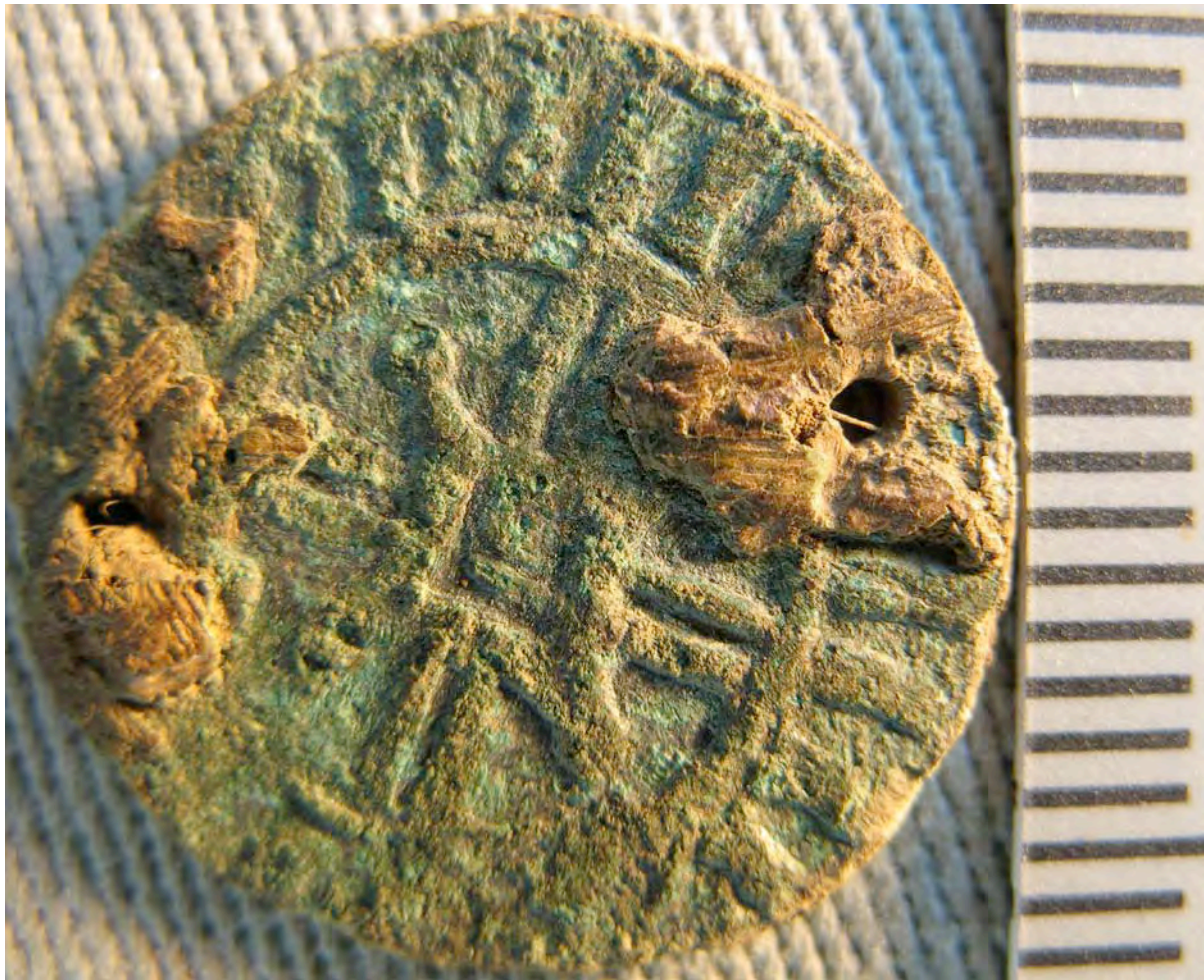
SASS104(Cc\_(F1.cross.DT3

Cross side of the coin under raking light, after cleaning.

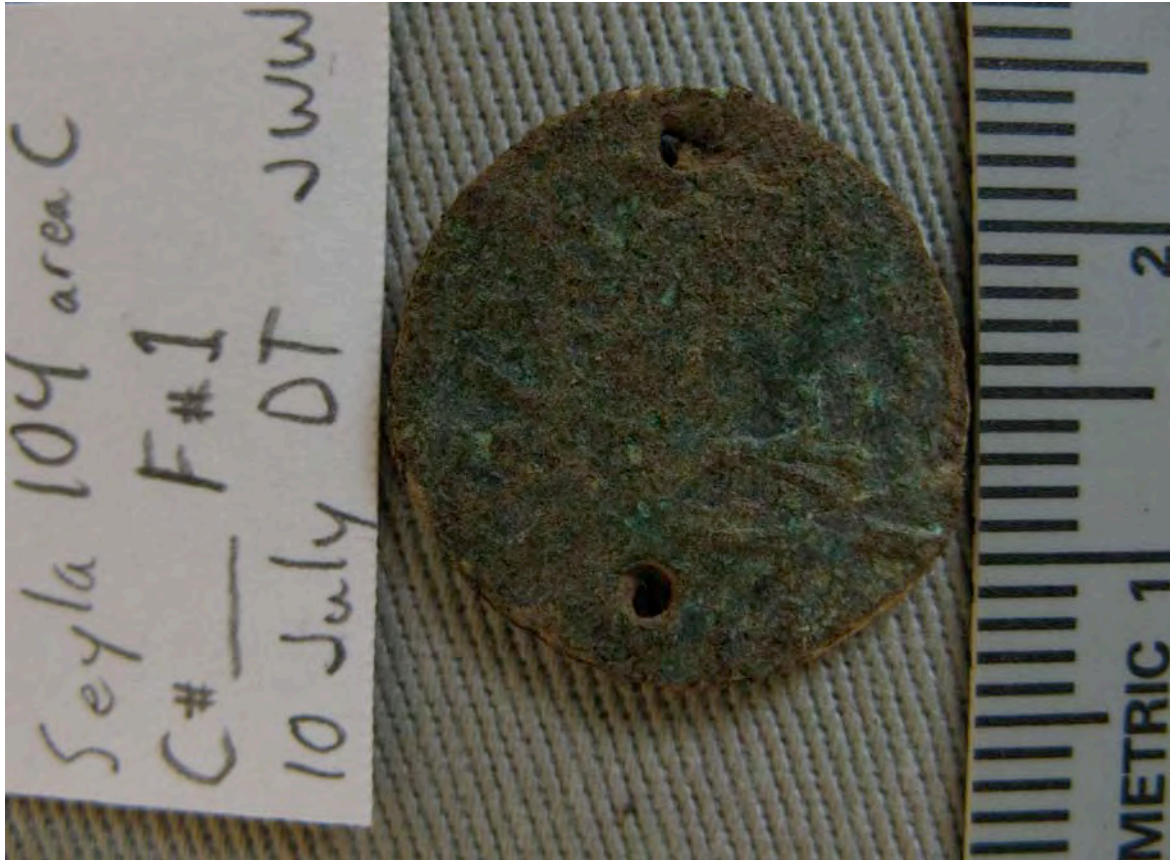
SASS104(Cc\_(F1.face.DT

Face side of the coin after mechanical cleaning,  
sunlight illumination.

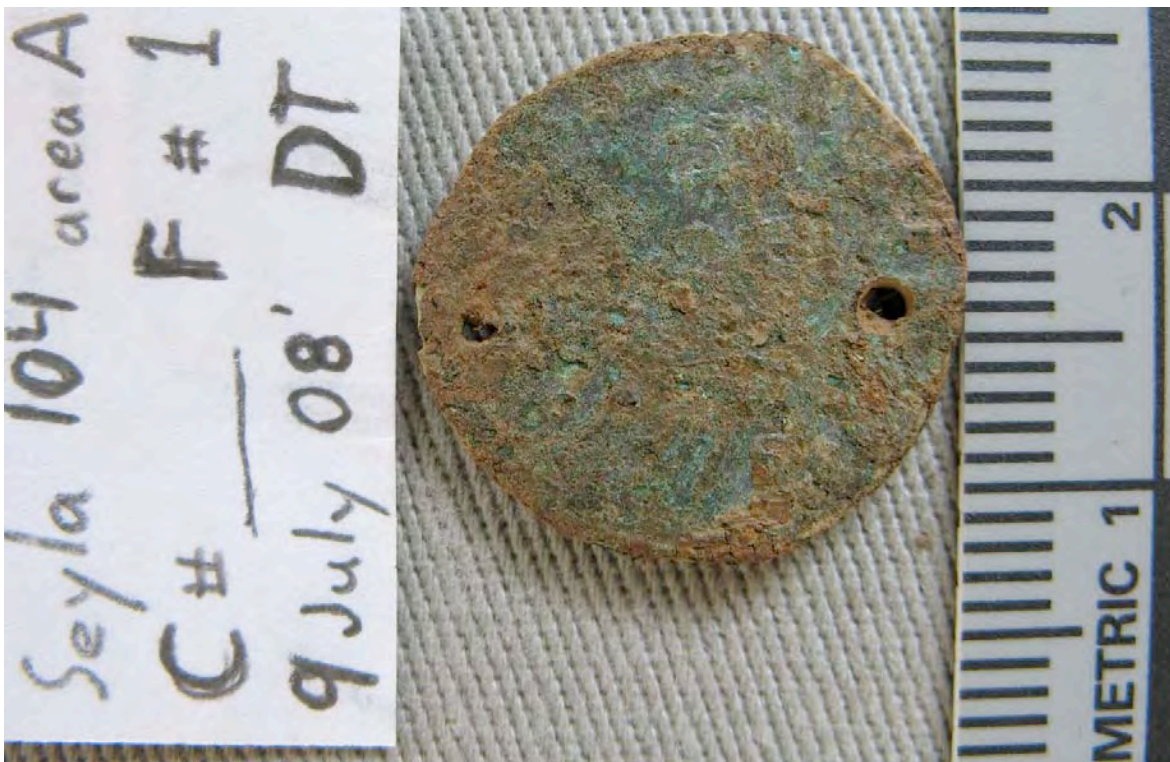
SASS104(Cc\_(F1.face.DT1

Face side of the coin during mechanical cleaning,  
sunlight illumination

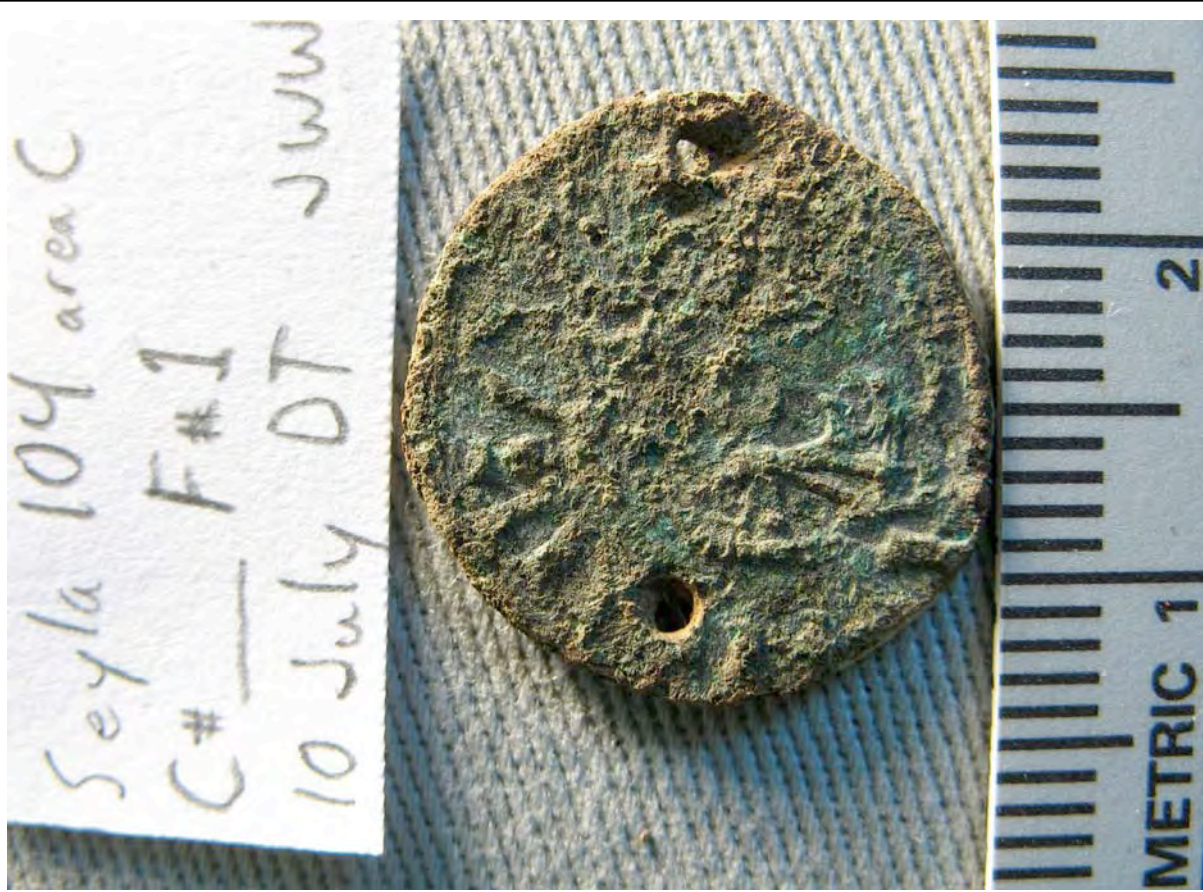
SASS104(Cc\_(F1.face.DT2

Face side of coin after cleaning, under raking illumination from upper right

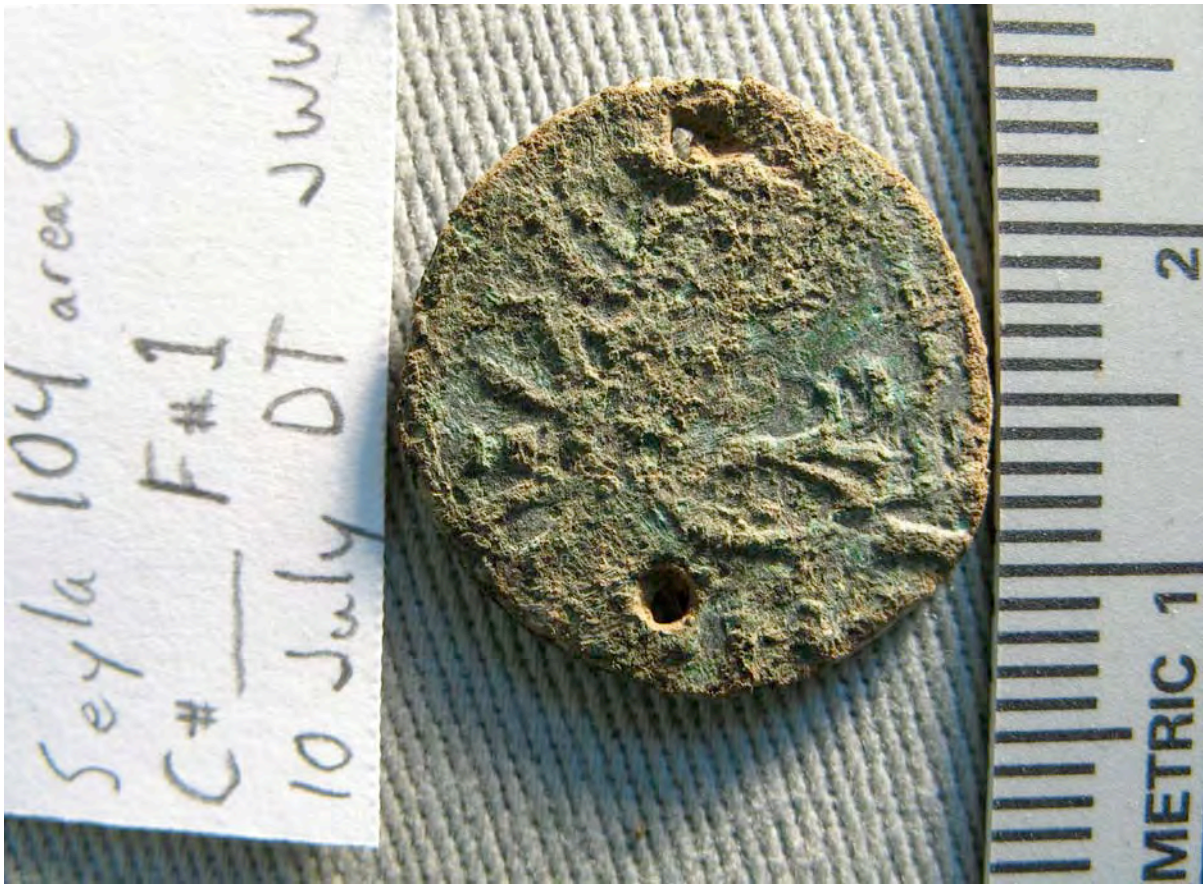
SASS104(Cc\_(F1.face.DT3

Face side of coin after cleaning, under raking illumination from lower right
