# Site Examination of the Col. James Barrett Farm Property, Concord, Massachusetts

Andrew Fiske Memorial Center for Archaeological Research  
Cultural Resource Management Study No. 25  
September 2008

A site examination of the Col. James Barrett Farm in Concord, Massachusetts, in 2007, provided evidence for significant late 18th and early to mid 19th-century landscaping activities around the standing house and discovered and tested a mid-19th century primary ceramic trash deposit. The property is historically significant because of Col. James Barrett's association with the American Revolution, the well-preserved early 18th-century architecture, and the continuous history of the land as a family farm. The excavations demonstrated that the property is archaeologically important because of the abundant evidence for landscaping activities and the many areas of intact deposits. The 23 test pits and 11 excavation units around the historic house (core constructed ca. 1705) indicate that there are intact strata and deposits in the yards, although many of the areas adjacent to the foundation have been disturbed by more recent foundation repair. Buried cobble pavings survive north of the h

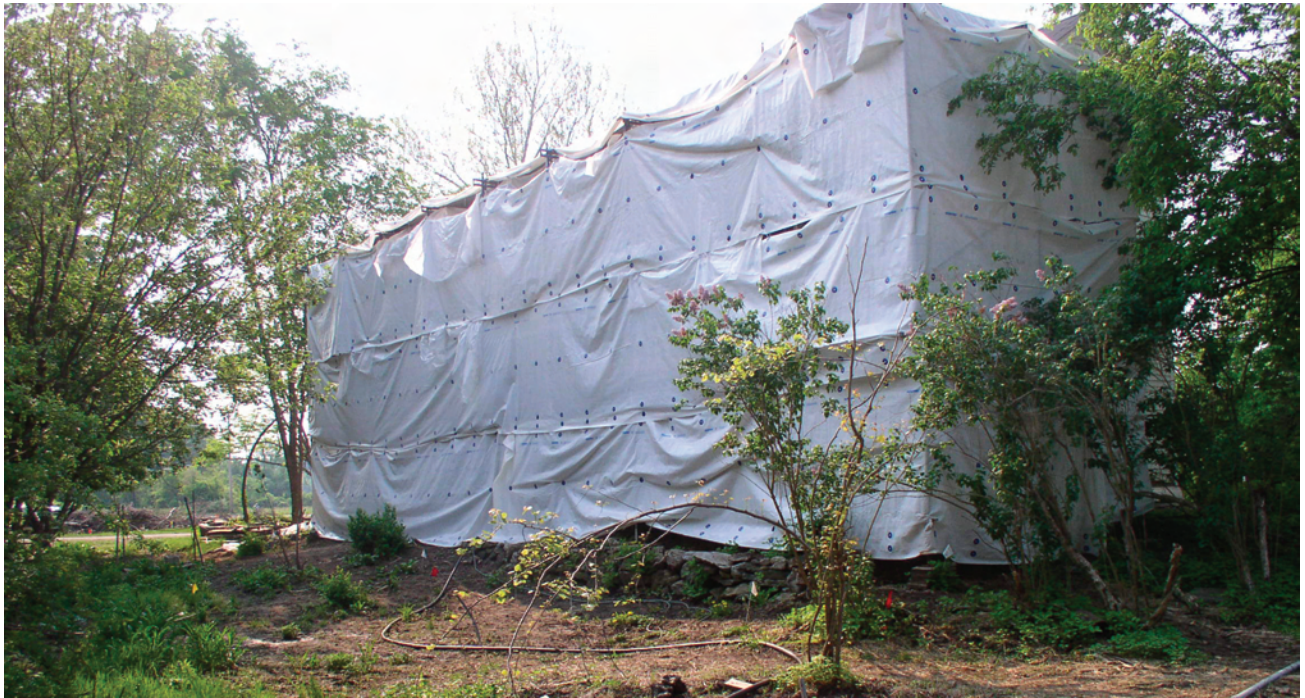
Figure 4. View of the scaffolding covering the north face of the house in 2007.

local volunteers and other UMass graduate students. The depths of some excavations were restricted by the high water table at the site and by the existence of scaffolding footings (Fig. 4). We determined the maximum safe depth for excavation units near the scaffolding footings in consultation with a structural engineer working on the standing structure.

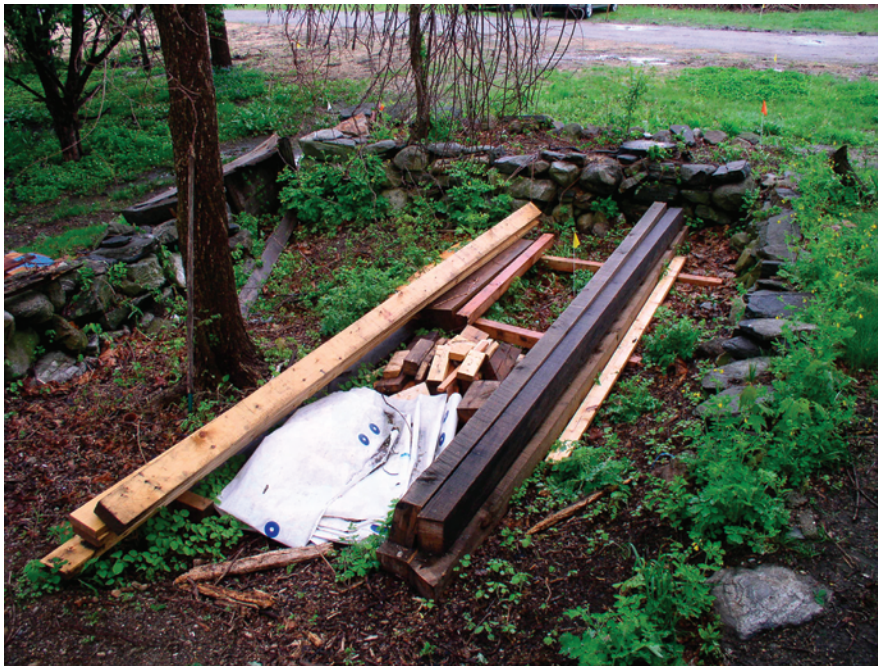
Figure 5. The remaining exposed east ell foundations.

An east ell which contained a well and a privy stood until 1977. The foundations of the east ell are still visible (see Fig. 6), as is the outline of the now partially filled well. The construction date and expansion sequence for the east ell is not known, although Frederic Detwiler has proposed, based on documentary evidence and comparisons to other standing buildings, that some part of the east ell was constructed by Col. Barrett prior to his death in 1779 (Detwiler 2007: 12, 15). The archaeological testing in the east ell suggests some alternate possibilities for the sequence of construction activities in this area (see below), although our testing in this area was limited. Some attached service space existed in the late 18<sup>th</sup> and early 19<sup>th</sup> centuries, but it is not clear if that consisted of the current ell, a precursor in the same location, or an ell in a different location. The east ell remains an area with a great deal of archaeological potential because of the possibility that broader excavation areas could provide a great deal of information about the age of the east ell and the use of this area over time.

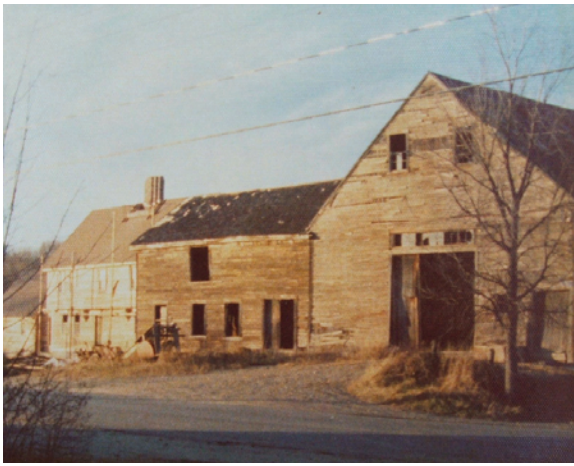
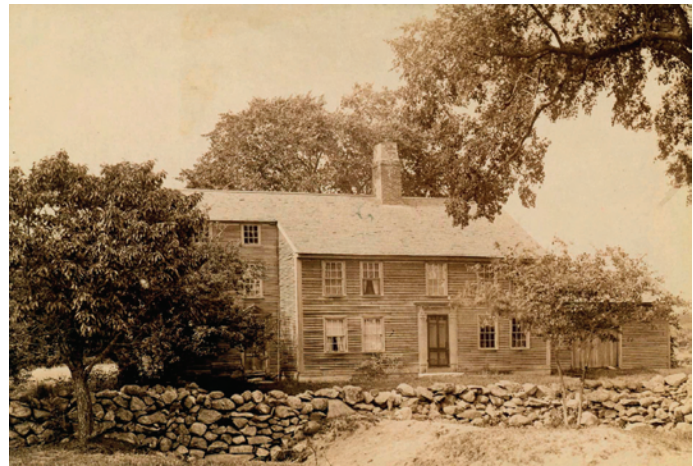
Figure 6. Historic photographs of the property: A) Barn ca. 1970; B) House with east ell (at the far right).

further back from the road. Both the east ell and the barn stood until the late 1970s and can be seen in historic photographs (Fig. 6).

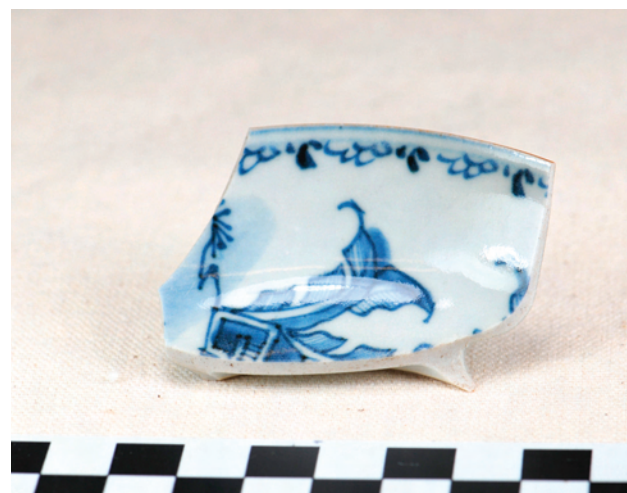
Figure 9. Porcelain saucer from level 3 of 611N 793E.

surface at some point and had trash deposited on it. The ceramics from Level 3 and the interface with Level 4 include a Chinese porcelain saucer (Fig. 9), numerous small pieces of redware, a fragment of a Jackfield hollowware, a few fragments of undecorated creamware, and blue shell edged, underglaze painted, and transfer printed pearlware. There was also a bone button and a ferrous buckle fragment. The ceramic sherds from this area were primarily in small fragments, suggesting that this was a sheet midden and not a filled trash pit.

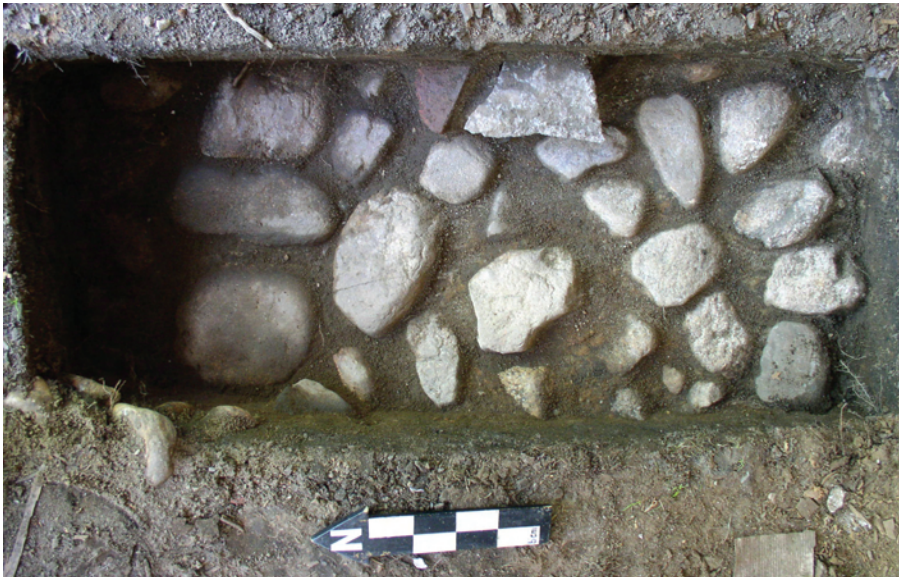
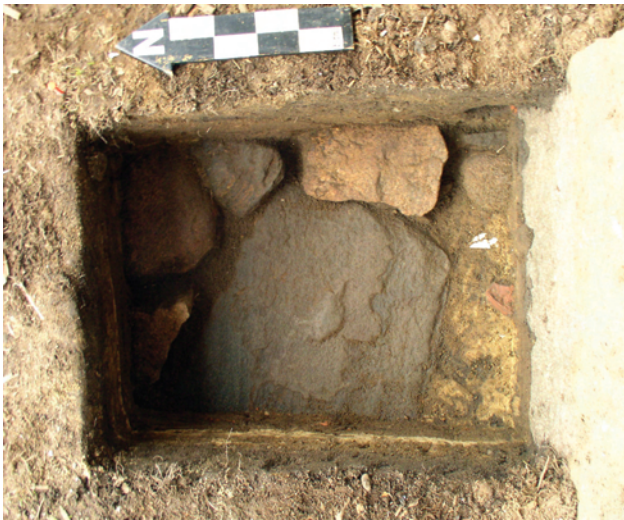
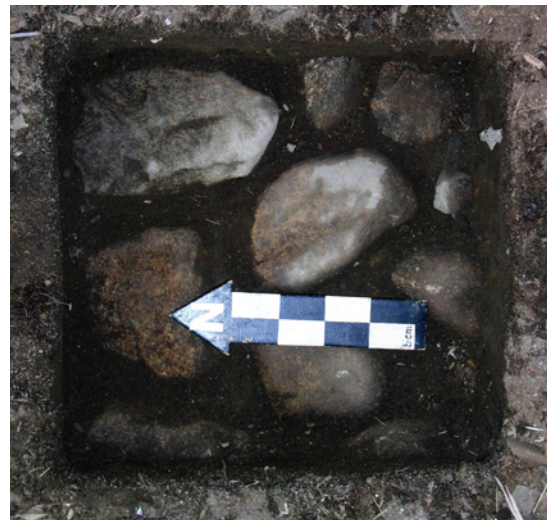
Figure 10. Cobble paving north of the house in A) 613.5N 801E; B) 613N 796E; and C) 613N 798.8E.

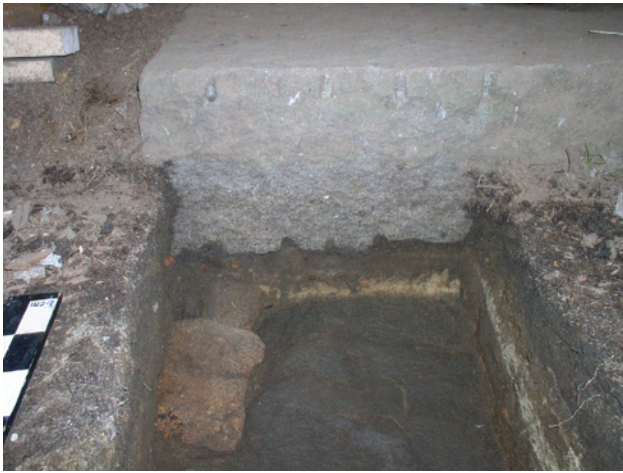
Figure 12. South profile of 613N 798.8E showing the strata sitting atop the cobbled surface and running under the doorstep.

from a variety of periods. Where the cobbles were shallowest (613N 796E), appearing at just 10 cm below the ground surface, this was the only stratum. In 613N 798.8E, placed to abut a stone doorstep, two strata (4 and 5) run under the doorstep (Fig. 12). These levels contain primarily pearlware (and no later wares), especially green transfer printed patterns, and abundant window glass and nails in Level 4. Although the transfer print pattern has not been specifically identified, the presence of a castle suggests that it may be a “Romantic” pattern of the type popular in the 1830s and 1840s, though production began earlier and continued later (Samford 1997). Green, as a color for underglaze transfer printing, also had its peak years of popularity in the same decades (Samford 1997: 20), and was not introduced until 1828 (Miller 2000: 13). These date ranges indicate that this doorstep was not put into place until the 1830s or later. Levels 2 and 3 are gravel and sand lenses, respectively, possibly related to leveling the area for setting the step. The cobbles were covered over completely by the time the granite doorstep was placed here sometime after 1830.

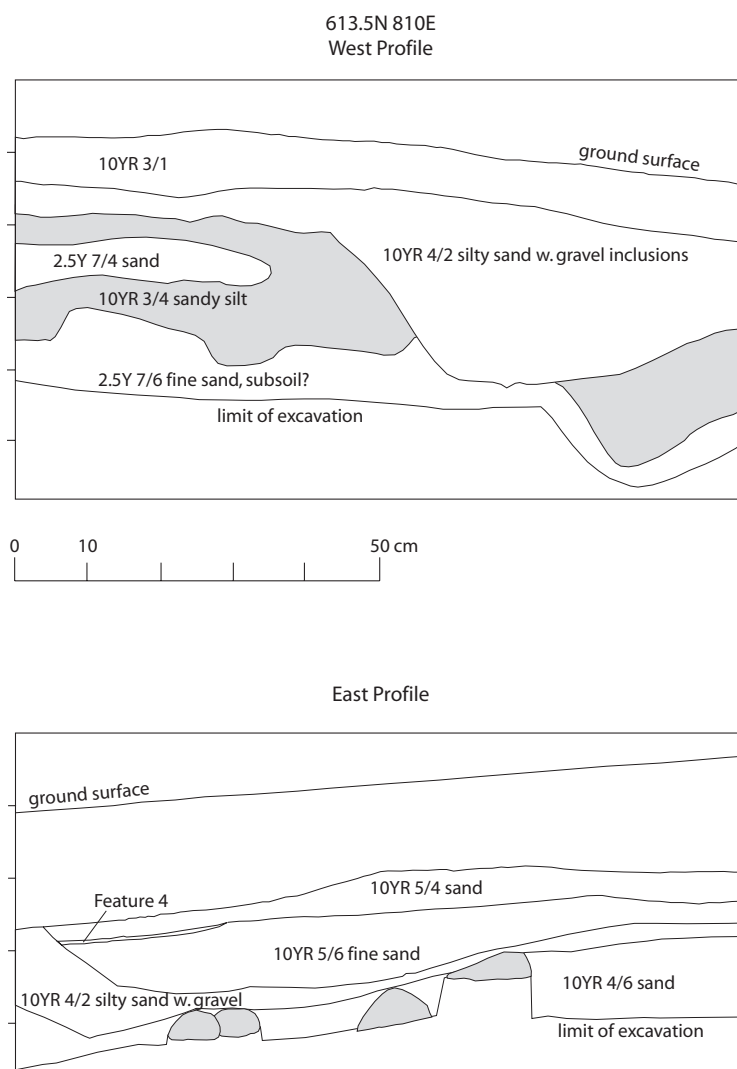
Figure 13. Profiles of 613.5N 810E

At the northeast corner of the house, a 1 × 1 m unit (613.5N 810E) revealed a complex sequence of activities atop a thin remaining deposit from the mid-19<sup>th</sup> century. The dates for the construction of the east ell are uncertain, but photographs from the later 20<sup>th</sup> century indicate that while the east ell was in use, this area was an outer dooryard for the door to the “well room” of the east ell. The whole of the unit was covered with the same organic and trash rich layer that characterized the area immediately behind the house. Excavation of this unit determined that a deposit of early–mid 19<sup>th</sup>-century material (Feature 4, cxt 79 at 19 cmbs) had sat atop at least 3 distinct layers of sand (Fig. 13). The small sliver of this feature that remained contained a piece of Staffordshire slipware, a fragment of an ironstone tea cup, pieces of pearlware, creamware, and a luster decorated ware (ca. 1820s to 1840s), and one large copper alloy disc button. The copper luster deco-

rated sherd gives this layer a TPQ of the 1820s. At some point, much of Feature 4 was cut or scraped away and was capped with a thin layer of sand. This level was cut through by a trench that ran from southeast to the northwest across the unit, destroying most of the 19<sup>th</sup>-century level, and that trench was also cut through by a deep pit in the northwest corner of the unit. The surface of the trench fill had the remains of two smaller pits (Features 5 and 6), possibly planting holes. The upper levels of this unit contained numerous fragments of flowerpots. There was very little of the Feature 4 deposit remaining, although it became thicker to the north and may continue into the backyard.

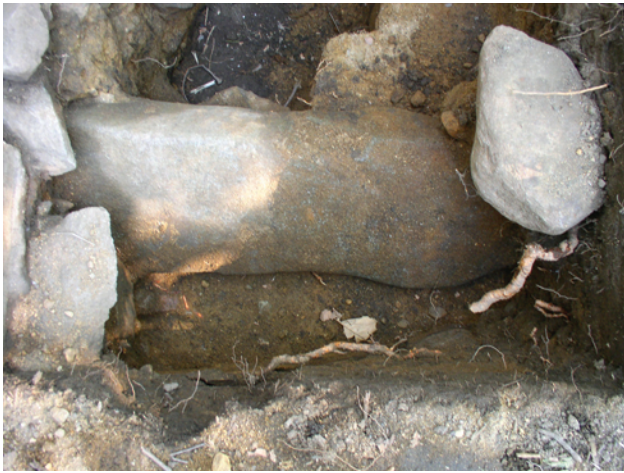
Figure 14. Worn granite block in 607N 811.5E. Width of area shown is ca. 1 m.

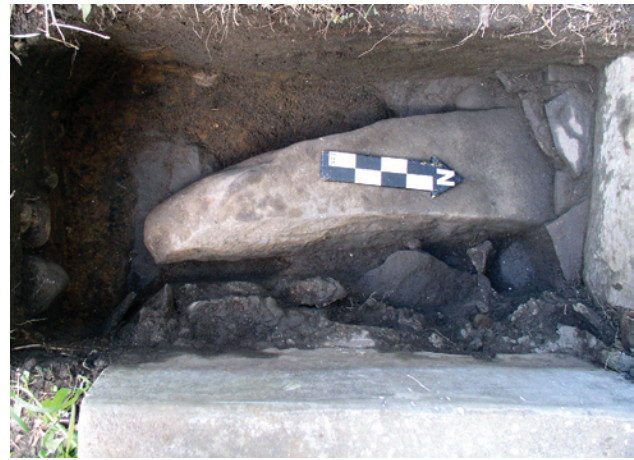
Figure 15. Supporting doorstep stones in 603.5N 804.1E.

This 1 m × 50 cm unit on the west side of the concrete front door step provided information about the doorsteps. Under the current concrete front door step is a slightly larger concrete pad. Beneath that there are two large irregular rocks that may have supported an earlier and larger front step. One runs north–south (into the foundation); the other is beneath it, supporting it, and runs east–west disappearing beneath the concrete pad (Fig. 15). Almost all of

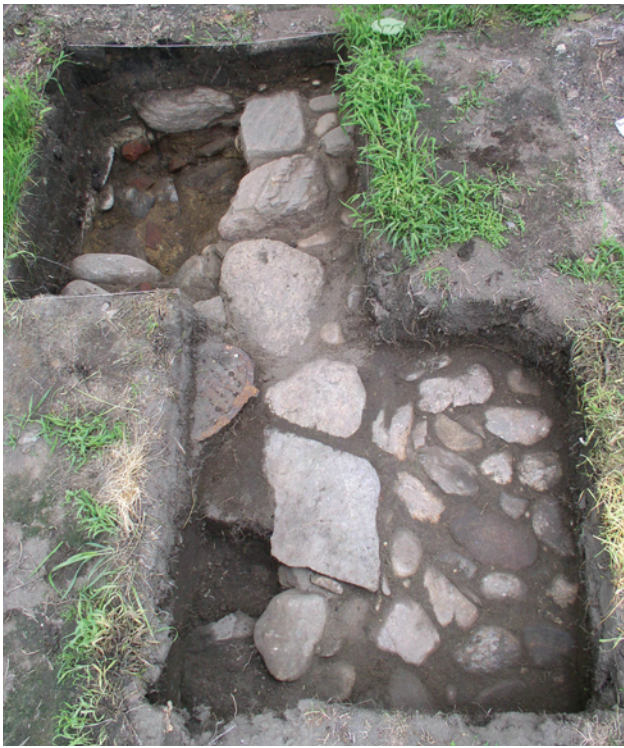
Figure 17. The exposed cobble paving in the west front yard.

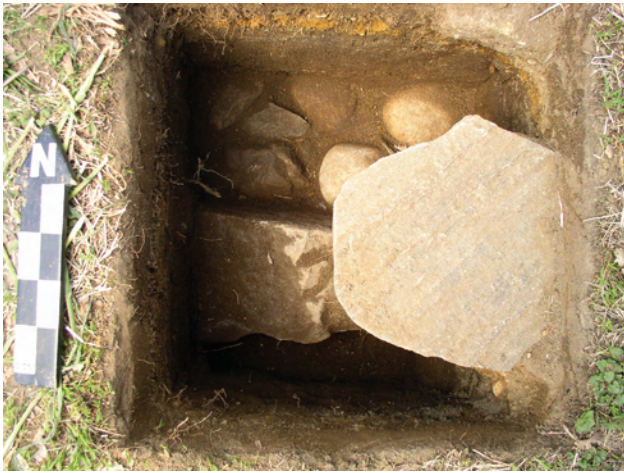
Figure 19. Cobbles in 601N 798E. The stone in the foreground is part of a walkway in a higher stratum. The cobbled surface is beneath.

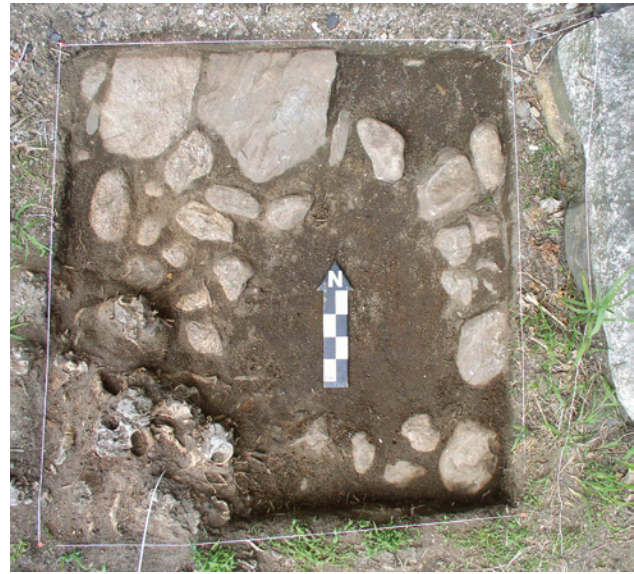
Figure 20. Cobbles in 605N 797E.

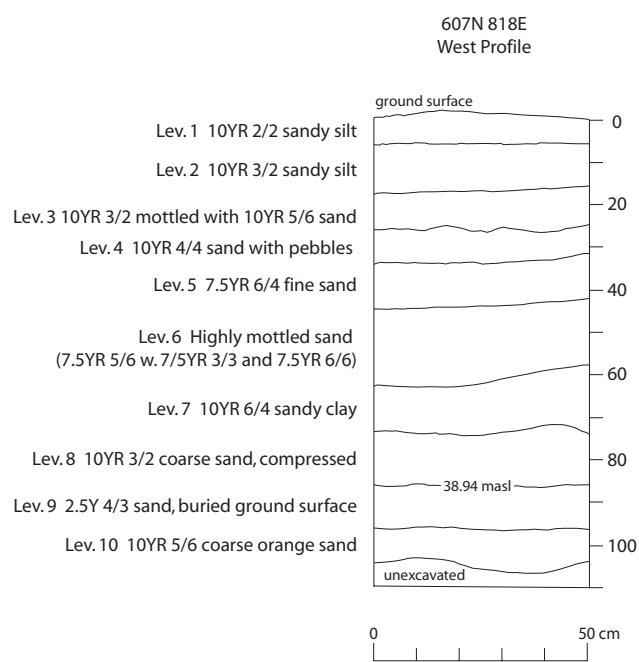
Figure 22. Profile of 607N 818E.

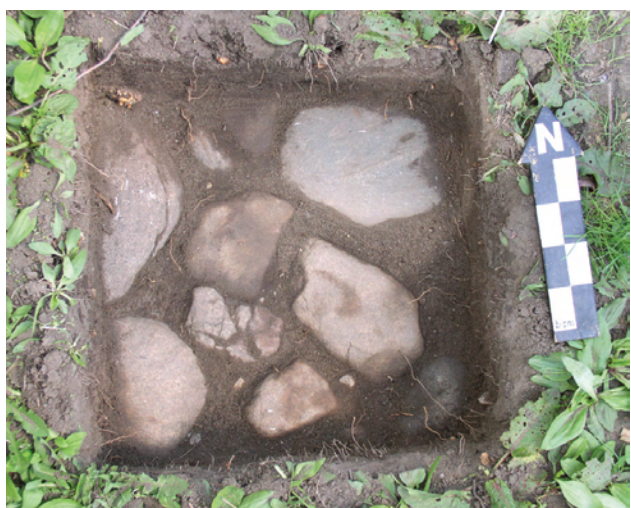
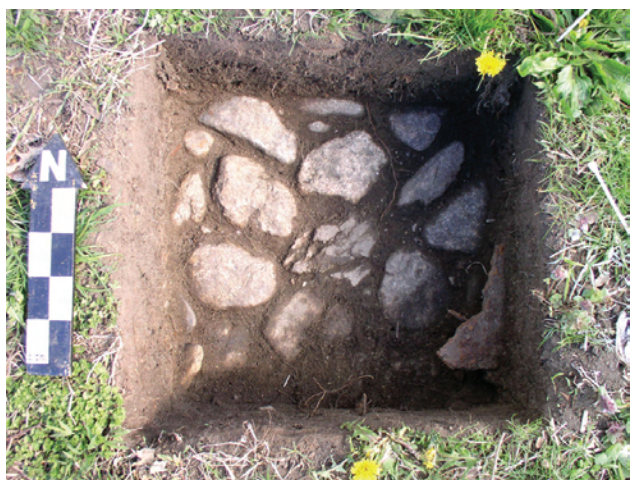
Figure 23. Cobbled surfaces in 607N 812E (A) and 603N 812E (B).

Close to the southeast corner and east side of the house, two test pits (603N 812E and 607N 812E) came down on a buried cobble surface 24 and 13

cm below the modern ground surface respectively (Feature 1). The cobbles in 603N 812E were small (15 × 12 cm and smaller) and irregular; those in 607N 812E were somewhat larger (Fig. 23). The deposit covering the cobbles, particularly in 603N 812E, was a very heavy domestic refuse scatter that included bone, ceramics, and metal objects from the 19<sup>th</sup> and 20<sup>th</sup> centuries, similar in many ways to the upper level trash deposits covering the cobbles in the west front yard. The top 24 cm of this 50 × 50 cm unit (contexts 24 and 26) contained 90 ceramic sherds (redware, whiteware, creamware, and transfer printed, hand painted, and sponge decorated pearlware), 49 fragments of glass, 86 nails, 6 buttons, a shoe horn, and two other pieces of shoe hardware, in addition to bone, brick, coal, and other ferrous debris. This cobbled surface around the southeast

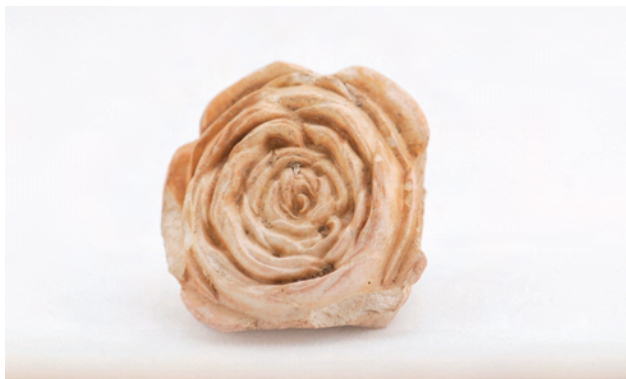
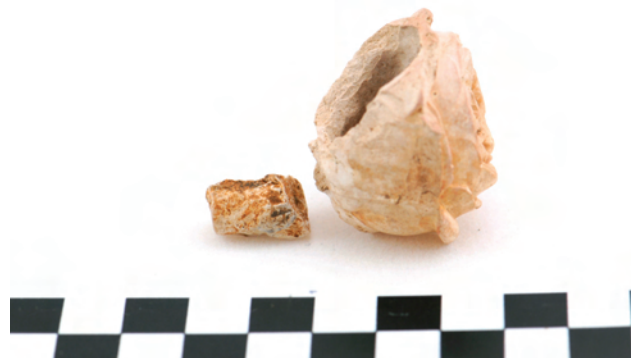
Figure 25. The molded rose pipe bowl, front and side views, from 613.5N 820.5E, level 4, and the cross-mending stem from 603N 812E in the east front yard.

molded pipe bowl in the shape of a rose; the clay has been tinted pink in parts (Fig. 25). The bowl cross mends with a stem fragment with molded leaves from the upper levels (above the cobbles) in 603N 812E. Elaborately molded forms such as this became popular in the 19<sup>th</sup> century. The cross mend between these two contexts is intriguing. Was one of these locations the primary deposit, with some trash then redeposited elsewhere during a cleaning episode? Are both locations secondary deposits? Or, were the two pieces initially deposited in these different locations? The deposits in 603N 812E above the cobbles post-date the ca. 1880s photograph of that corner of the house in which the cobbles are visible. Were some of these materials redeposited in a pit feature in the east ell cellar in an attempt to clean up the front yard of the house?

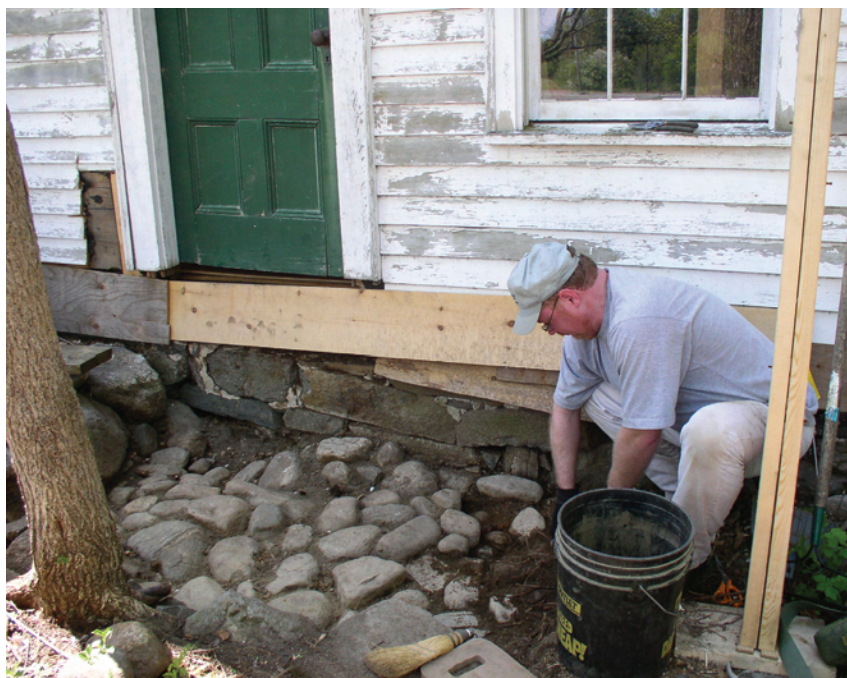
Figure 26. Plan and photograph of the excavated cobbles in the western section of the east ell.

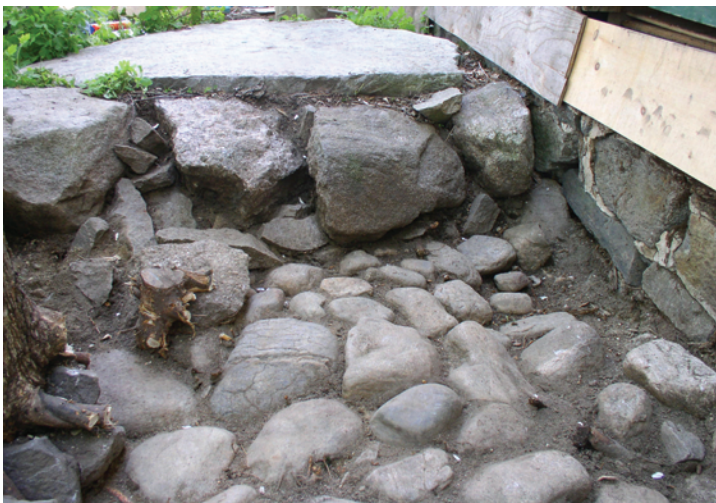
Figure 28. East ell cobbles continue under the surrounding fieldstone foundation. View is to the south.

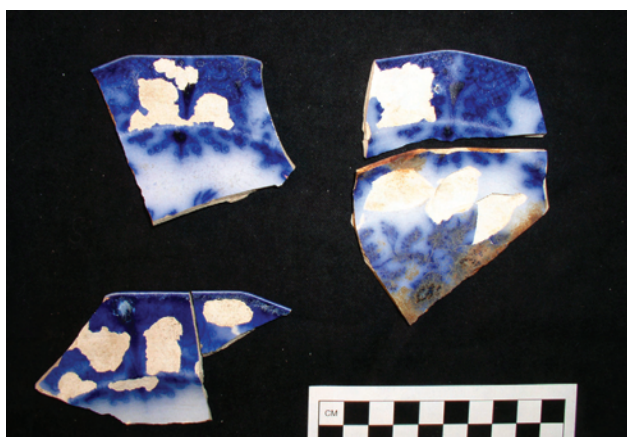
Figure 29. Flow blue plate fragments, vessels 25 and 26.

Forty-nine ceramic vessels, mostly from the 19<sup>th</sup> century, were identified in the MNV analysis from these two units (Table 6). Date ranges were obtained for several of the more distinctive or diagnostic vessels. The presence of several flow blue plates (Fig. 29, vessels 25–26) indicates that ceramic deposit dates to after 1845, the date at which these wares became widely available in North America (Samford 1997: 24; Miller 2000: 13). Other datable artifacts include an ironstone tea bowl with blue underglaze

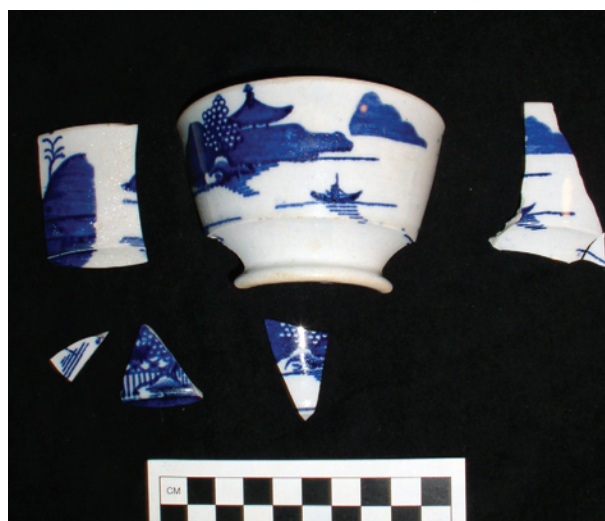
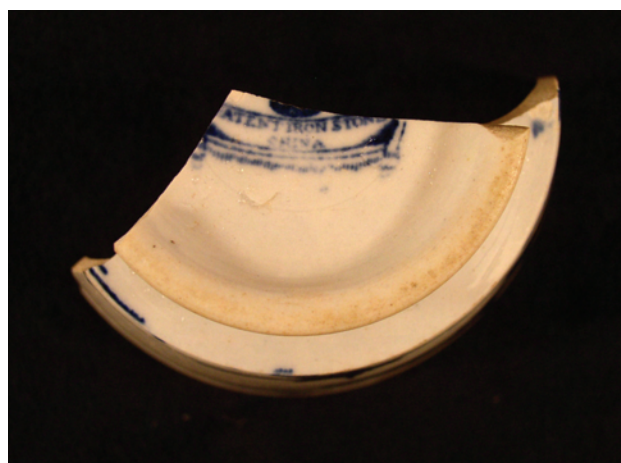
Figure 30. Ironstone tea cup fragments and maker's mark, vessel 11.

painting (Fig. 30). The partial maker's mark on the bottom of the cup (vessel 11) reads “-ATENT IRONSTONE/ CHINA” inside a fringed banner with an indeterminate rounded object centered above it. This mark is very similar to the standard printed mark used by Mason from 1815 to ca. 1840 (Godden 1980: 224). In the complete mark, a rounded crown is centered above the banner with the word “MASON'S” arching above the crown. In the late 1850s and following, other producers of ironstone china acquired Mason's molds and mark and continued to use a more angular crown and fringed banner, sometime with their own name beneath (see examples in Godden 1980: 231, 267). This cup is more likely attributable to the first period of use of this mark (1815–1840) than the second, given the rounded crown, the cup's London or Grecian shape (popular

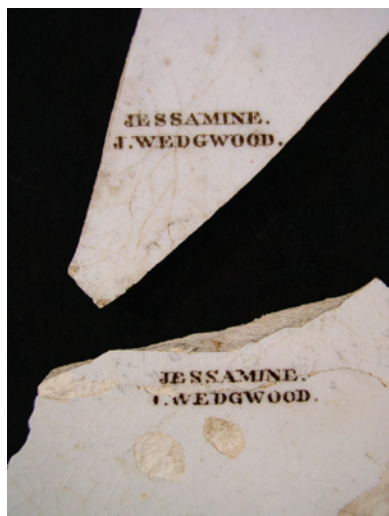
Figure 31. One example of the three “Jessamine” pattern plates and saucer, vessels 20 to 22, and the maker’s marks from the plates.

There are three vessels (nos. 20–22) of the same brown transfer printed pattern, two marked “JESSAMINE/ J. WEDGWOOD” on the back (Fig. 31). This mark was used by several potters between ca. 1841 and 1860, but not by the famous Josiah Wedgwood who did not use the initial “J” in his marks (Godden 1964: 687). Additionally, production date ranges were obtained on two different types of blue shell-edged pearlware vessels. The first, a plate or saucer, with an impressed design, has mean beginning and end dates of 1809 and 1831 (Miller 2000: fig. 5D). The second, a large straight edge plate or platter, had a mean date range of 1841 to 1857 (Miller 2000: fig. 5H). Cross-mending vessels in different levels and different soil matrices suggest that this midden is probably the result of several deposits over a short period of time. Additionally,
