Site Examination of the Durant-Kenrick House, Newton, Massachusetts

**Prepared for:
Historic Newton
527 Washington St.
Newton, MA 02452**

**Prepared by:
Christa M. Beranek
With contributions by David Landon, John Steinberg,
Christiane Carducci, Danielle R. Cathcart, Allison Conner,
Samantha Henderson, Kalila Herring, Julie Powers, Meagan Ratini,
Joshua Stewart, and Courtney Williams
Andrew Fiske Memorial Center for Archaeological Research
University of Massachusetts Boston**

Cultural Resource Management Study No. 63

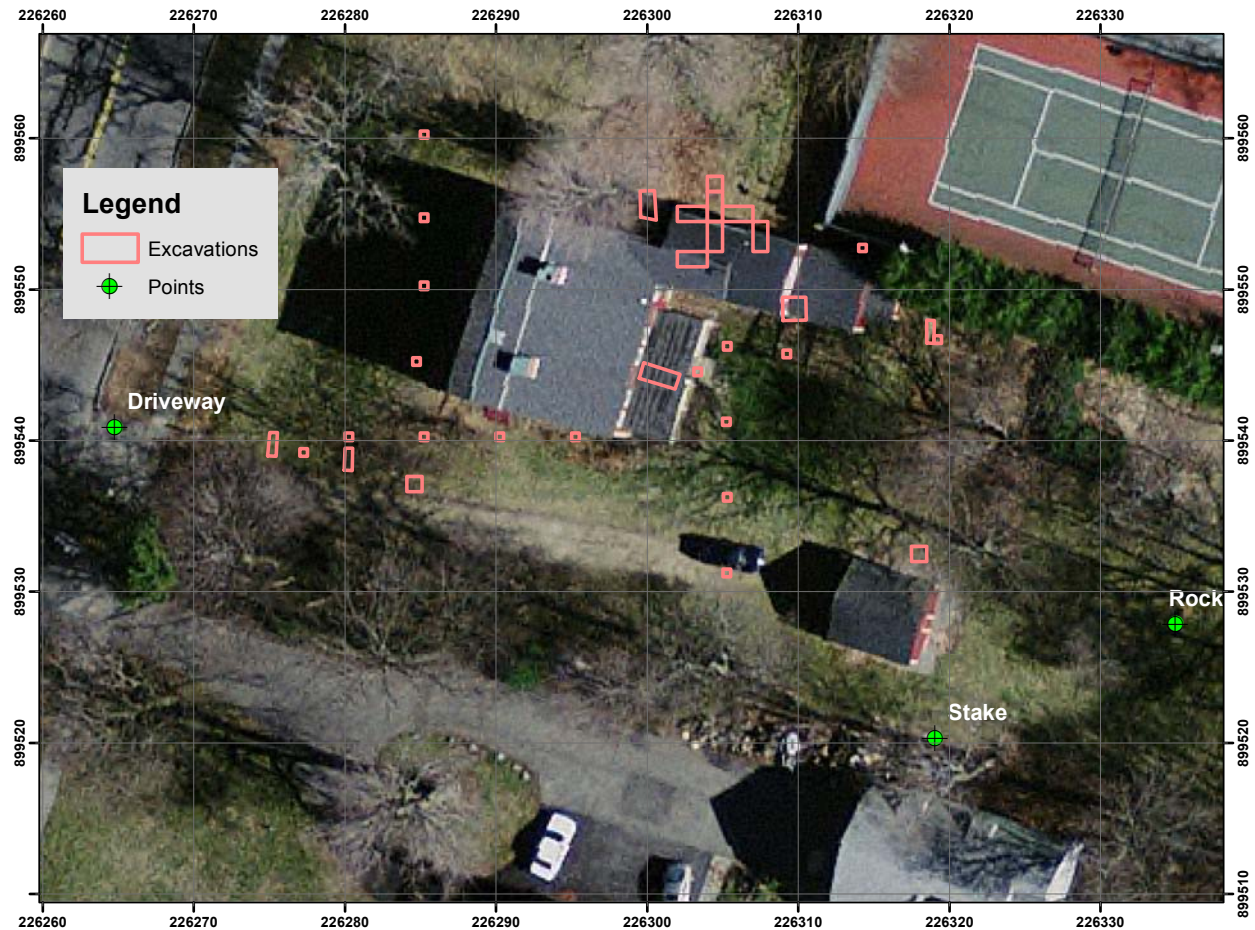
Figure 2.1. Location of shovel test pits and excavation units with resection points, shown over the air photograph of the site prior to construction. Numbers in the margins of this and other figures are meters in the Massachusetts State Plane grid, with north to the top.

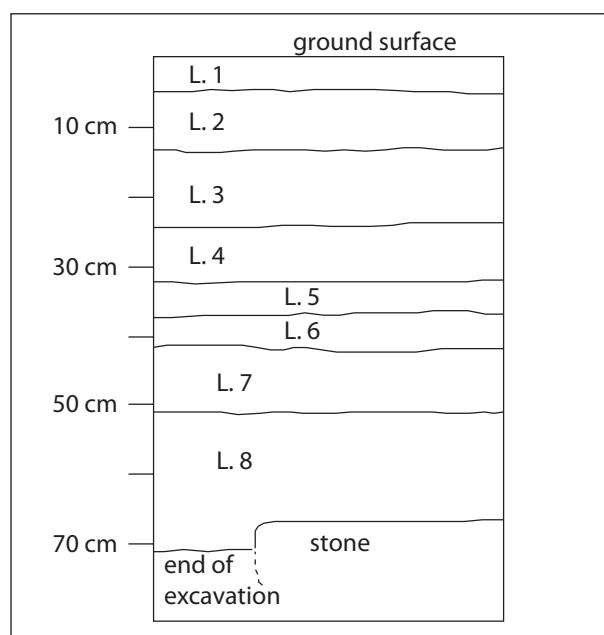
Figure 2.4. East profile of STP 8.

Level	Depth (cmbs)	Interpretation/Soil Description	Artifacts
1	0-4	Topsoil and root material	Modern nails
2	5-13	20th c. topsoil; very dark brown medium sandy silt w light gravel	Modern nails; wide array of historic ceramics
3	14-24	Buried yard surface; dark brown medium sandy silt w increased gravel	Cut nails, coal
4	25-32	Construction debris; dark yellowish brown w gravel, building stone	None
5	33-37	Redeposited subsoil; dark yellowish brown w few inclusions	None
6	38-42	Buried A horizon; very dark brown w light gravel	None
7	43-51	Transition to B horizon; mottled medium sandy silt w cobbles	None
8	52-71	B horizon; yellowish brown, less mottled sandy silt w rock	None

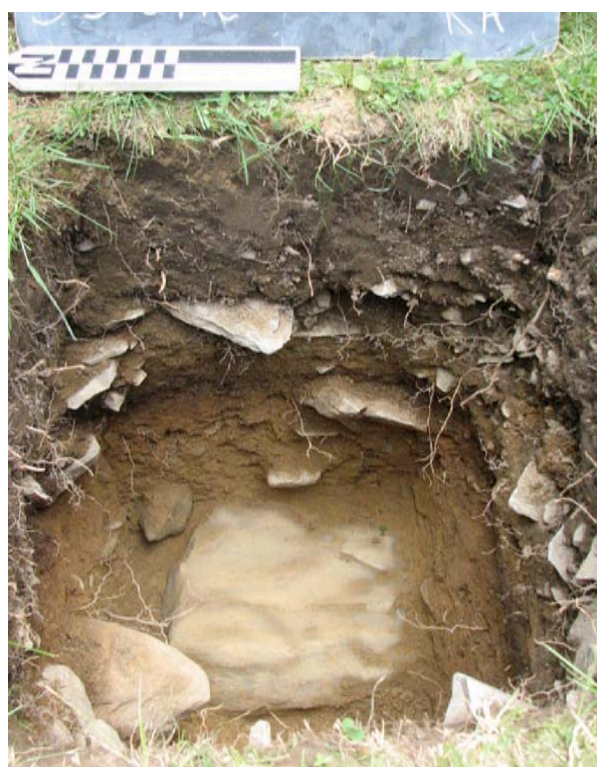
Figure 2.5. East wall of STP 8 with rock rubble visible in the walls.

Layer 4 was characterized by even more dense rock rubble and a mottled mix of dark brown and brighter B-horizon soils (Fig. 2.5). This transition was found in STPs 3, 8, 9, and 10 and stretched across the front yard. The large cobbles, gravel, and rocky foundation stones consistently continued into this level. Fewer artifacts were recovered; there were no artifacts in STP 8; STP 9 had one nail; and STPs 3 and 6 had a few sherds of glass and redware. This layer was probably deposited during the construction of the house's foundation ca. 1734.

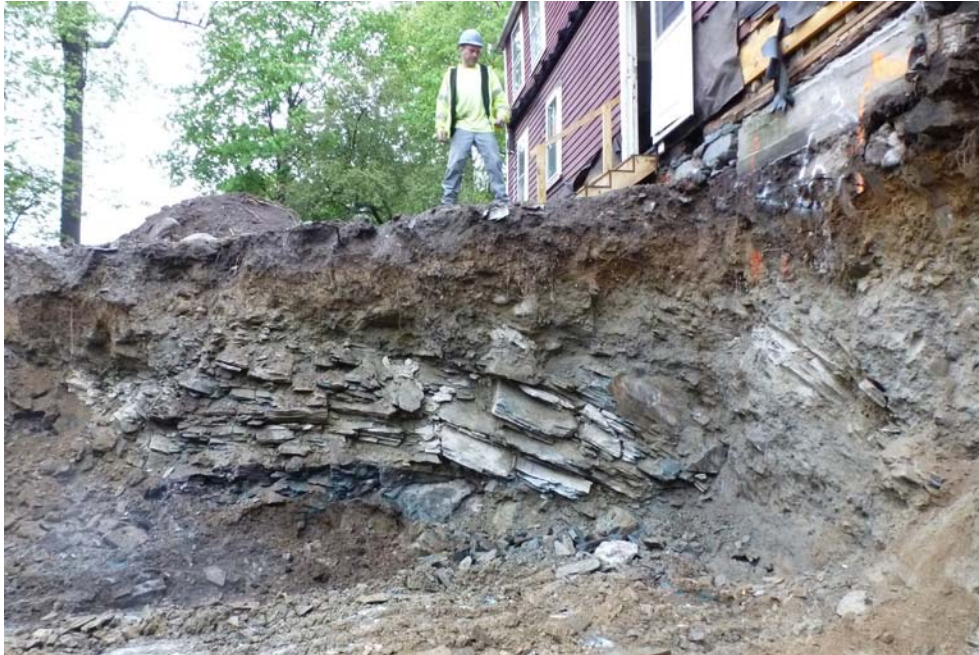
Figure 2.7. Profile of the construction excavations for the new ell cellar showing the shallowness of the bedrock around the house.

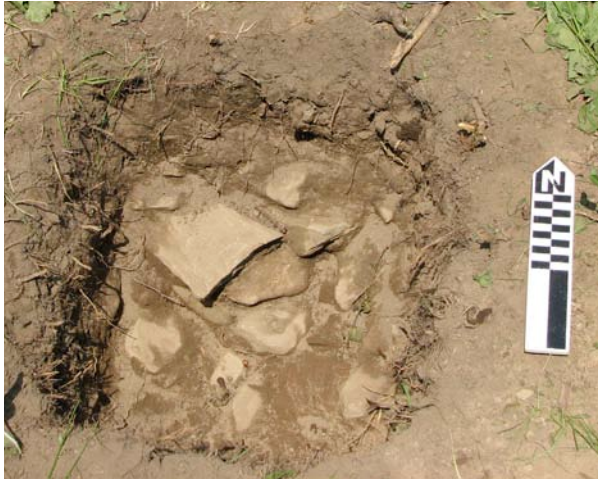
Figure 2.8. Stone rubble in STP 1 at 20 cmbs.

material. Beneath this in STP 1 was a dense brick and stone rubble level at 20 to 45 cmbs (Fig. 2.8); in STP 2 the corresponding layer (from 25 to 34 cmbs) contained some rock and gravel. Both of these levels contained some 18th and early 19th-century artifacts, suggesting, as in the front yard, an exposed ground surface made up of construction debris, gravel, and only a small accumulation of soil existed for a relatively long period, roughly the first century of the house's existence. Beneath the gravel and stone rubble layers were contexts that seemed to be thin buried ground surfaces (contexts 8 and 15) that contained no artifacts or only sherds of redware, followed by a transition to subsoil at between 42 and 50 cmbs.

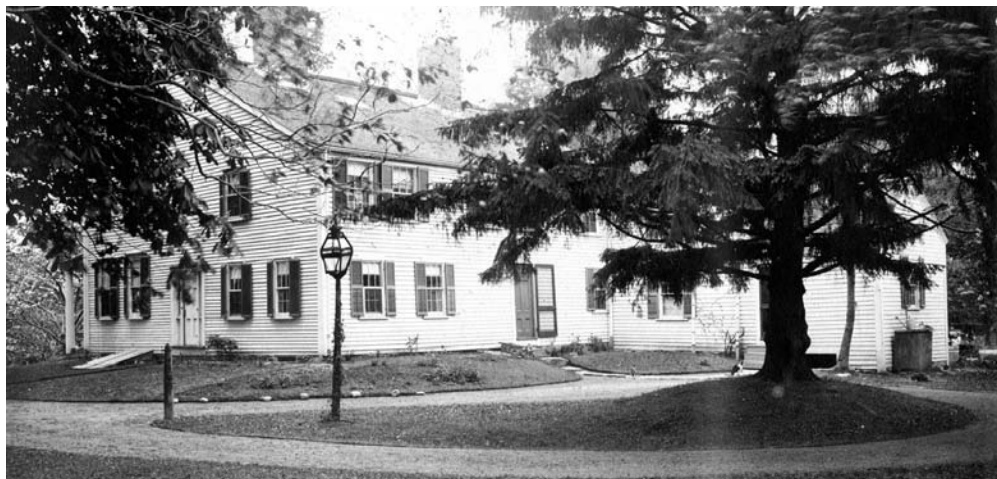
Figure 2.10. The rear of the Durant-Kenrick house between 1900-1912, showing the circular driveway (Grady, Brockway, and Fuhrer 2010: 133).

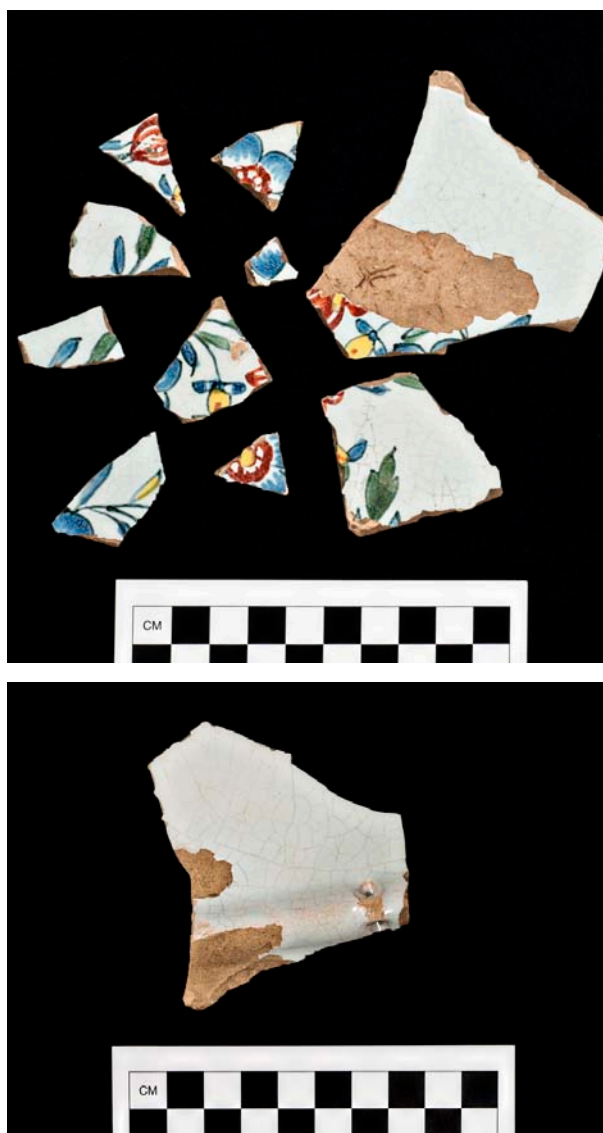
Figure 2.12. Tin-glazed fragments from STP 13; front showing decoration and rear showing hole in foot rim.

The 14 sherds of the tin-glazed flatware (Fig. 2.12) offered an interesting find; a hole bored into the foot rim suggests that they might be from a charger, a large flat dish that was used both to serve food and as a display piece hung on the wall (Lange 2001: 101). Lange writes that using ceramics as decorative pieces on walls, mantelpieces, or sideboards became common in the late 17th century, but that the manufacture of large decorative chargers had primarily ended by the mid-18th

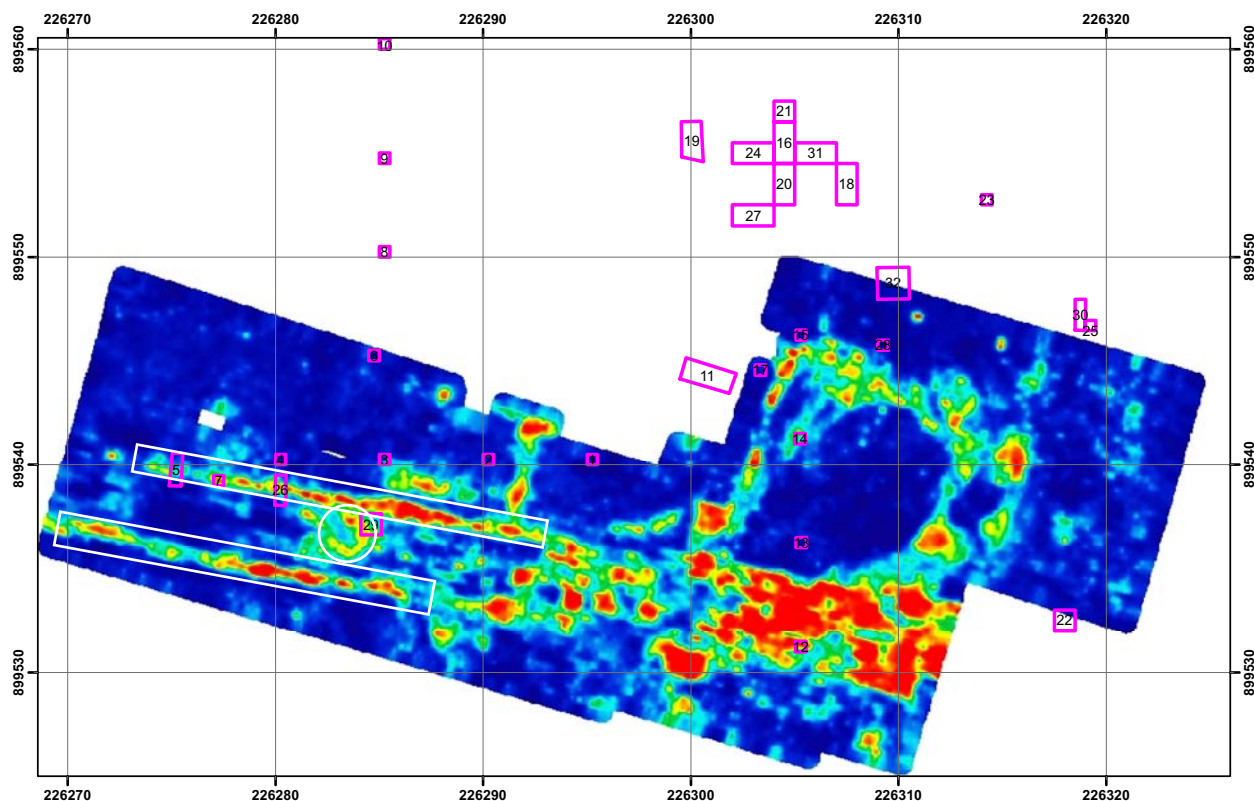
Figure 2.13. GPR image of Anomaly 3, seen as two parallel lines, highlighted by white rectangles. East-west fall 500 MHz GPR survey of the south side of the house at 6-14 cm below the surface. The false positive for an anomaly in the driveway can also be seen, in the white circle.

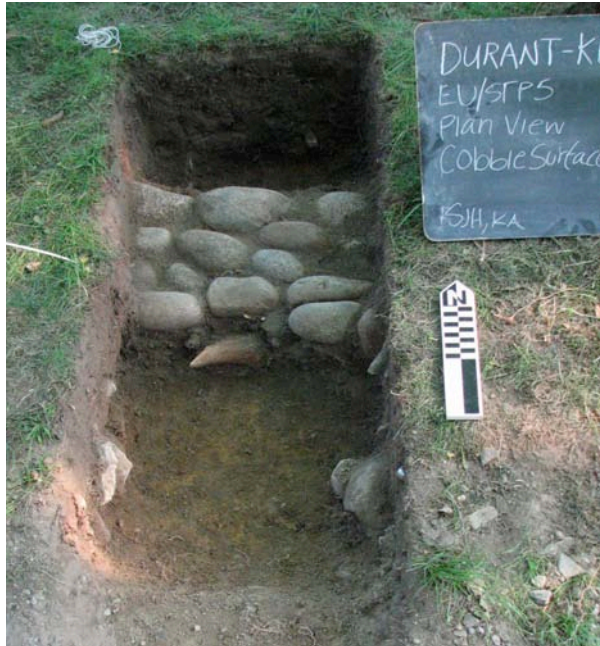
Figure 2.14. Cobble edging along the north border of the driveway in EU 5.

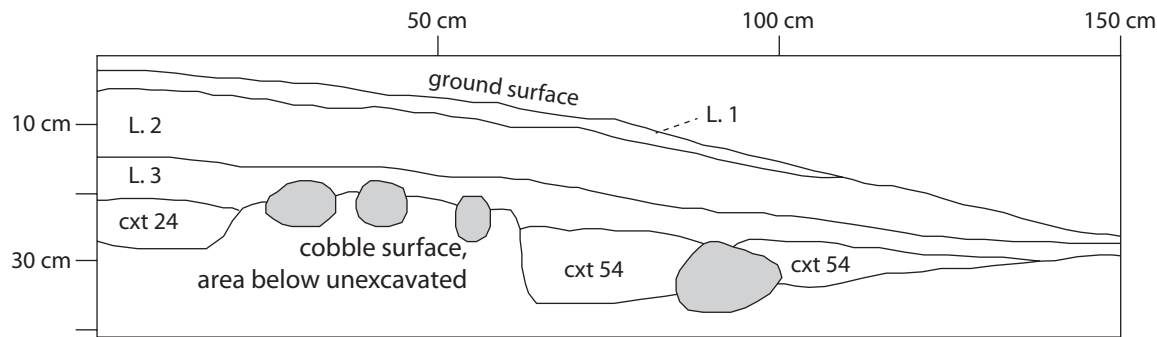
Figure 2.15. East profile of EU 5.

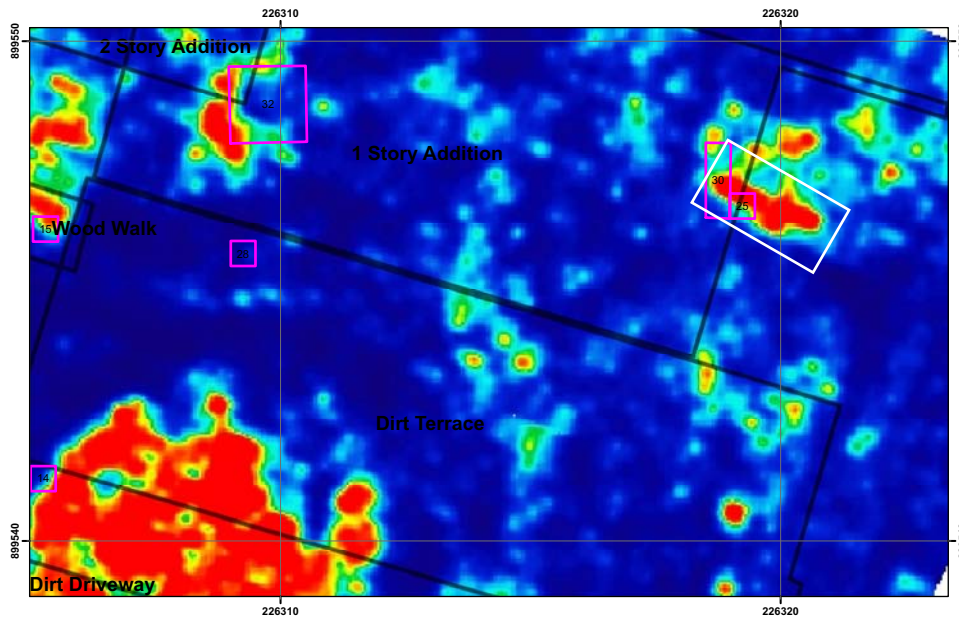
Figure 2.16. GPR image of Anomaly 6, PVC pipe, in the east-west spring 500 MHz survey at 50-55 cm below the surface.

The GPR survey also detected several anomalies (6, 7, and 8) that represent 20th-century utilities. Anomaly 6, seen in Figure 2.16, was a strong signal seen in the backyard, off the back end of the recently torn down ell. The signal was seen beginning at 40 cm below the surface in all of the spring surveys using the 500 MHz antenna. The signal is not apparent in the survey conducted

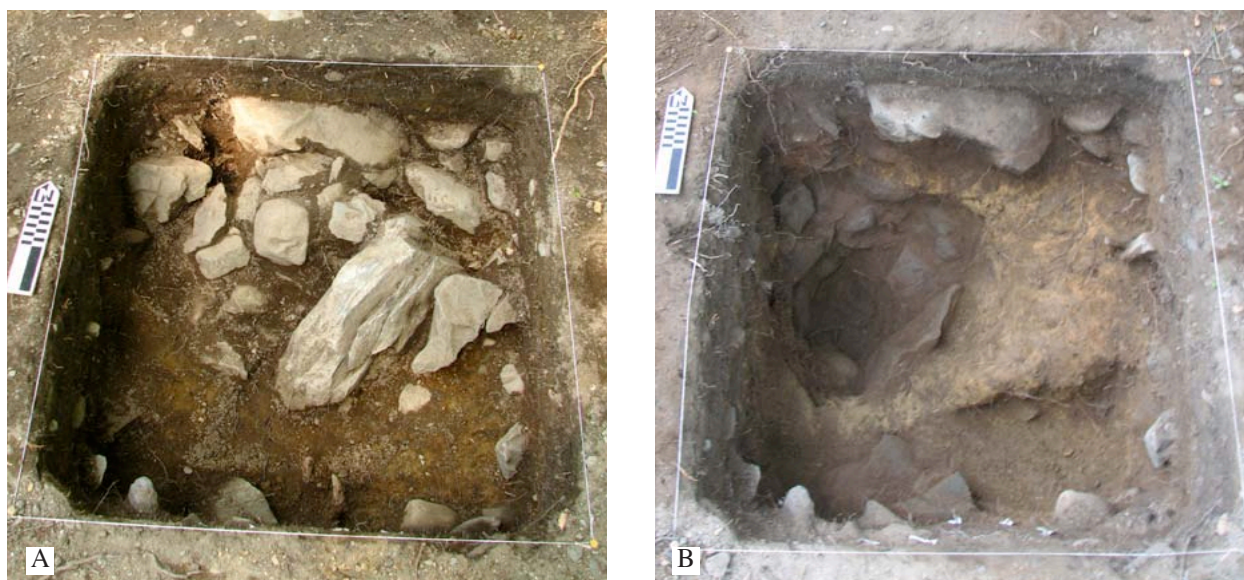
Figure 2.18. EU 22; A) Rocks from the barn foundation; B) posthole.

jumbled rocks sitting in a depression and over an irregular pit feature, possibly a large, structural posthole (Fig. 2.18). The rocks covered the northern part of the unit, and were probably displaced from a wall or foundation. The 1874 atlas (Fig. 1.3a) shows an outbuilding (the barn) in this location; this barn and the house's ell burned in a fire on the night of November 14, 1875. According to a newspaper account, the fire started in the barn and spread to the ell by way of a wooden shed (not depicted on the map) that stood between the two (Grady, Brockway, and Fuhrer 2010: Appendix 4). The same account lists the contents of the barn as a cow, 40 hens, and 10 tons of hay. One of the artifacts in a fill layer adjacent to the disturbed rocks was a well preserved horseshoe with nails still in place (Fig. 2.19), though this may have come from an earlier use of the barn, as no horses were mentioned among the animals lost in the fire. The 1886 atlas (see Fig. 1.3b) does not show any outbuildings, suggesting that the barn might not have been reconstructed. The fill over the rocks is covered in part by a layer of coal ash, suggesting that the coal ash layers found elsewhere in the rear yard may also date to after 1875.

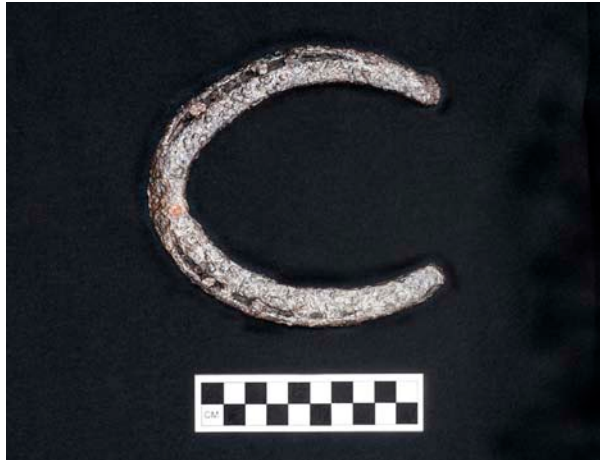
Figure 2.19. Horseshoe recovered from EU 22.

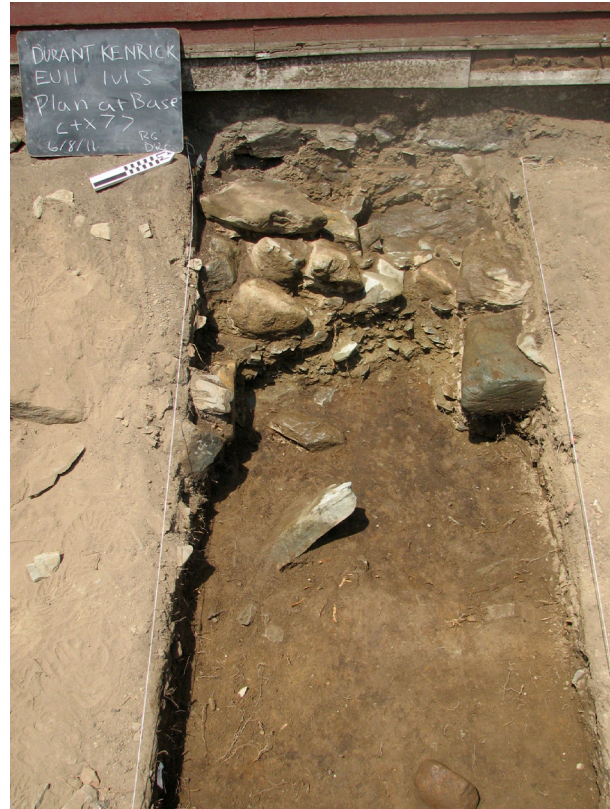
Figure 2.20. EU 11 excavation in progress with the stones that re-enforced the foundation becoming visible.

Since this rock debris is continuous with and built into the rear foundation (see Fig. 2.20), it seems likely that the construction episode was either the construction or re-enforcement of the rear foundation wall. The house as originally built in the 18th century had a full two and a half stories in the front, but only lean-to rooms in the rear (Grady, Brockway, and Fuhrer 2010: 60). This lean-to was raised to incorporate a full second story at an unknown date during the Kenrick occupation. Traditionally, a date of the 1830s was given; Grady suggests a date between 1790 and 1810 based on some of the stylistic elements in the new rooms (Grady, Brockway, and Fuhrer 2010: 64-65). The construction around the rear foundation may be connected to raising the rear rooms to a full two stories; the lean-to, as a less substantial structure than the front of the house, could have been built with a lighter foundation, piers, or even posts in the ground (we have no evidence for selecting one of these configurations over another). Either at the point when the lean-to was raised, or some time later, the original rear foundation seems to have been deemed inadequate for the new weight of the structure above and it was rebuilt or reinforced, resulting in the broad foundation and berm of rocks that we uncovered. The coal in the ground surface covered by this construction event suggests that the foundation work was not carried out until the 1830s or later. This suggests that the addition of the second story over the former lean-to might have taken place in the 1830s, but is not conclu-

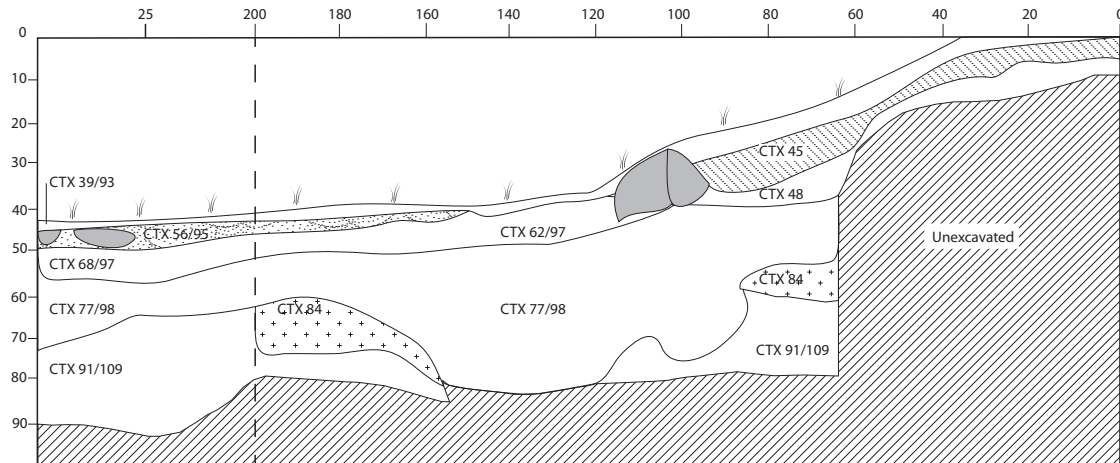
Figure 2.21. South profile of EU 11 and its extension. The unexcavated area at the right is the house foundation.

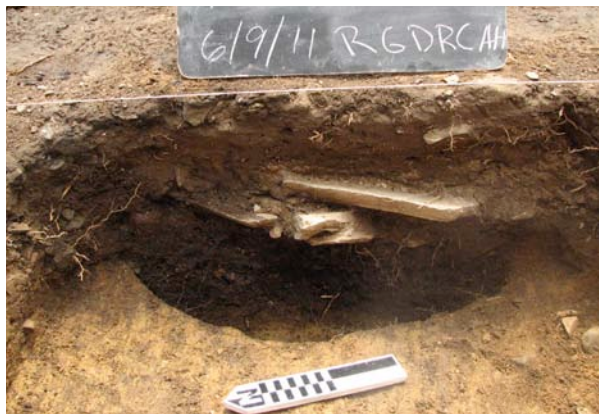
Figure 2.22. East profile of EU 11 (before adding the extension) showing the small pit feature.

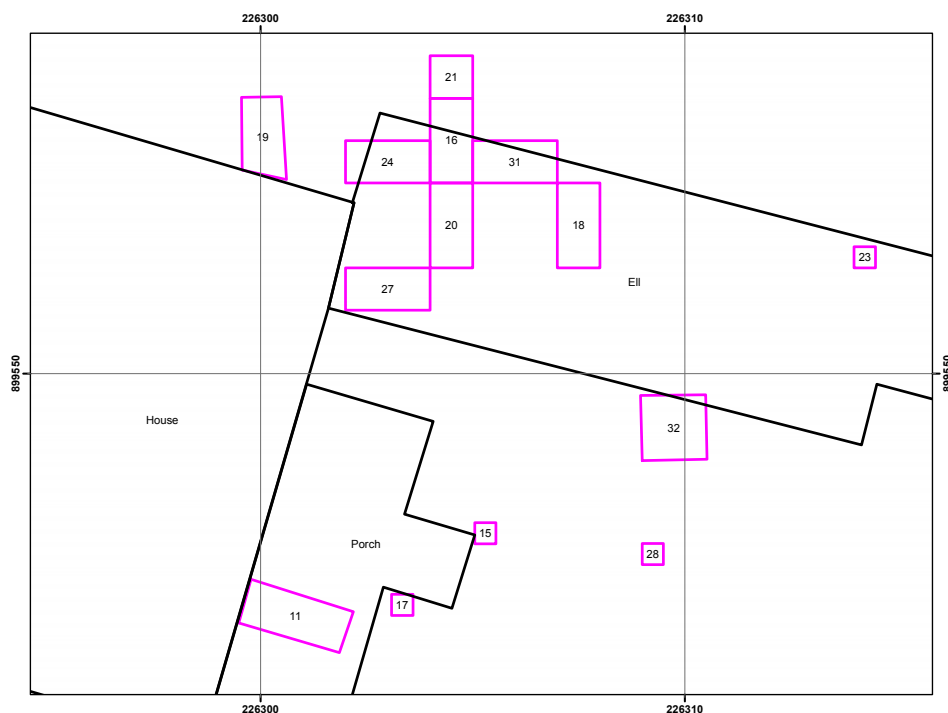
Figure 2.23. Plan of units near the northeast corner of the house shown over the pre-2011 building footprint.

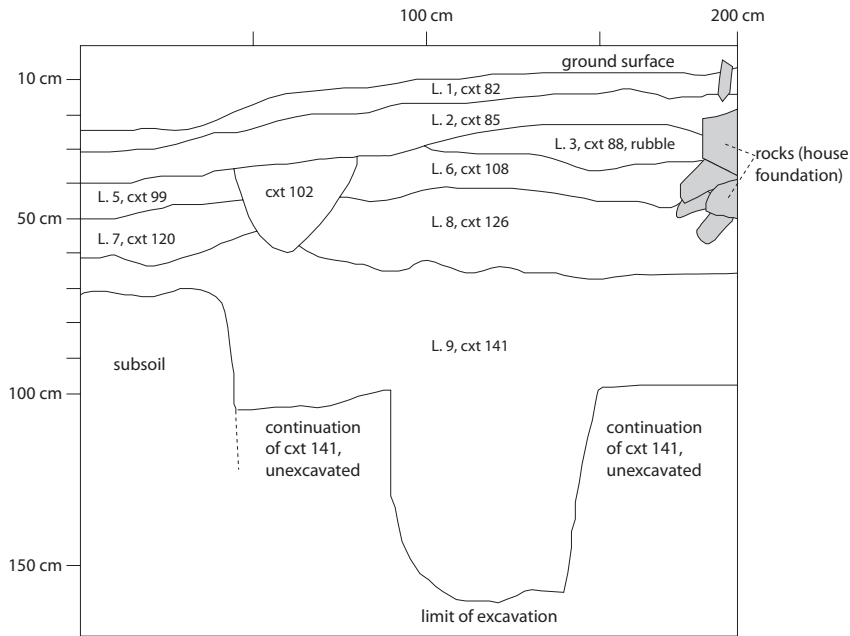
Figure 2.24. EU 19 east wall profile.

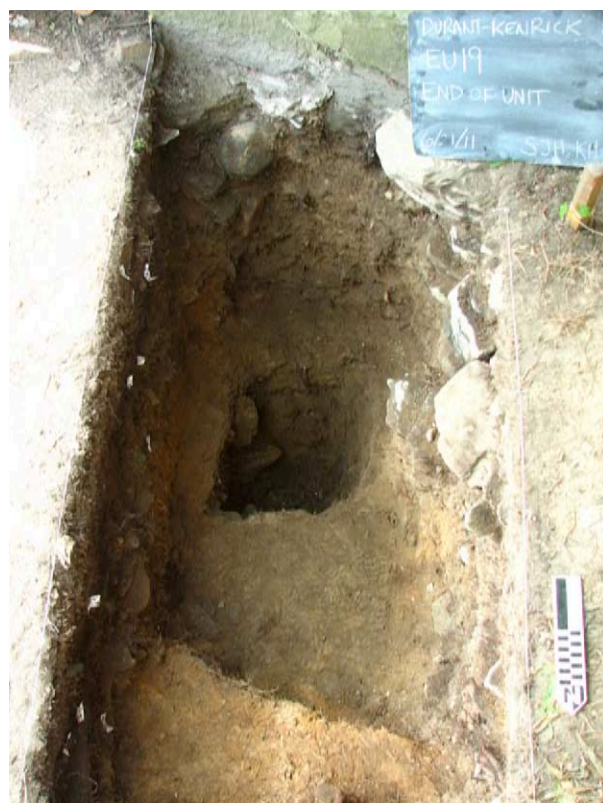
Figure 2.25. EU 19 at the end of excavation. The lighter soil at the north end of the unit is subsoil; the dark soil in the south (top of the photograph) is fill in a straight edged cut. The deeper hole is a test to find the bottom of the fill; the whole unit could not be excavated to this depth for safety reasons.

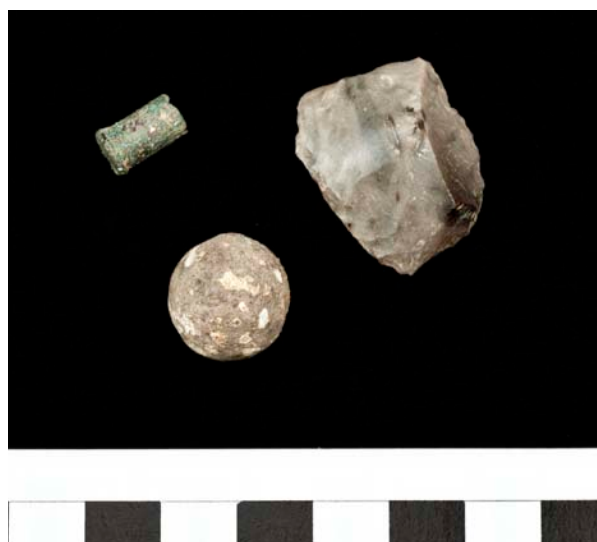
Figure 2.26. Gunflint, musket ball, and shell casing from context 141, EU 19. Scale in cm.

Beneath contexts 120, 126, and 108, a large mottled deposit was identified as context 141, located only on the south portion of the unit, near the foundation. This deposit fills a cut in the subsoil that has a straight, vertical north edge (Fig. 2.25). The context was characterized by dark cultural soil with a mix of 18th and 19th century artifacts, including 2 gunflints, a musket ball, overglaze painted creamware, and yellowware (Fig. 2.26). The relatively large piece of yellowware from deep in this deposit, is not likely to have been

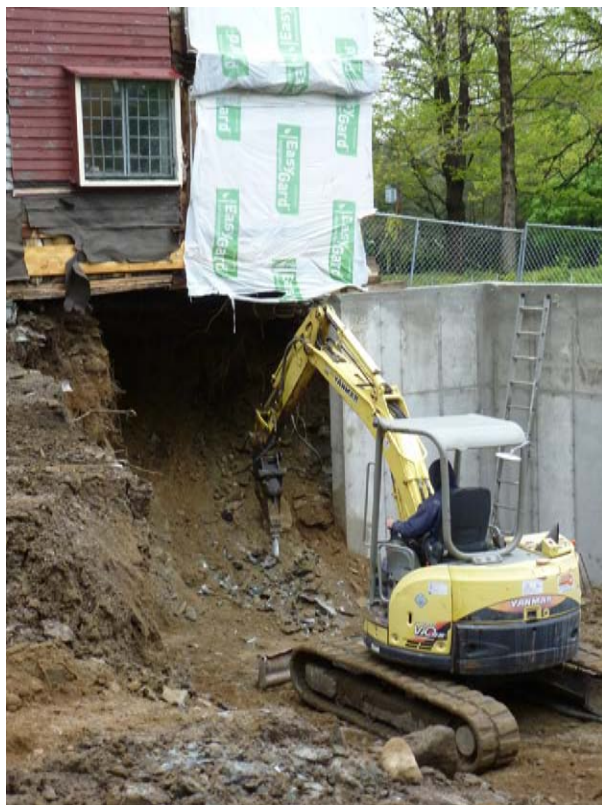
Figure 2.27. Construction excavations of a passage under the northeast quadrant of the house. We were able to view the profile of the cut discovered in EU 19.

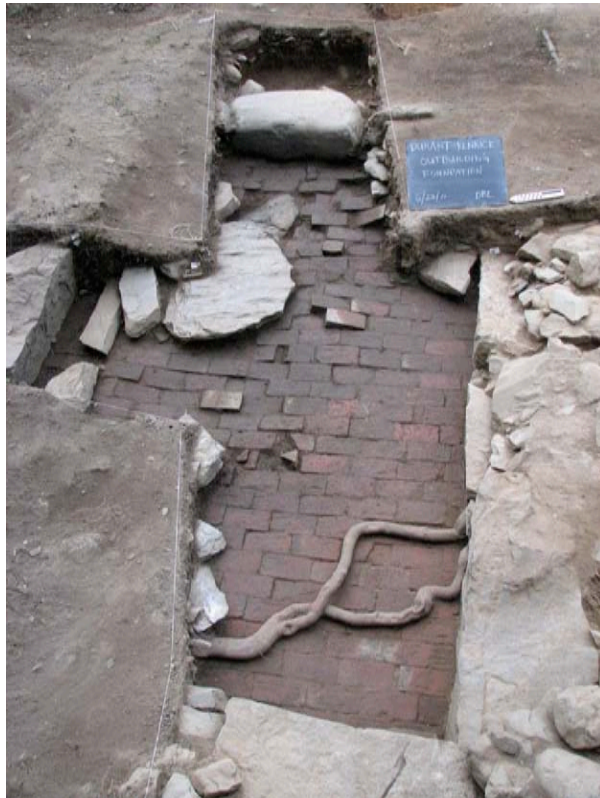
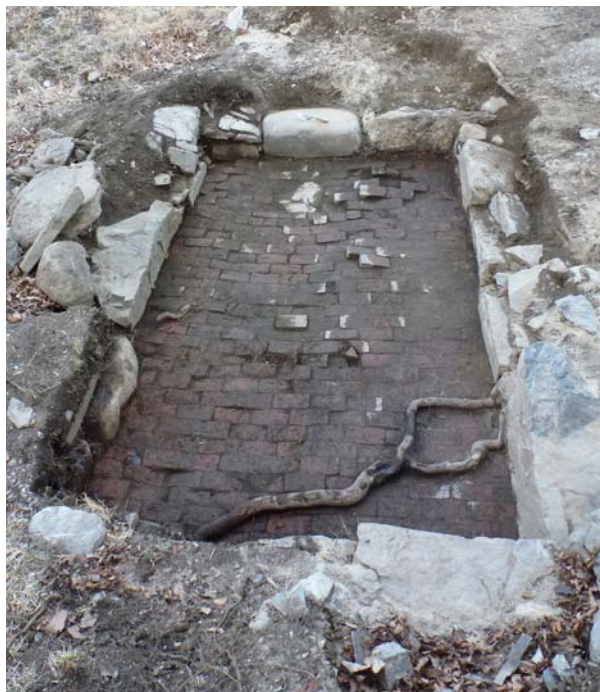
Figure 2.28. The dairy, facing east, at the end of the 2011 season (top) and after the removal of all of the fill deposits in February 2012 (bottom). The northeast corner of the house is just outside the bottom right of both photographs.

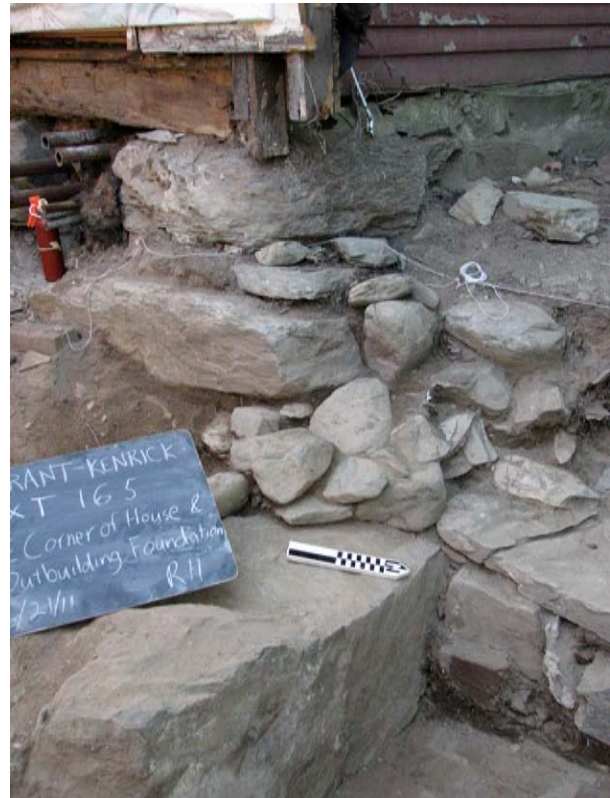
Figure 2.29. Detail of the northeast corner of the house and southwest corner of the dairy.

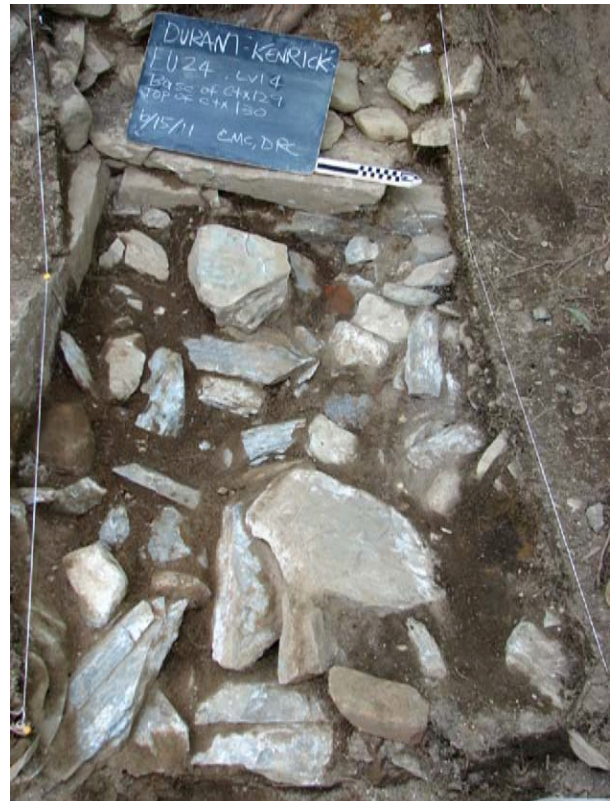
Figure 2.30. Displaced stones and bricks in the dairy fill. EU 24 is shown, but other units had similar deposits, although the stone was less dense in some areas.

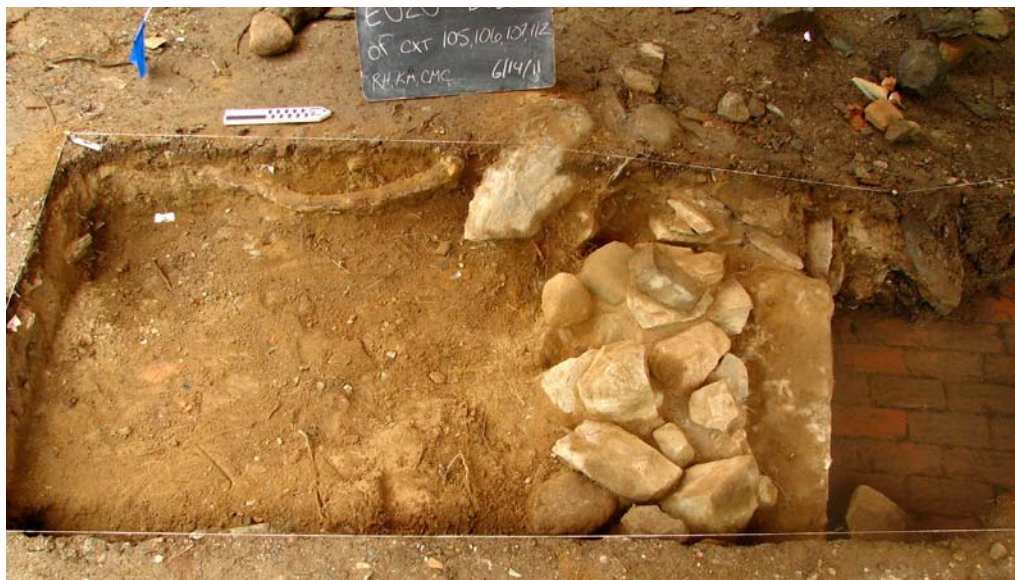
Figure 2.31. Smaller stones set into a trench immediately outside the dairy's large foundation stones.

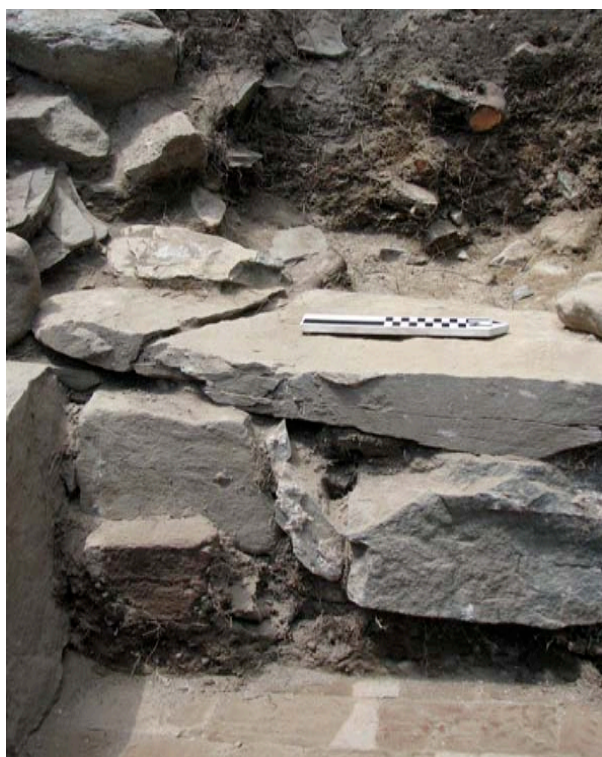
Figure 2.32. Detail of the southwest corner of the foundation, showing the bricks running under the west wall.

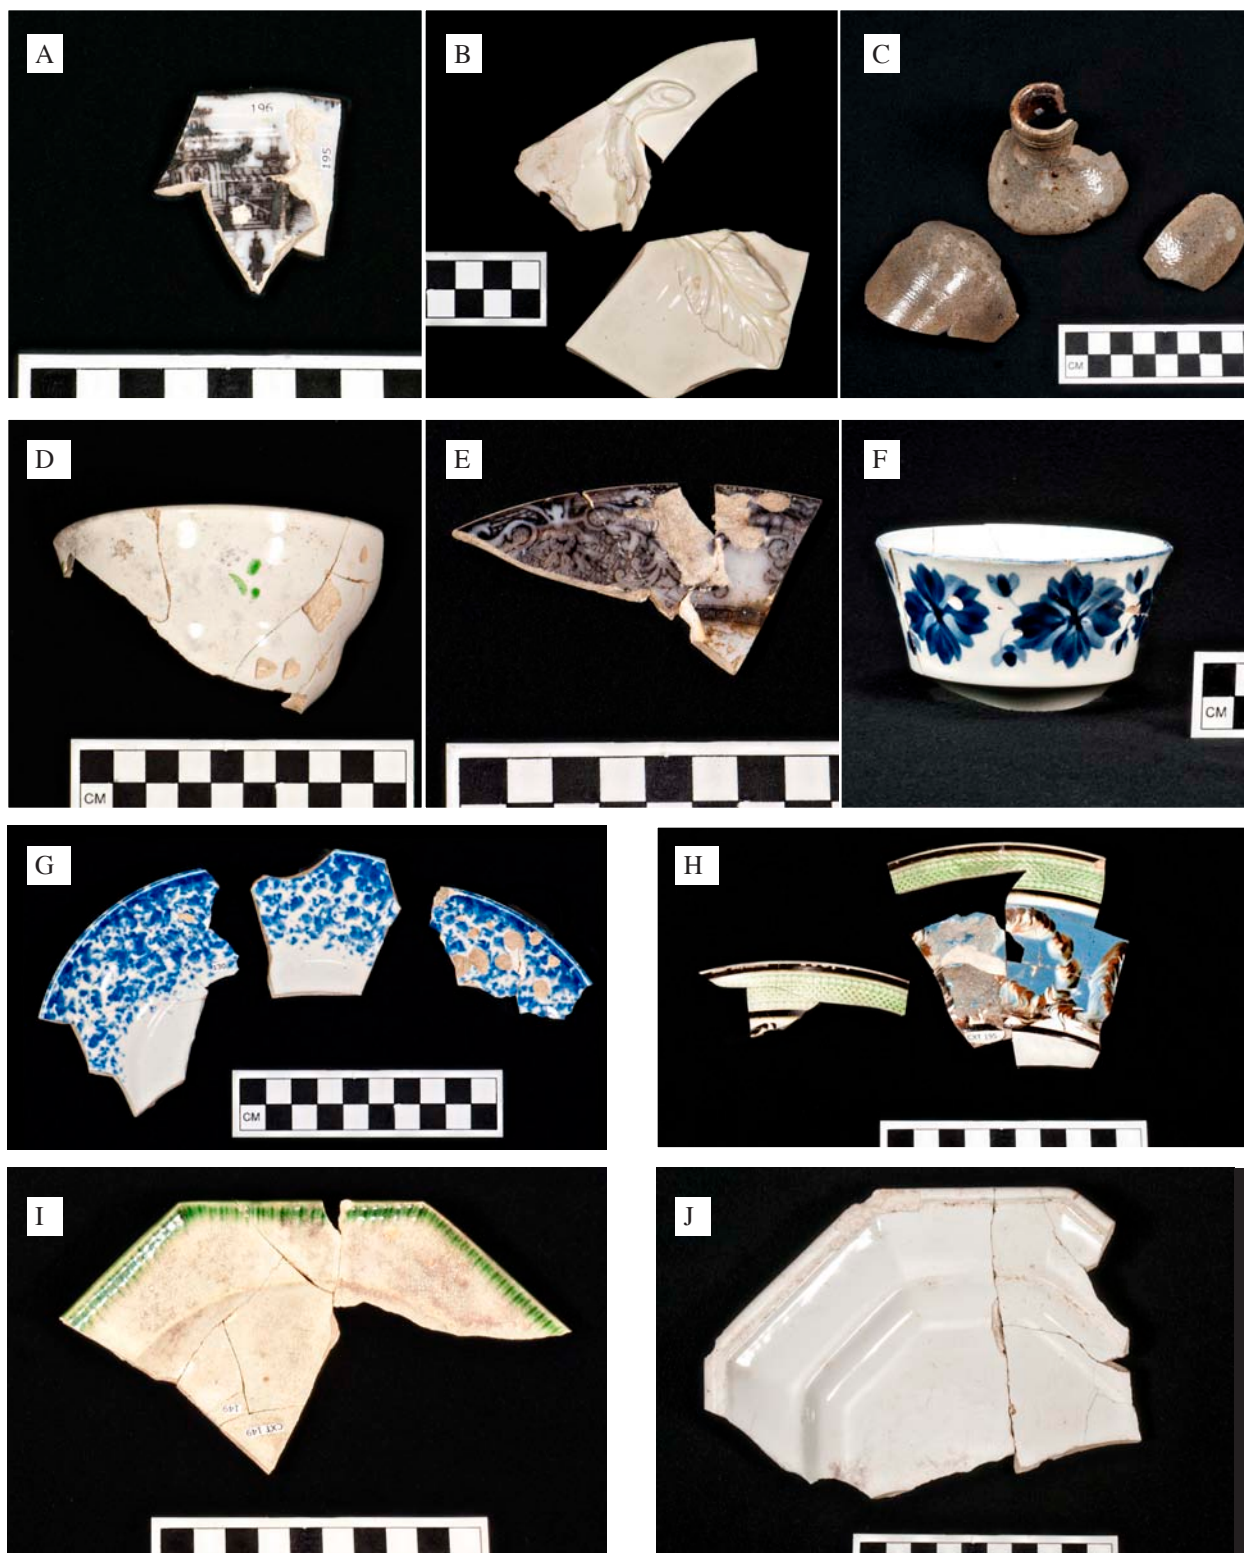
Figure 2.33. Example ceramic vessels from the dairy fill. Scales in cm. A) ves. 84, flow black whiteware bowl; B) ves. 83, molded creamware, possible jug or teapot; C) ves. 82, stoneware bottle, possibly for ink; D) ves. 16, whiteware tea bowl painted in chrome colors; E) ves. 48, flow black whiteware bowl or saucer; F) ves. 39, hand painted pearlware tea bowl; G) ves. 44, sponge decorated pearlware bowl; H) ves. 32, factory slip decorated pearlware bowl; I) ves. 15, shell edged pearlware plate; J) ves. 45, ironstone plate or platter. Photographs by Melody Henkel.

(Fig. 2.33). There was the possibility of mending more vessels, but with a few exceptions, we only mended undecorated or poorly dated wares if they had a clear rim or base. To determine the MNV, the wares were separated by decorative elements, body type, size, and vessel form where possible. Each group was then counted as a “vessel” for the purposes of the count. Although 36% of the ceramic sherds are redware, only 17 redware vessels (25% of the vessels) were identified, including one flower pot and one milk pan. Other redware fragments were too small to provide definitive information on vessel types, but typical forms include milk pans, bowls, and storage jars. Redware sherds are much more difficult to sort into different vessels because they lack the distinctive decorations that allow us to separate different refined earthenwares from each other. Therefore, the number of redware vessels is almost always undercounted relative to other ware types. Most of the identifiable vessels are tea and table wares

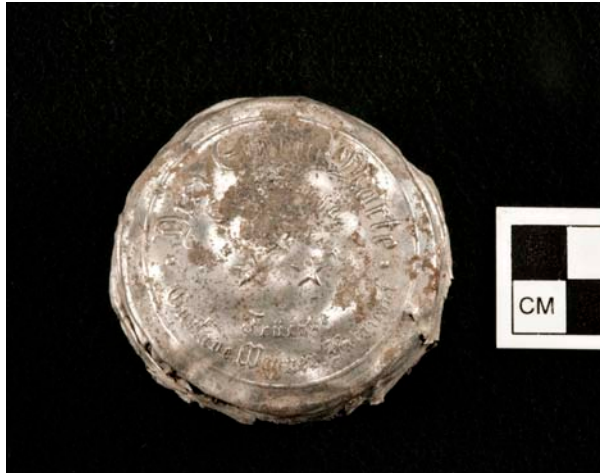
Figure 2.34. Lid from a jar of fruit preserves with text in German. Photograph by Melody Henkel.

Two marked artifacts in the fill provide a little more information about the specific foods that were packaged. One is a tin-plated lead lid that was found crushed and was carefully unfolded by Dennis Piechota, the Fiske Center conservator. This lid (Fig. 2.34) has a roughly 6 cm diameter and is designed to screw onto a glass jar. The surface has text in German reading “Drei Sterne Marte Eingemachte Früchte/ Trade Mark/ Gustave Mayuer Fabricant” with three stars in the center of the lid between “Trade” and “Mark.” This translates as Three Star Brand Fruit Preserves, with Gustave Mayuer being the producer. (The German script is a little difficult to read, so it is possible that the last name is Wagner, not Mayuer.) No matches for this lid or producer have been identified; however, there is a Gustav Mayer, who trained as a confectioner in Germany and Switzerland and immigrated to New York in 1864, where he is known for his biscuits and sugar wafers (NY Landmarks Preservation Commission 1989). He also seems to have worked with tin, and patented a machine to make Christmas ornaments. We have not found any information to indicate that he is the same Mayuer who also made fruit preserves, but have not checked New York business directories for the period.

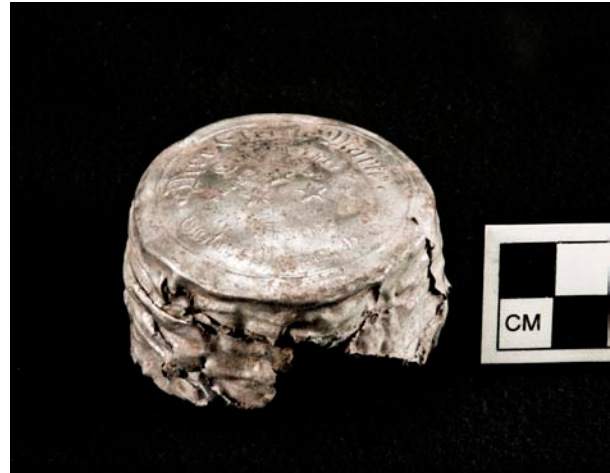
Figure 2.35. Foil seal from a wine bottle. Photograph by Melody Henkel.

The second marked object is a circular foil seal that was probably placed over a cork in a wine bottle (Fig. 2.35). In modern wine bottling, these seals are called capsules and can be made from one of several metals or from plastic. This item is

roughly 3 cm in diameter with a slightly irregular edge and is made of lead with small amounts of tin and copper. It is embossed with a circle of raised dots surrounding the text D. LEIDEN L[TD?]/ COLOGNE RHINE. The center bears a rampant lion standing over a shield with a cross. The identification of this as a seal for a wine bottle is based on its size, the region of origin, and the fact that similar foil seals were identified on other imported wines in the cargo found on the 1865 wreck of a steamship. Switzer (1974) provided a typology and description of the many food, medicinal, and beverage bottles found on the wreck of the *Bertrand*. Glass and ceramic beer bottles had plain

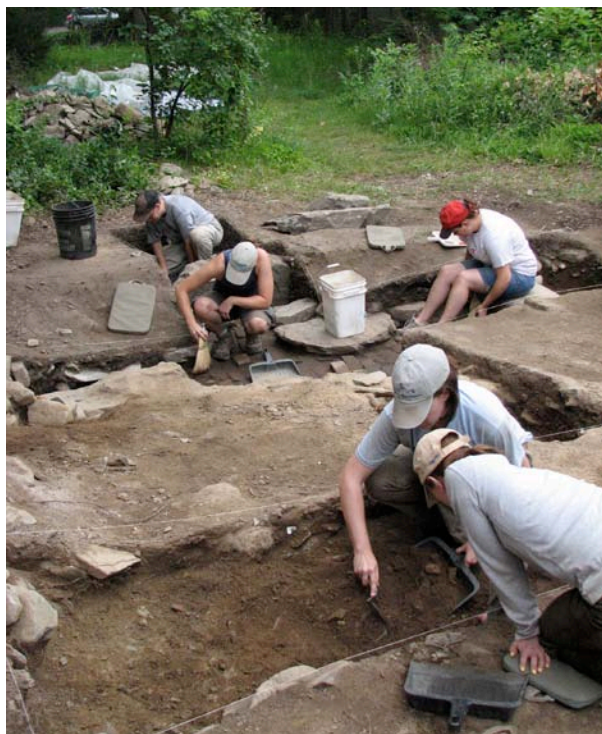
Figure 2.36. The location of EU 27 in the foreground relative to the dairy (units in the rear of the photograph).

Unit 27 was a 1 × 2 meter excavation unit placed on-grid, approximately three meters from the northeast corner of the house beneath the demolished ell (Fig. 2.36). The west wall of the unit directly abutted the house for one meter. A large number of surface finds suggested that this area may have been a primary location where household trash was deposited. This unit contained a

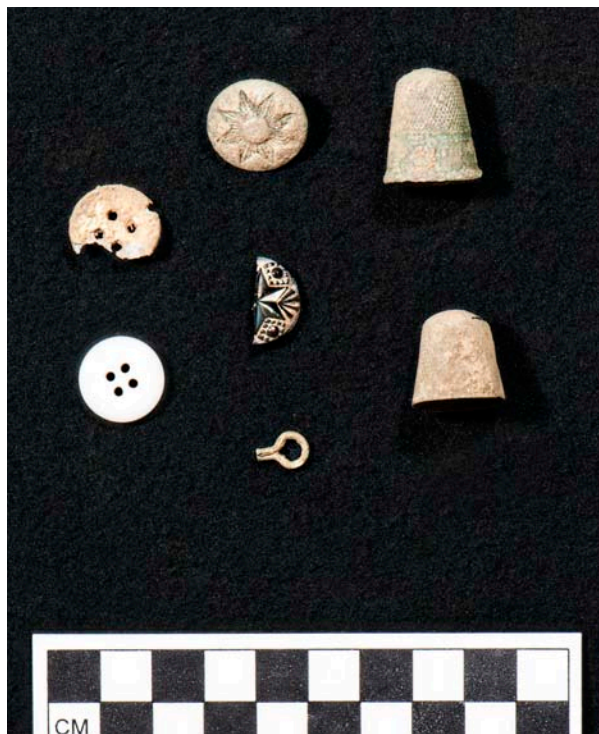
Figure 2.37. Small finds from EU 27: copper alloy, black glass, and milk glass buttons, thimbles, eye. Photograph by Melody Henkel

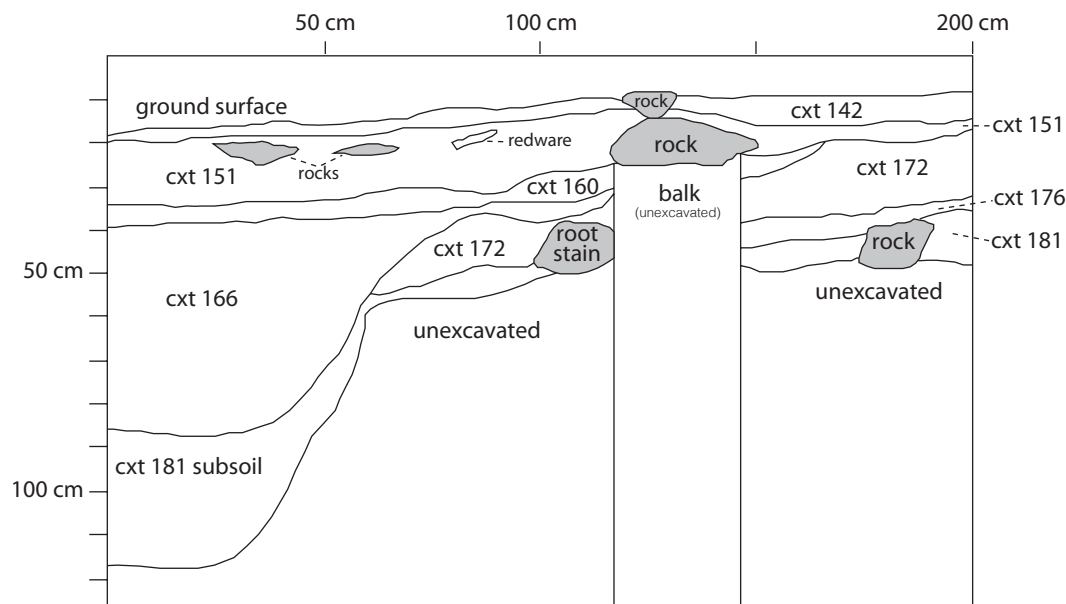
Figure 2.38. South wall profile of EU 27.

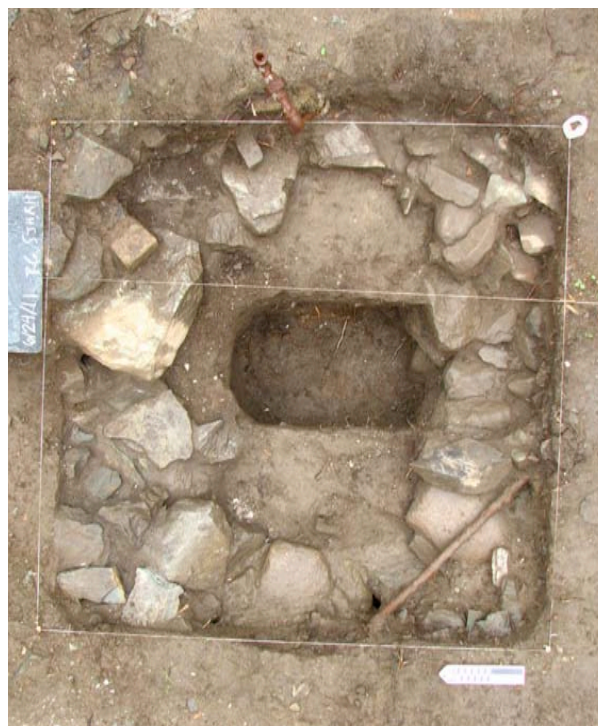
Figure 2.39. Overhead photograph of the well; the deep area is the initial test pit that located the feature.
