Site Examination of the Durant-Kenrick House, Newton, Massachusetts

**Prepared for:
Historic Newton
527 Washington St.
Newton, MA 02452**

**Prepared by:
Christa M. Beranek
With contributions by David Landon, John Steinberg,
Christiane Carducci, Danielle R. Cathcart, Allison Conner,
Samantha Henderson, Kalila Herring, Julie Powers, Meagan Ratini,
Joshua Stewart, and Courtney Williams
Andrew Fiske Memorial Center for Archaeological Research
University of Massachusetts Boston**

Cultural Resource Management Study No. 63

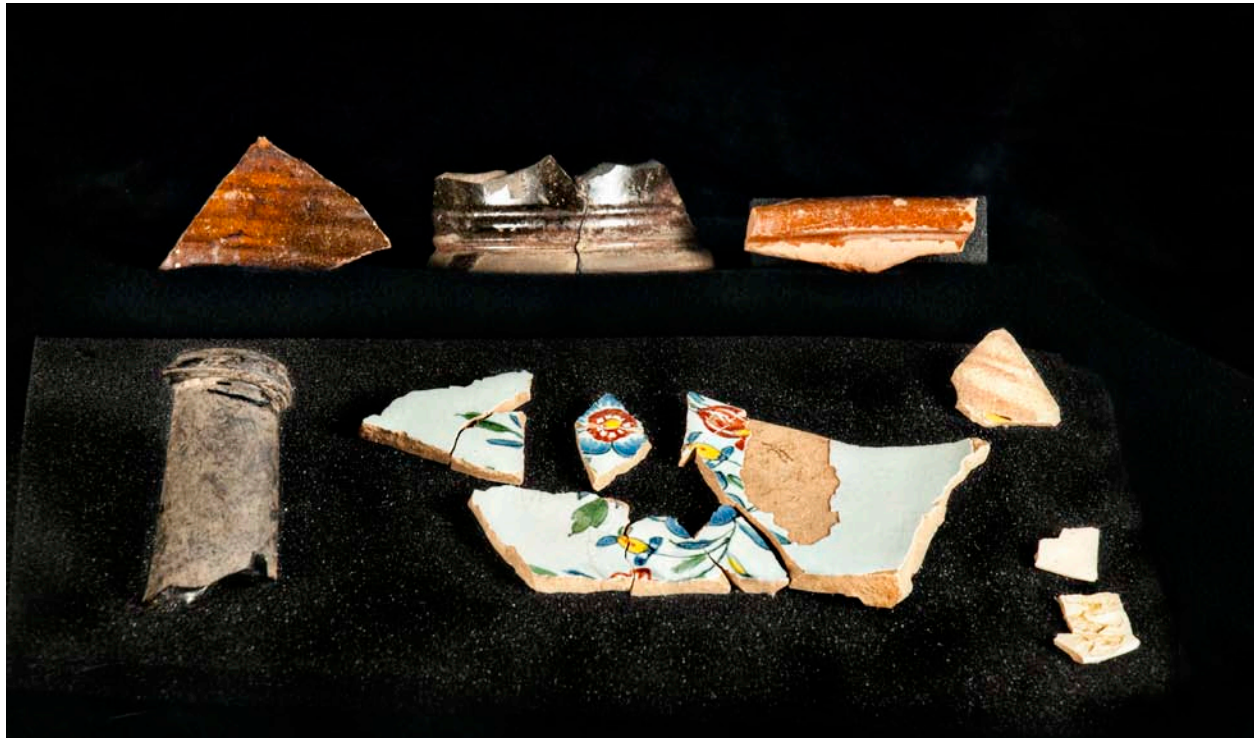
Figure 4.1. Artifacts associated with the household of Edward Durant III from STP 13. Photograph by Melody Henkel.

of vessels represented that is based on distinct ware types or distinct rim diameters and styles. (Therefore, many of the redware body sherds do not contribute to the vessel count). These vessels include a redware mug, other utilitarian redware vessels such as milk pans and storage jars, a piece of Staffordshire slip decorated ware, a French tin-glazed charger, and at least two pieces of creamware tableware. The creamware represents the most recent ceramic in the deposit, since it was developed in the 1760s and introduced to North America over the next decade. The redwares may have been made locally, while the creamware and Staffordshire ware were imported from England and the charger from France. The charger has a hole pierced in its foot rim so that it could be hung as decoration. This is the only significant 18th-century trash deposit located during the fieldwork. More of it may be preserved about 1 foot below the surface in the area that was once the eye of the historic driveway, under the new driveway and parking spaces.

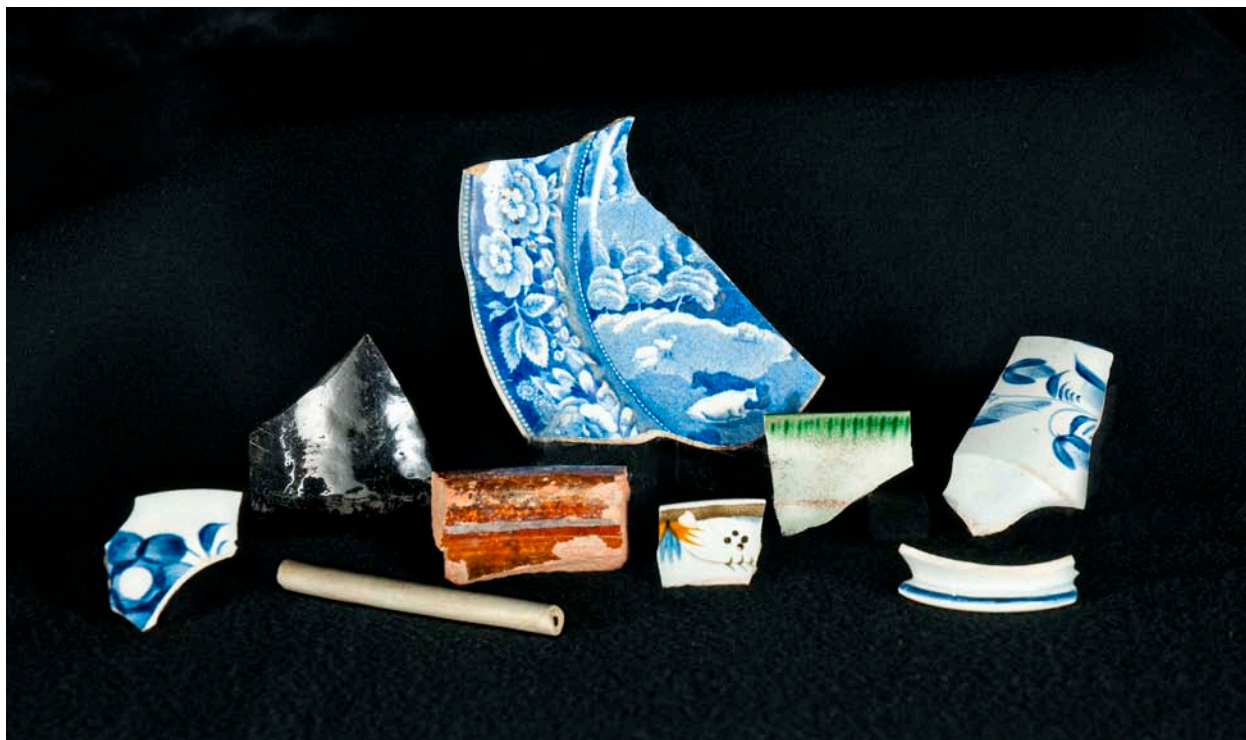
Figure 4.2. Artifacts associated with the household of John Kenrick from context 166 in EU 27.
Photograph by Melody Henkel.

different periods in the early 19th century in EU27, immediately outside the kitchen door (Figs. 4.2 and 4.3). These deposits were not as organic as the trash deposit in STP 13, suggesting that plant and animal waste was discarded elsewhere and only inorganic trash was discarded here close to the house. All together, there were a minimum of 54 ceramic vessels represented in this unit, not including redware. Most of these are refined earthenware table wares. The earlier deposit in EU27 dates from prior to 1830 and consists of the fill or a large post hole (context 166). The artifacts were probably incorporated into the fill of the hole when the post was removed. This might indicate that before the ell with the dairy was constructed, there was some other addition at this corner of the building, though without any additional post holes, this remains tentative. They consist of wares popular in the 1820 when John Kenrick's household occupied the property. The post hole is covered by two layers (contexts 142 and 151) that seems to have built up very quickly; they contain wares that are on average more recent than the post hole, but none with TPQs later than the 1830s, suggest-

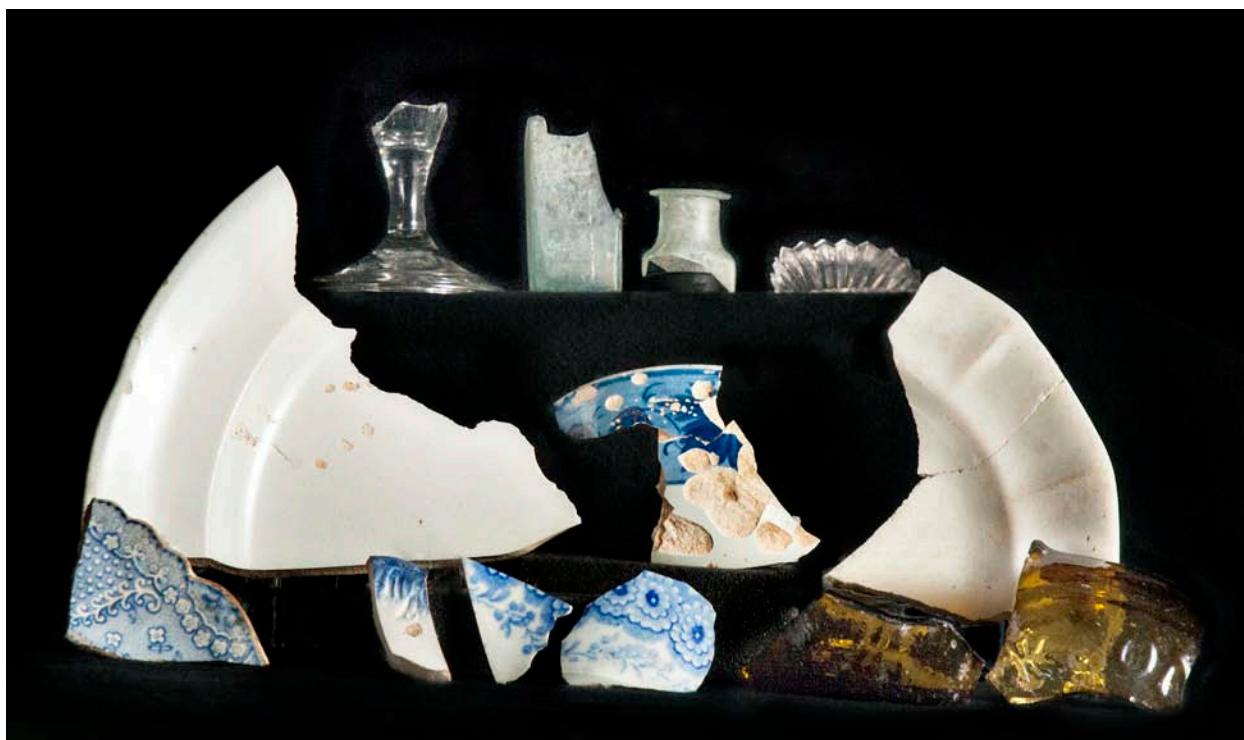
Figure 4.3. Artifacts from a ca. 1830 deposit, from the household of either John Kenrick or John A. Kenrick from contexts 142 and 151 of EU 27. Photograph by Melody Henkel.

ing that deposition here did not continue after the dairy was built. These two levels alone account for 27 of the identified vessels with a number of crossmends. This disposal event probably took place around the time the property changed hands from John Kenrick to his son John A. Kenrick. Deposition in this area seems to have stopped ca. 1830 and there was almost no soil built up over the most recent trash deposit, suggesting that the ell that contained the dairy covered this area (which then remained covered by the 1875 ell).

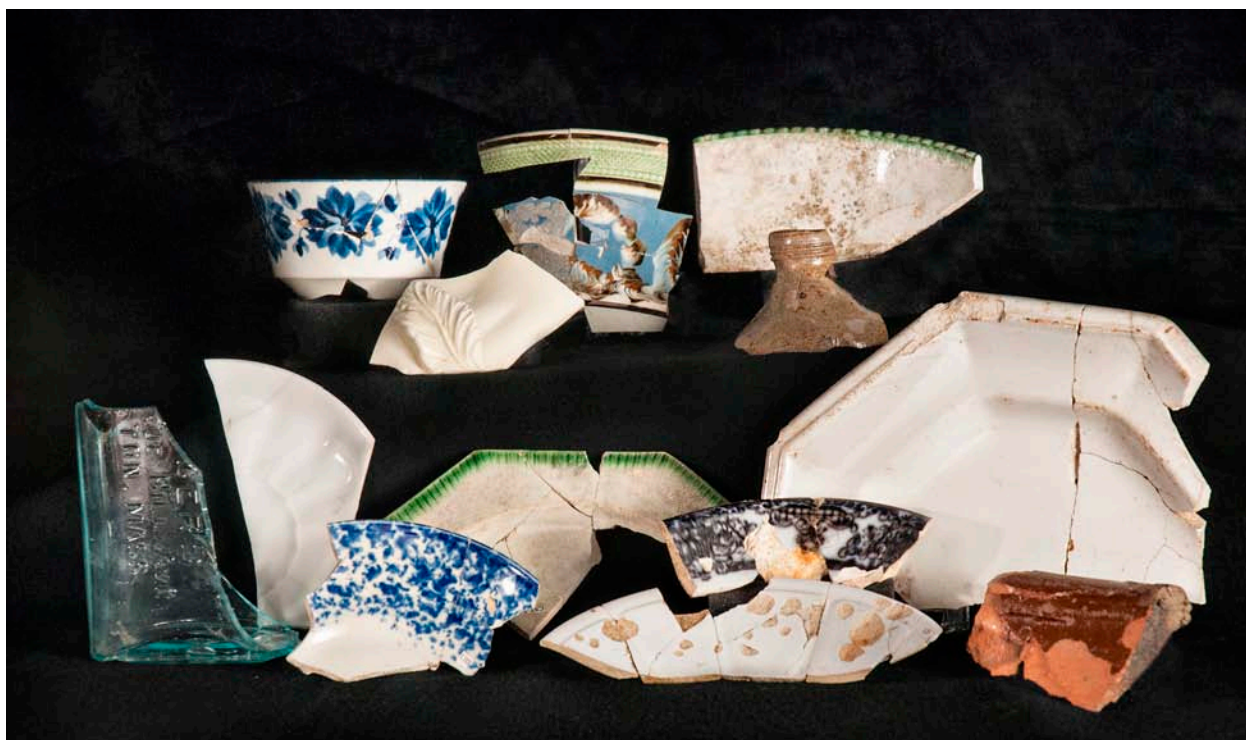
Figure 4.4. Artifacts from the fill of the dairy in 1875, associated with the household of John A. Kenrick. Photograph by Melody Henkel.

The trash deposit that filled the dairy (Fig. 4.4) came from 1875, from the years just after John A. Kenrick had died and his widow, children, and their families continued to occupy the house. There were at least 68 ceramic vessels represented in the fill, but also a large amount of architectural material and destruction debris. The ceramics in the dairy fill were primarily older vessels that would have been popular several decades before they found their way into this trash deposit. There were very few vessels for which a majority of the fragments were located (only 26 vessels consisted of two or more mended pieces), which

raises the question of where the mending pieces were discarded. These pieces may be redeposited from elsewhere, although there were no identified mends between vessels in the dairy and elsewhere on the site. The fill also contained artifacts related to food packaging including tin cans (a relatively new product at household sites), a lid from a jar of German fruit preserves, and the foil seal from a wine bottle.

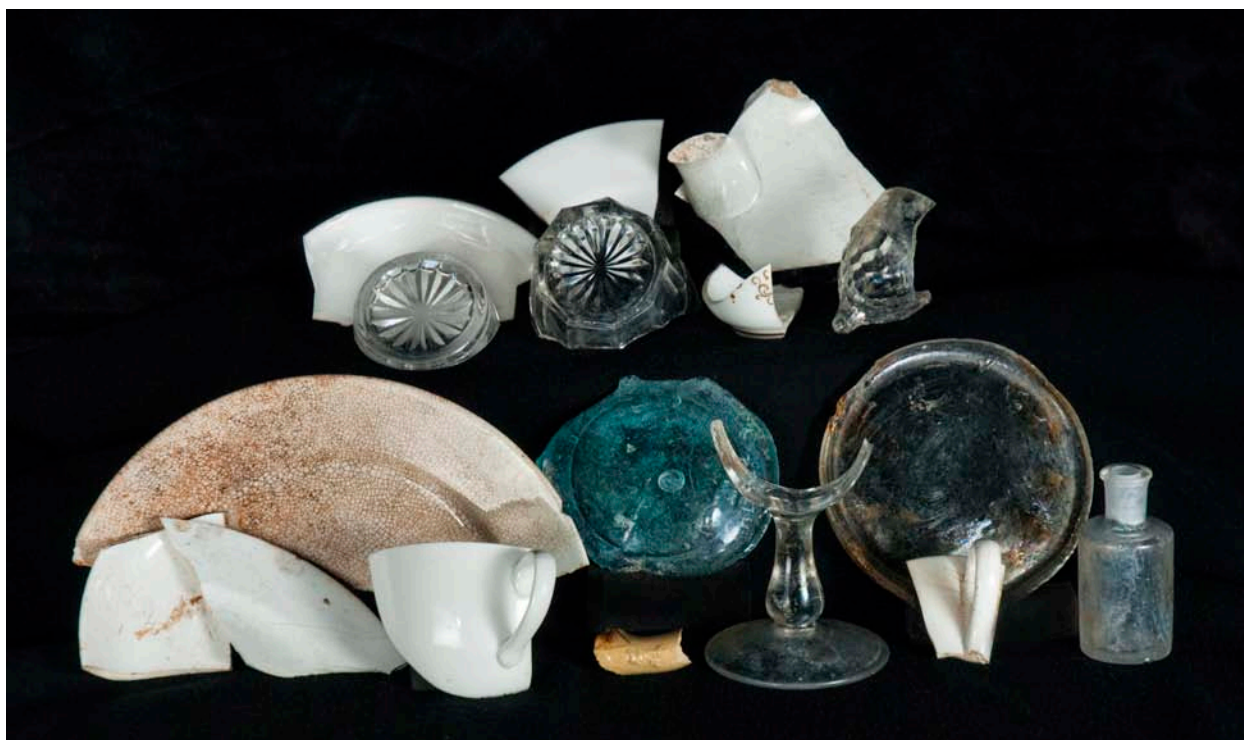
Figure 4.5. Artifacts from context 199, possibly associated with the Holden household. Photograph by Melody Henkel.

Lastly, the deposit discovered during monitoring is visually quite different from the others, consisting almost exclusively of colorless glass table wares and undecorated white ironstone ceramics (Fig. 4.5). Undecorated wares such as this became popular in the later 19th century, but continued to be produced and used well into the 20th century.

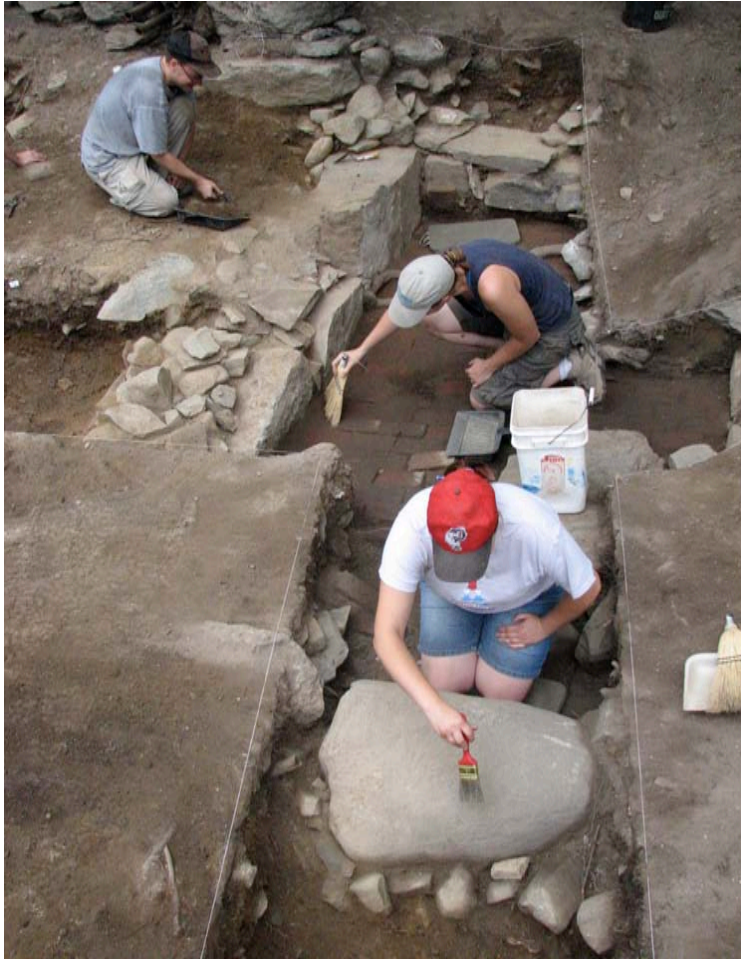
Figure 4.6. Dairy excavation in progress in 2011.

The brick-floored feature that we have been referring to as a dairy was the most significant feature discovered during excavation (Fig. 4.6). The feature was described in detail in Chapter 2, so the focus here is its identification as a dairy, parallels to other similar structures, and its possible uses. Terming it a dairy focuses on its most specific, and possibly earliest, use. It is likely that its function shifted to include more general cool food storage over time, especially as the Kenrick's farm holdings decreased. Its location in an ell, away from
