**Archaeological Investigation of the
Drive Circle and West Hyphen at Gore Place
Waltham, Massachusetts**

**Prepared by:
Christa M. Beranek and Alexandra U. Crowder
Fiske Center for Archaeological Research
University of Massachusetts Boston**

Cultural Resource Management Study No. 74

April 2016

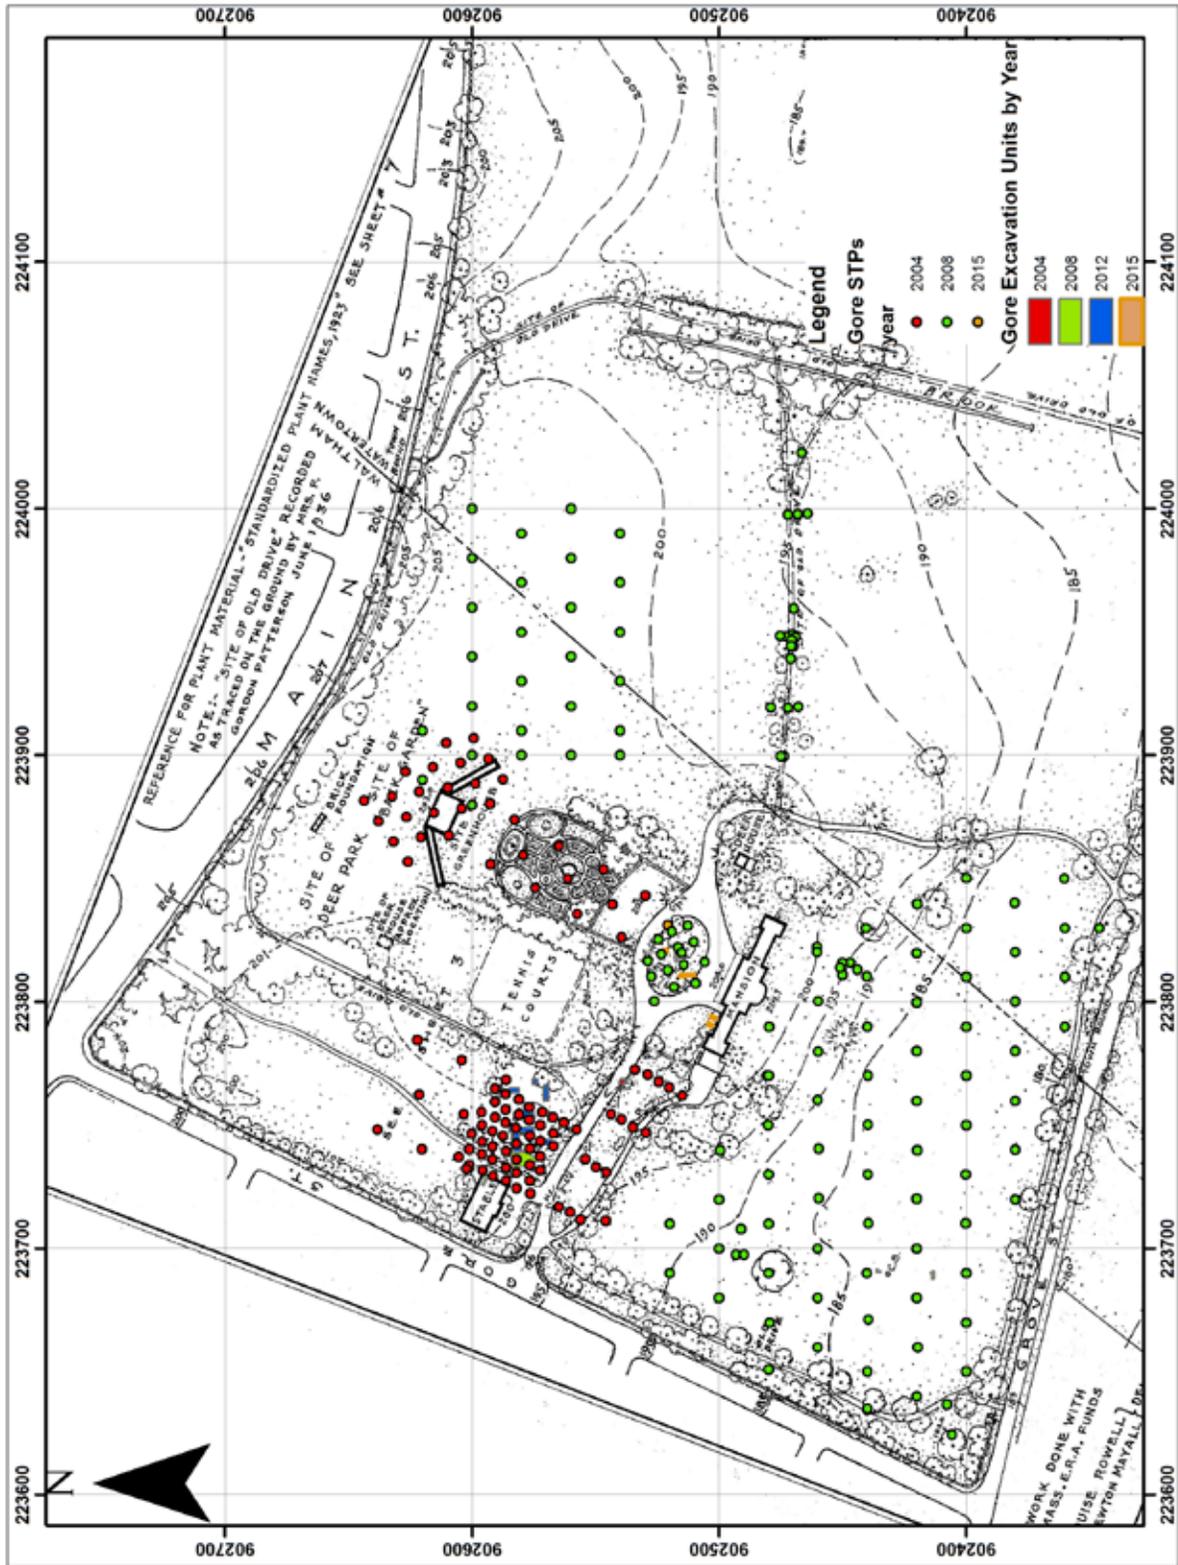
Figure 4. Excavation locations from 2004 (Smith and Dubell 2006), 2008 (Smith et al. 2010 and Beranek et al. 2011), 2012 (Romo and Beranek 2014), and 2015 (see Figure 5 for detail) on the 1935 HABS map of the Gore Place property. The margins show the Massachusetts State Plane grid in meters.

and later greenhouse, vegetable garden, and flower garden (Smith and Dubell 2005). Study of the grounds was expanded by investigation of both specific landscape features consisting of the drive circle and straight walk, and portions of what have been termed the ‘agricultural periphery’ consisting of the field east of the graperly/greenhouse and the south lawn to identify areas that may have been cultivated by Gore as part of his intense interest in farming (Smith, Beranek and Steinberg 2010). A site examination of the carriage house, greenhouse, and associated enclosures was conducted most recently not only to learn about these features, but to help determine an appropriate site for relocating the original carriage house that will ensure preservation of significant archaeological features and deposits (Beranek, Smith, and Steinberg 2011; Romo and Beranek 2014). All of these excavations are mapped on Figure 4.

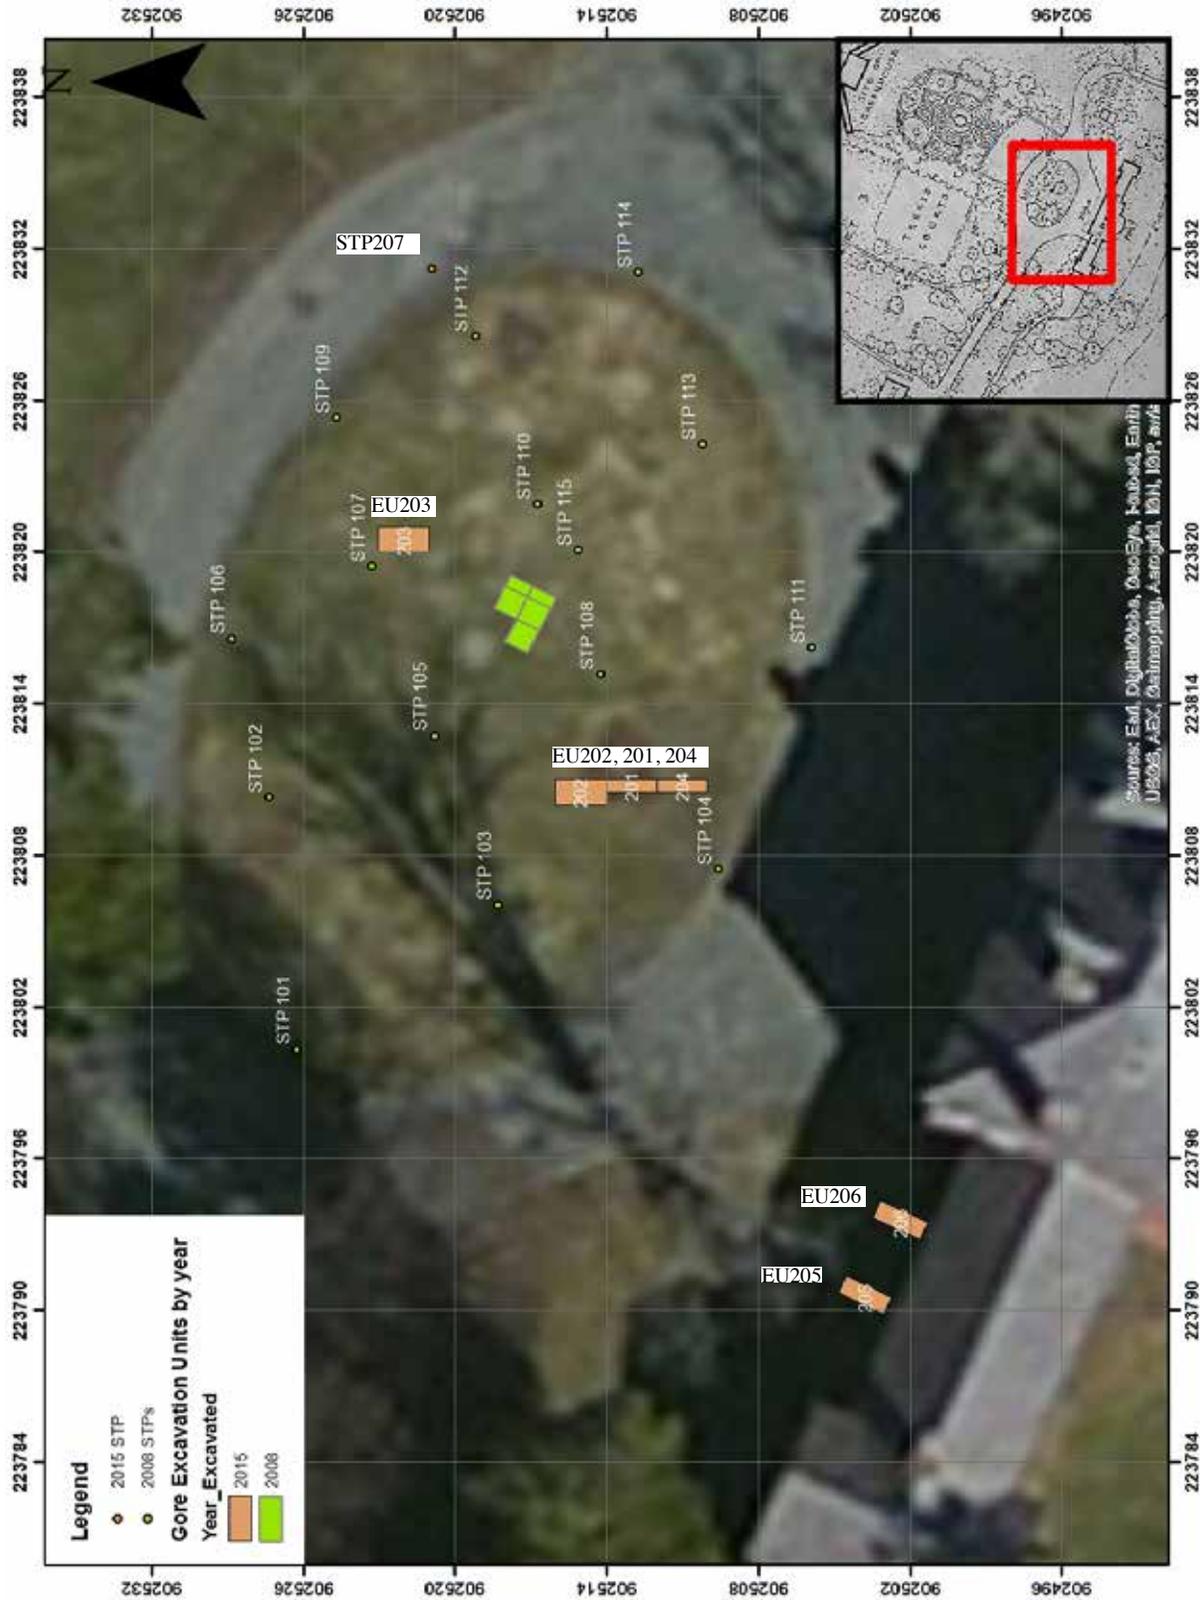
Figure 5. Detail of excavation unit locations (2008 and 2015) in the drive circle and against the west hyphen. The margins show the Massachusetts State Plane grid in meters.

Gore Place is currently interested in understanding and potentially reconstructing the landscape features to the north of the 1806 mansion house. The 2015 fieldwork focused on the drive circle and a possible cellar access against the west hyphen of the house (Fig. 5). The Gore Place Society contacted the Fiske Center for Archaeological Research at the University of Massachusetts Boston, for the purpose of conducting an archaeological survey of these areas to test features previously

In 2008, the Fiske Center conducted a GPR survey of the grassy oval in the driveway north of the mansion (which had not been surveyed by RSI), followed by test pits across the oval and excavation units focused on the well (see Fig. 5; Smith, Beranek, and Steinberg 2010). We located a path that ran from the well towards the house, and in our initial interpretation identified a possible square enclosure from the GPR slices (Fig. 9). The GPR results also suggested that the grassy area surrounding the well may have had a straighter edge facing the house, rather than the oval configuration seen today.

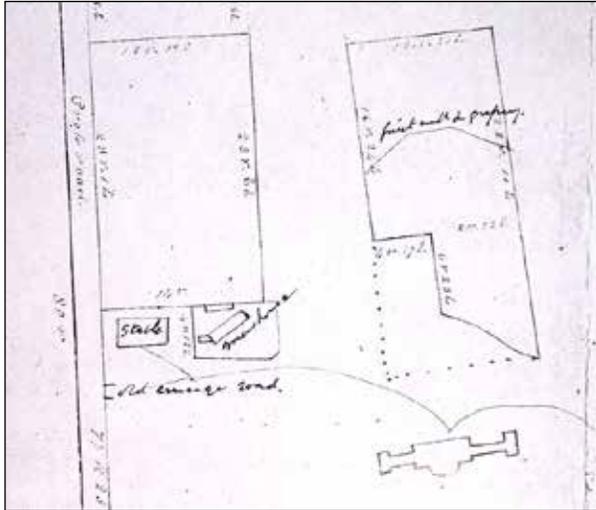
Figure 6. Detail of a plan of Gore Place drawn when the estate was sold to Theodore Lyman Jr. ca. 1834. The mansion is in the lower right corner. Note that the entrance driveway, labeled “old carriage road” is shown as a simple line, with no oval north of the house. Although the Lyman map is very detailed in many respects, it does not show other paths and walkways that were known to exist on the property at the time. The depiction of the driveway may or may not reflect its actual layout.

Occupation by Rebecca after the death of Christopher in 1827 is unclear, but by the time of her death in 1834, Judge Charles Jackson was renting the property. The parcel containing the “mansion house, stable, vinery and sheds” was purchased by Theodore Lyman Jr. in the same year (Fig. 6). Theodore and his wife, Mary, maintained a keen interest in scientific agriculture and in further developing the pleasure gardens on the property. Changes made during their ownership include redesign of the formal flower garden north of the house following a modern European style that stressed curves over the earlier rectilin-

ear forms of the eighteenth century. They also may have improved greenhouse facilities and the grapery and were responsible for painting the house white. Mary Lyman died in 1836 prompting Theodore to put the property up for auction. The earliest detailed map of the property comes from the Lyman period (Fig. 6).

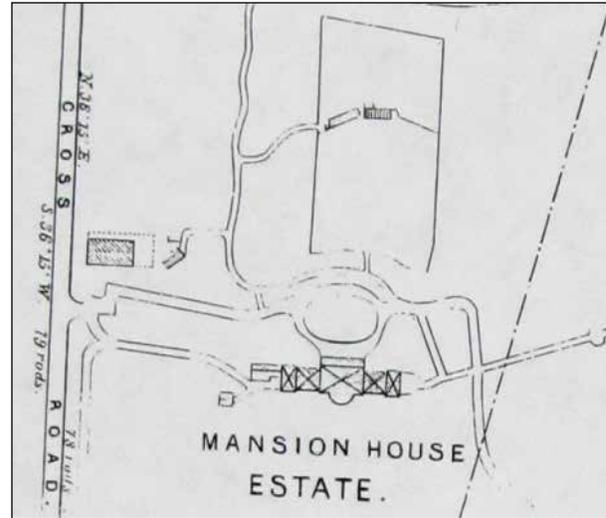
Figure 7. Detail from the 1841 plan of Gore Place during John Singleton Copley Greene's tenure. In contrast to the Lyman map, the author of the Greene map depicted numerous pathways. The map is the first visual representation of the oval in the drive on the north side of the house.

John Singleton Copley Greene purchased the estate in 1838 and continued to employ a gardener and farm manager who maintained the pleasure garden character of the property. A number of changes were made during their tenure, including the probable demolition of the greenhouse east of the carriage house (Fig. 7). Based on the 2015 excavations, it seems likely that Greene also reconfigured the driveways around the house. The Greens sold the mansion house lot in 1856 to Theophilus Walker, who in turn sold it to his nieces, Mary Sophia and Harriet Sarah Walker in 1890. A number of changes appear to have been made to the property during this period, including the removal of the vegetable garden north of the carriage house and improvement of the grapery greenhouse.

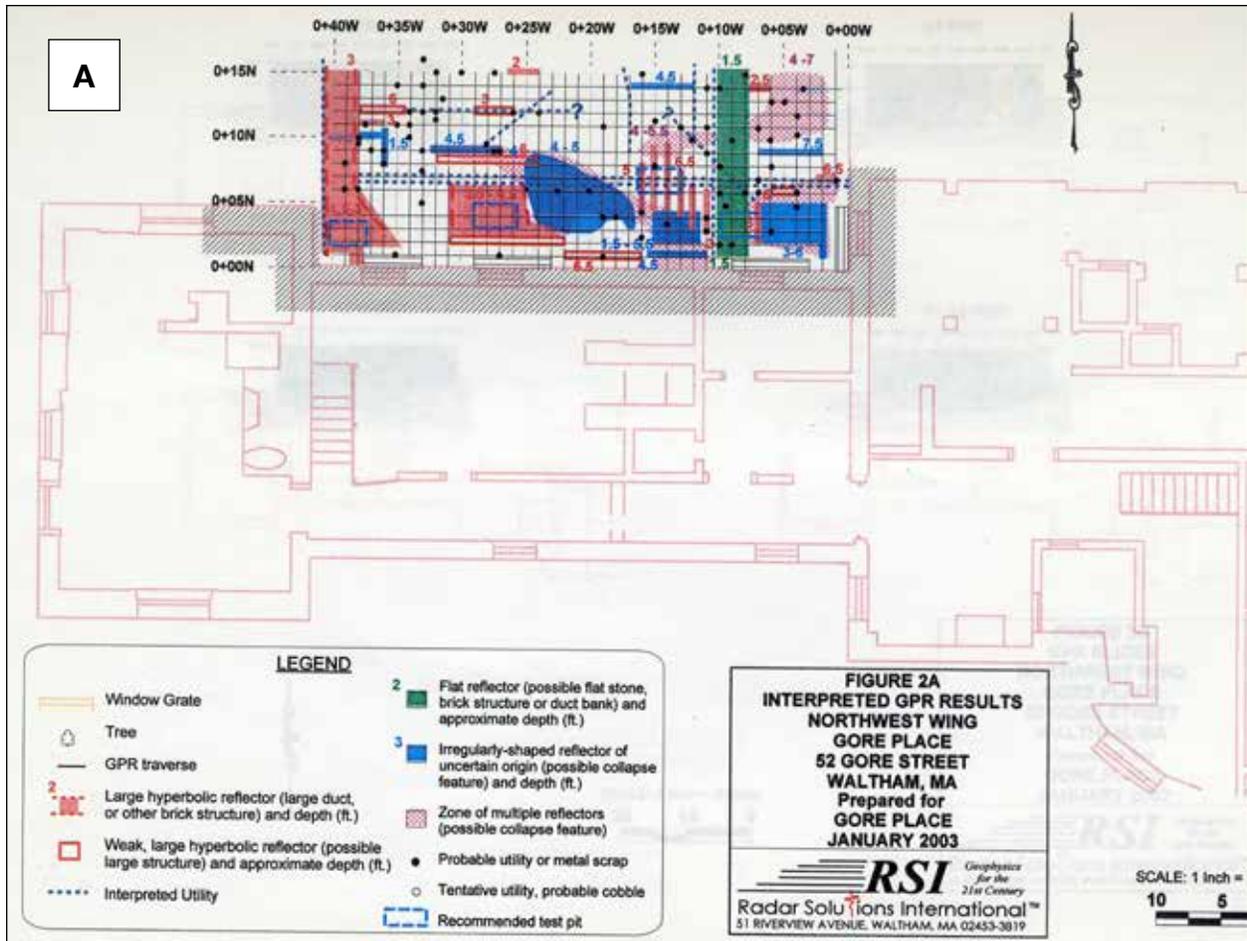
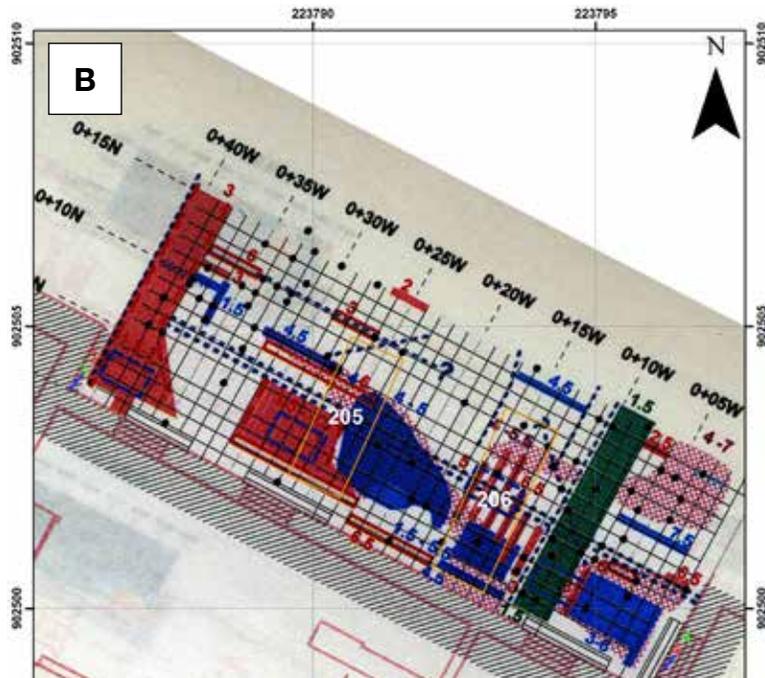
Figure 8. A) Interpreted results of RSI's GPR survey north of the west hyphen (Kutrubes 2000); B) The same RSI interpretations relative to the Massachusetts State Plane grid with 2015 excavation unit locations shown.

In 2002, in conjunction with the architectural studies of the cellar, Doria Kutrubes of Radar Solutions International (RSI) conducted a ground penetrating radar (GPR) survey of three areas adjacent to the house (north and south of the west hyphen and north of the east hyphen) and of the basement floor under the main block of the house. The RSI report includes an interpretation of the feature types and depths in these areas, and we used Kutrubes' results from the north side of the west hyphen (Fig. 8) as one of the factors in placing our excavation units in the area. See below for a discussion of our results relative to the GPR predictions.

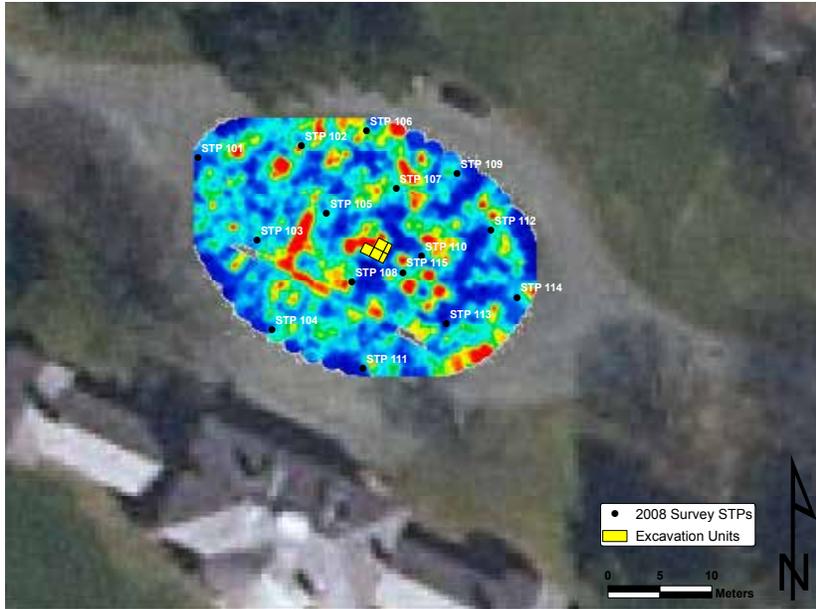
Figure 9. One of the GPR slices of the 2008 survey of the oval, showing what we initially interpreted as a square cornered feature in the south west portion of the oval. In fact, this is two unrelated reflectors crossing at right angles, not a single feature.

correct (see Fig. 9). The strongest and eastern-most reflection is from a water pipe, and the two reflections that intersect the pipe at right angles north and south of the well are caused by two different sources and are not part of a structure. EUs 201/202/204 and 203 were placed to cross

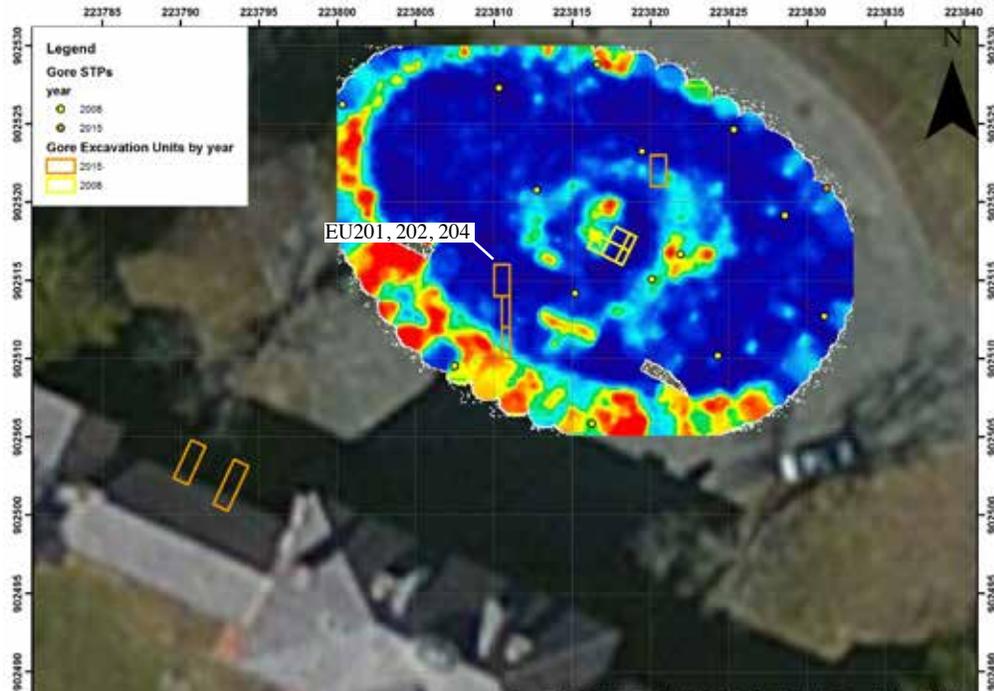
Figure 10. Slice 9 of the 500 MHz GPR survey from 2008. We placed excavation units 201, 202, and 204 to investigate the strong reflector (red) along the south side of the oval.

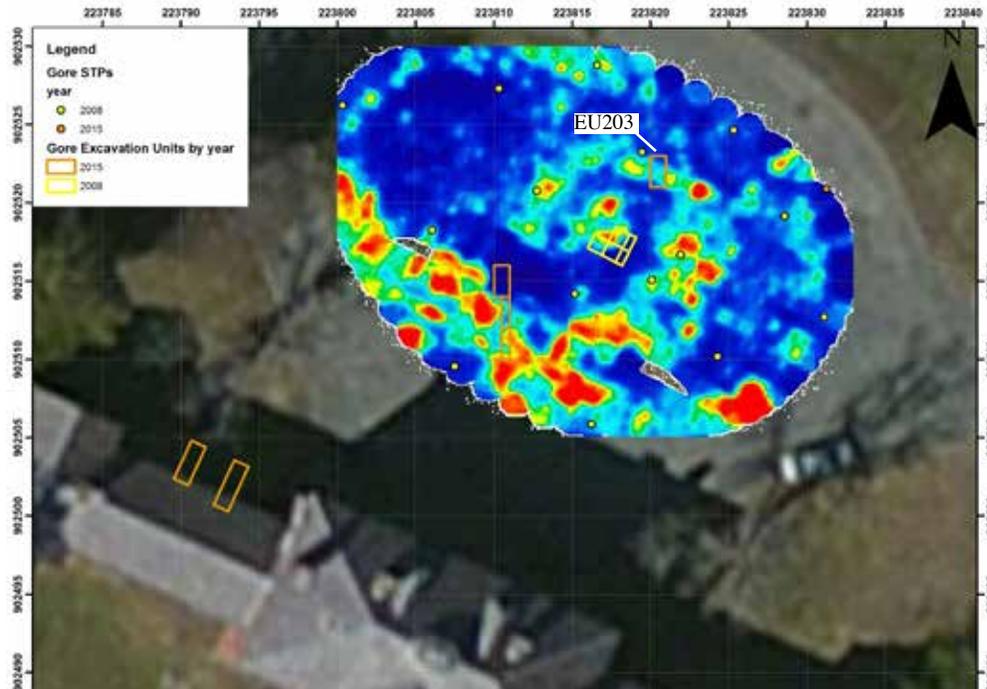
Figure 11. Slice 11 of the 500 MHz GPR survey from 2008. We placed EU203 to investigate the reflector northeast of the well in the center of the oval.

EU203 was a 1 x 2 m unit (long axis N-S) located in the center of the north side of the drive circle, east of STP107 (excavated in 2008), and was placed to investigate an east-west linear geophysical anomaly (see Fig. 11). The stratigraphy of EU203 (Fig. 18) consisted of topsoil (contexts 1101, 1104) covering a broad, shallow pit (context 1106) that was cut into a deep, gravel rich landscaping fill layer (context 1105). This landscaping fill had been deposited over a compact olive brown sandy clay (context 1109) layer of excavate from digging the well that was spread out around the well. The top surface of this level is at the same elevation as the Gore gravel driveway, so

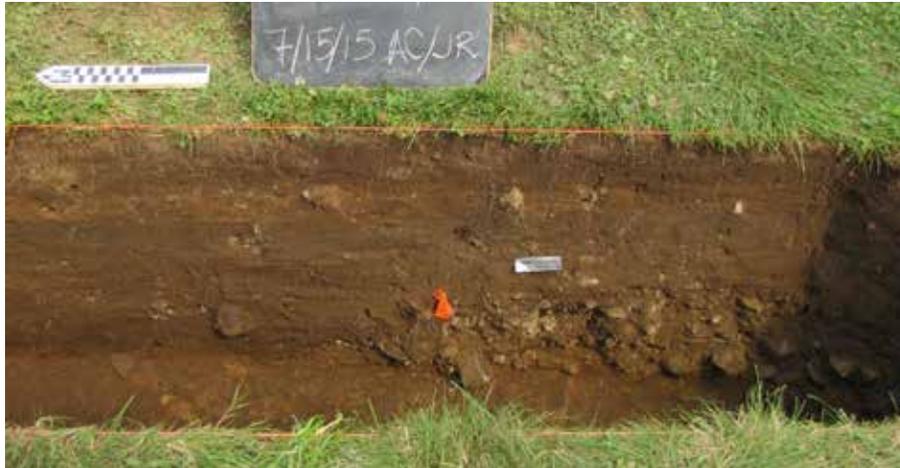
Figure 15. Photograph of the gravel driveway in the east wall profile of EU204.

In the southern third of the unit, a gravel surface with 10YR 5/2 very dark grayish brown sandy silt was revealed (Fig. 15). The gravel surface (context 1123) was sorted, with larger cobbles located at the bottom of the layer. No artifacts were recovered in context 1123. The layer was approximately 10-25 cm in depth and has been interpreted as the Gore-era driveway. At approximately 55 cm below surface, context 1123 gave way to a mixed gravel and 10YR 4/4 dark yellow brown silty sand fill that was given the designation context 1129. The mixed fill is believed to possibly be the "Gore Fill" seen elsewhere in excavations on the property. No artifacts were recovered

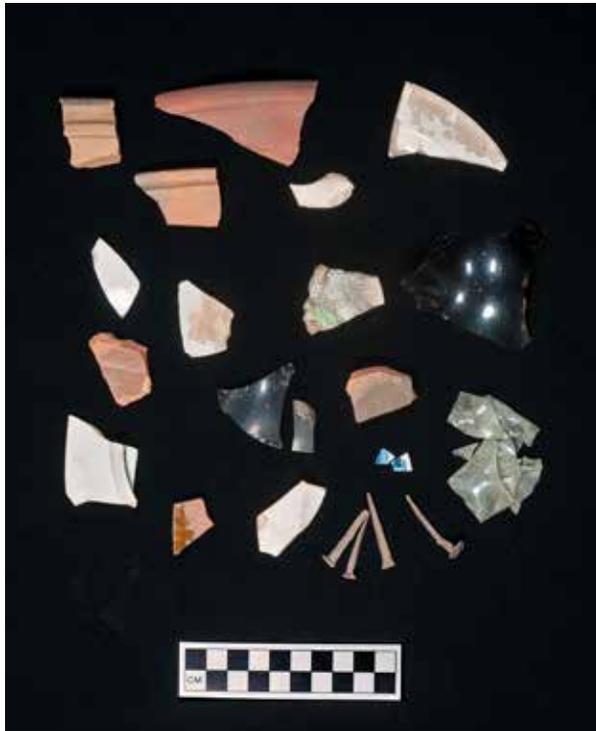
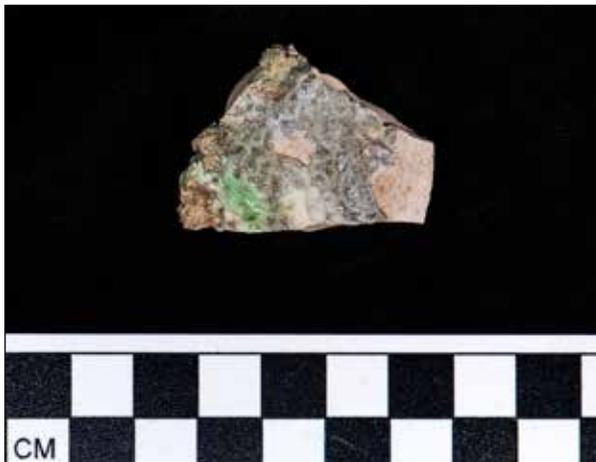
Figure 16. A selection of artifacts from context 1107, buried ground surface in EU202. Detail: an unusual earthenware sherd from an unknown vessel type.

One of the artifacts recovered in context 1107 (the buried ground surface), is an unidentified earthenware sherd (Fig. 16 detail). The sherd's original vessel type is unknown, and it exhibits evidence of being burned or over fired. The original vessel had areas of green and white decoration. One side of the sherd appears to have a scalloped edge, and it has a lot of large grit adhesions on the base, probably from its kiln firing. Because of its unusual form and decoration, we have speculated that it is not likely a table or utilitarian ware and may have belonged to a less common decorative form. We had not found any good parallels for the form of this object.

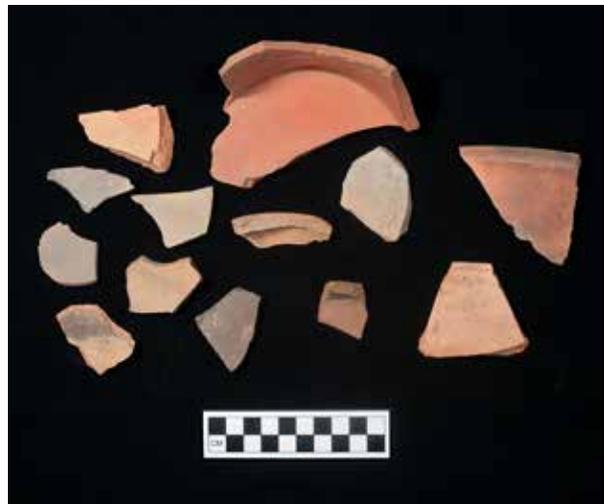
Figure 17. Planting pot sherds from context 1115, including several that have been burned.

pect that scatter of artifacts encountered at 30 to 40 cm below the start of the layer, which included burned planting pot fragments (Fig. 17), was once a historic surface, in the Gore and/or Lyman era, that was buried by another layer of topsoil at the same time as the gravel driveway was buried. One possible origin of the burned planting pots and other burned ceramics is that they originated in the 1799 structure fire, which is the event that

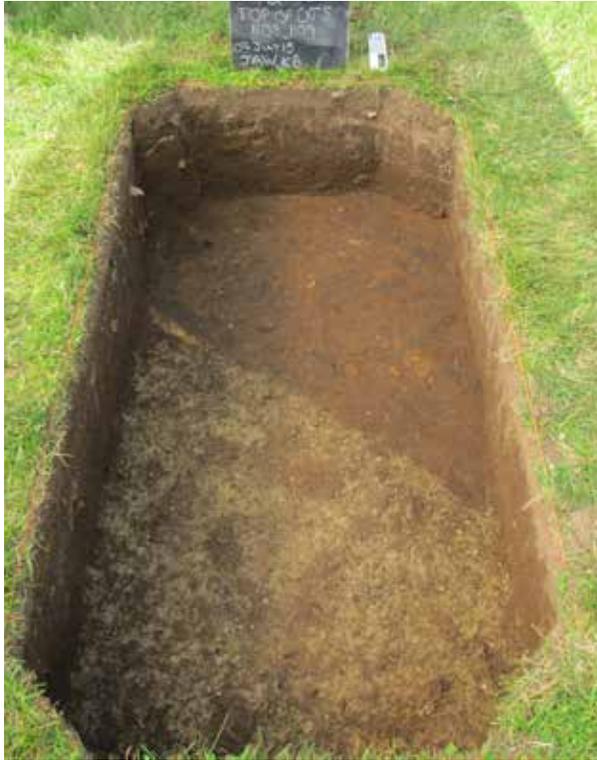
Figure 19. The top of context 1109; note the very linear demarcation between the two contexts.

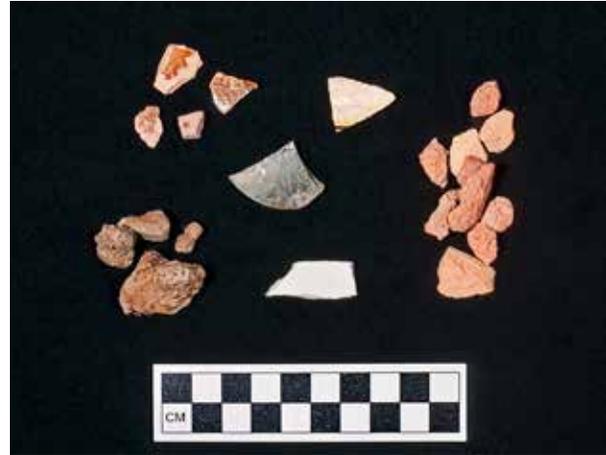
Figure 20. The complete artifact assemblage from context 1111, EU203, including glazed redware, a single fragment of Staffordshire slip decorated ware, brick fragments, a piece of white salt glazed stoneware, a piece of dark green bottle glass, and pieces of corroded iron.

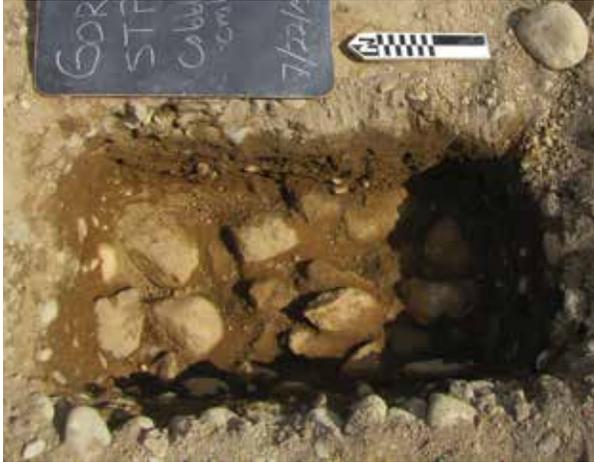
Figure 21. The top of the cobble surface in STP207.

the cobble surface was 16.69 masl (meters above sea level). It was so well constructed that it seems likely that it was an earlier driveway surface, predating the asphalt. There was no layer here that resembled the Gore-period driveway deposit found in EU204, meaning that either the Gore period driveway did not take this route or that it was removed in order to lay the cobble driveway. The only artifacts from this SPT were two fragments of refined earthenware missing their glaze, so not diagnostic for dating.

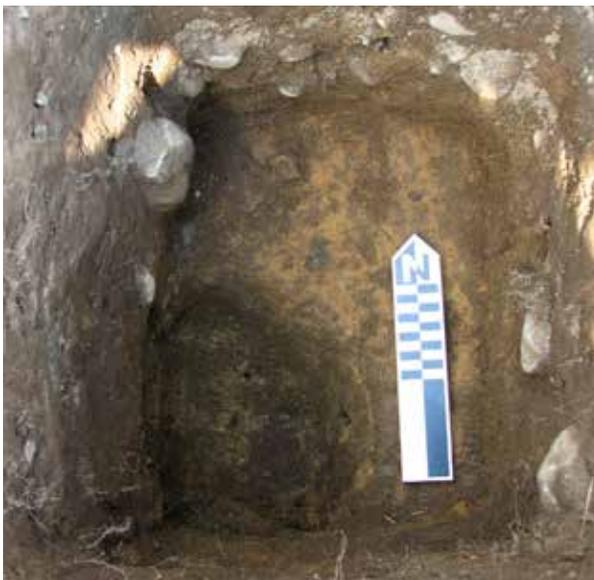
Figure 22. STP109, excavated in 2008, with a post hole in the SW corner.

Reviewing old field records, it seems likely that we encountered the same cobble surface in three other test pits excavated in 2008. STPs 106 and 109 (Fig. 5) located under northern edge of the grassy oval both encountered a layer of cobbles at 45 cm below the surface. In both cases, the STPs seem to have found an edge of the cobble deposit (ie, the southern edge of the cobble driveway), and both had post holes or shallow pits just south of the cobbles, suggesting an early fence line along the driveway (Fig. 22). Also in both STPs, the cobbles were the same depth below the surface as those discovered in 2015, and the deposits immediately below the cobbles were similar to those discovered in 2015, a thin layer of dark silt over subsoil. In STP101, also from 2008, located at the west end of the grassy oval, we found a layer of cobbles at 23 cm below the surface. In this case, the cobbles sat on top of the sand and gravel mixture known as “Gore fill,” suggesting that here the cobbles were placed on top of an older, Gore-period driveway.

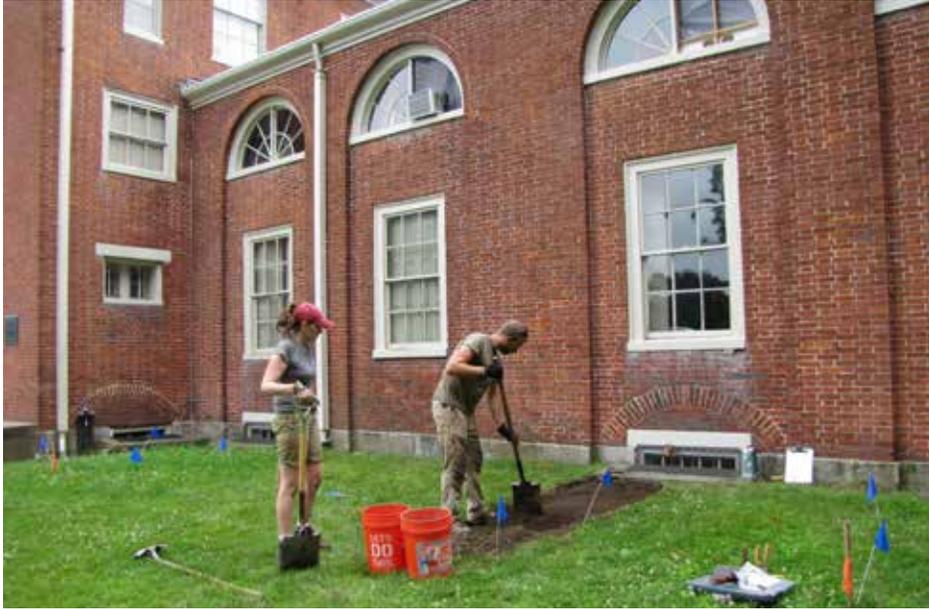
Figure 23. Starting excavation of EU205. Note that the unit abuts the window well of a cellar window with an arch in the brickwork above the window. The architects have interpreted the arch as evidence that this window and another cellar window to the east (left in the photograph) were once doorways. EU206, not yet excavated in this photograph, is located under the middle of the three large first floor windows.

EU205 was purposely placed against the third window well to the west of the north entrance (Fig. 23). The unit was located adjacent to the arched window to determine if the arch, which was different from several of the surrounding windows, indicated its use as a cellar entrance during previous periods of mansion occupation. It was also placed in order to determine if any cellar ramp or entrance features were still intact. EU206 was placed between the second and third windows to the west of the north entrance in order to investigate an unknown GPR reflector, and see if the reflector was part of an intact ramp leading to the cellar. This unit was located below a first floor window that architectural analysis suggested had once been a door.

Two of the basement windows have arches in the brickwork above them, which the architects have said indicate that they used to be cellar doorways (Fig. 23). In EUs 205 and 206, we encountered a buried ground surface at roughly 120 cm (47 inches) below the modern surface. In parts of EU 206, there was a thin clay cap on top of the buried topsoil, similar to the clay that capped the road between the carriage house and the greenhouse (uncovered in the excavations in the fall of 2008). There were also wheel ruts in EU 206 (Fig. 27). The fact that the buried ground surface is relatively level and at the same depth in both units suggests that these two former doorways were not accessed by two separate ramps or sets of stairs. Rather, the whole area in front of this hyphen seems to have been exposed, with access not unlike what now exists at the west end of the house – a ground surface door with low clearance that you enter and step down to the cellar floor (Fig. 39). The absolute elevation of the top of the buried ground surface is 16.45 masl, only 45 cm (18 inches) lower than the top of the cobble driveway in EU204 (at 16.90 masl) (see Table 4). The current cellar floor of the room nearest to EU 205 is roughly 80 cm (32 inches) below the top of the buried ground surface outside.

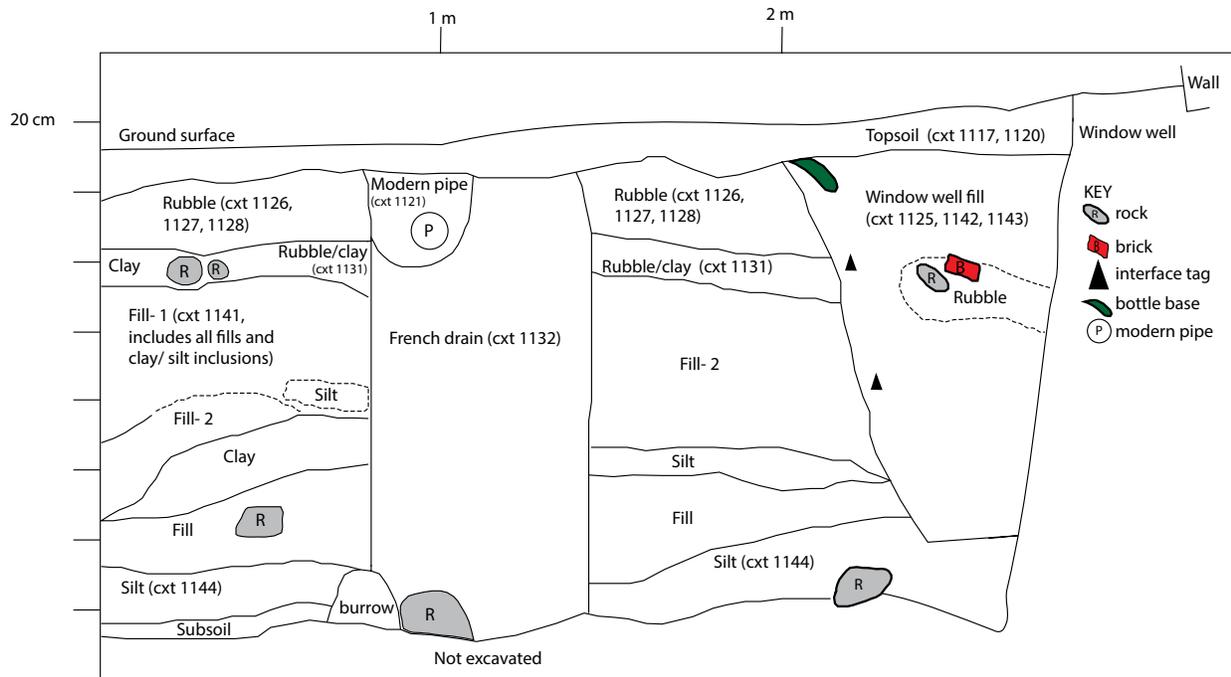
Figure 24. East wall profile drawing of EU205.

Both of the units hit subsoil in the northern half of the unit between 1.44 and 1.58 meters below surface (Figs. 24 and 25). Subsoil was identified as 10YR 3/6 dark yellow brown silty clay with some brown mottling and gravel inclusions. Directly above the subsoil, both units contained a very dark brown/black silt layer that measured between 29 and 4 centimeters thick. Designated as context 1144 in EU205 and context 1146 in EU206, this layer is believed to be a buried ground surface, and may represent the ground level of the cellar entrance. Artifacts recovered included small fragments of historic ceramics (porcelain, white salt-glazed stoneware, redware), and a pipe stem (Fig. 26). Both context 1144 and context 1146 contained white salt-glazed stoneware sherds with basket molding that were manufactured between 1740-1765 (Miller 2000: 10). In EU206, removal of the buried ground surface revealed what appear to be two wheel ruts, each approximately 11 cm wide and about 50 cm away from each other (Fig. 27). The ruts are oriented NW-SE. EU206 also contained what has been interpreted as another buried surface – context 1145 – located directly

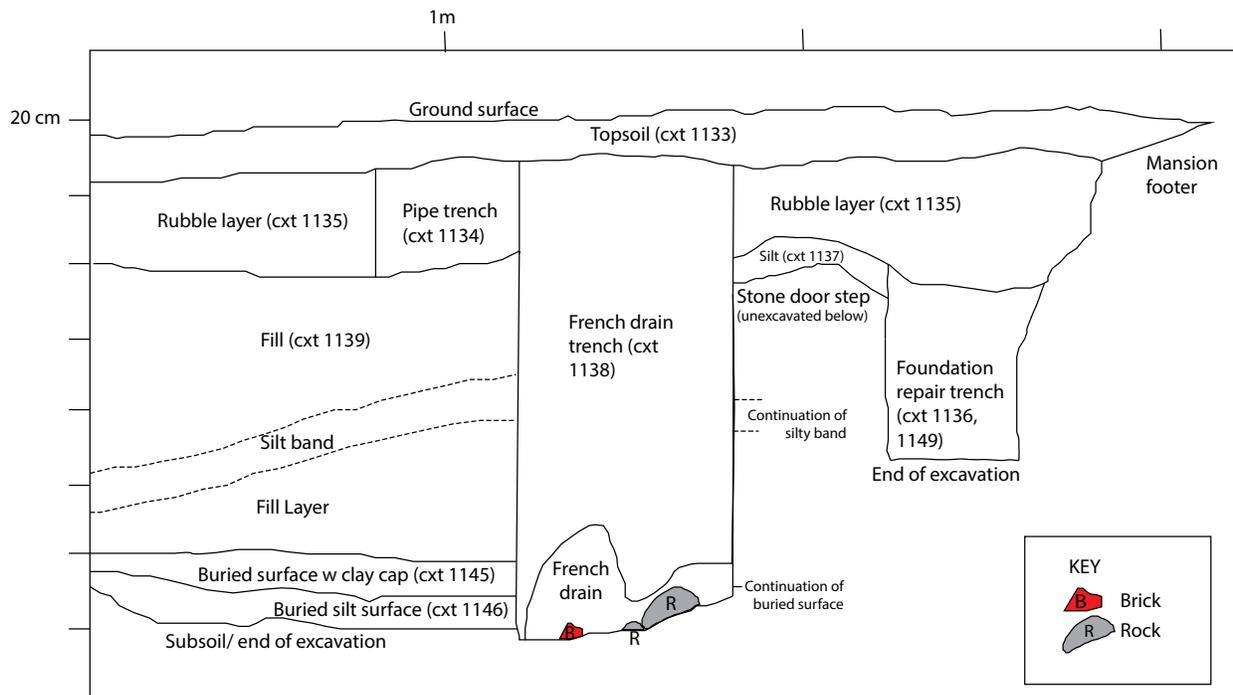
Figure 25. East wall profile drawing of EU206.

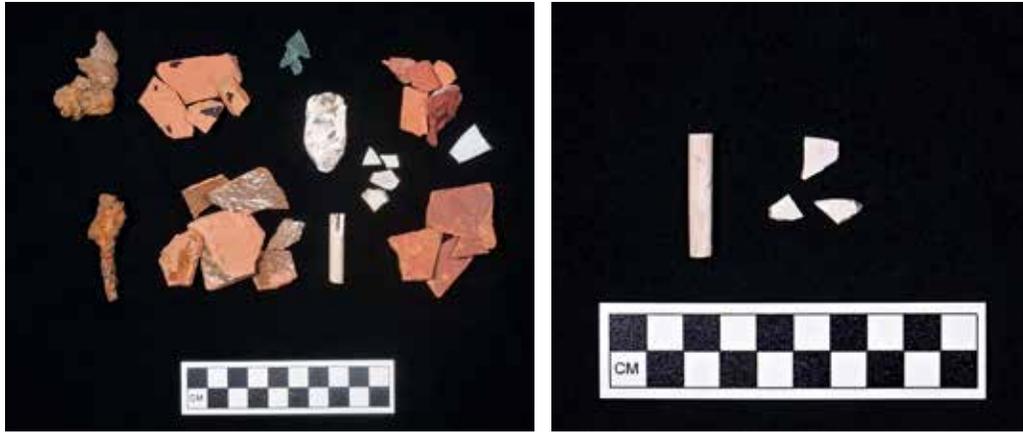
Figure 26. The complete artifact assemblage from the buried ground surface in EU205 (context 1144, left) and EU206 (context 1146, right).

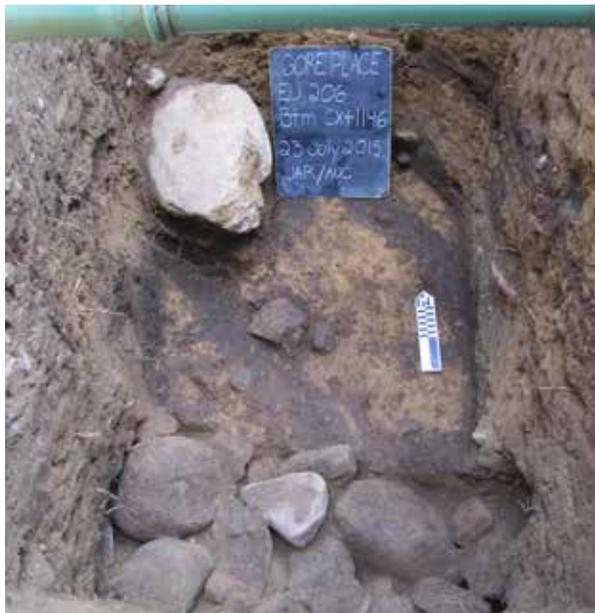
Figure 27. Dark features in the floor of EU206 interpreted as wheel ruts. The rocks in the lower part of the image are the fill of the later French drain.

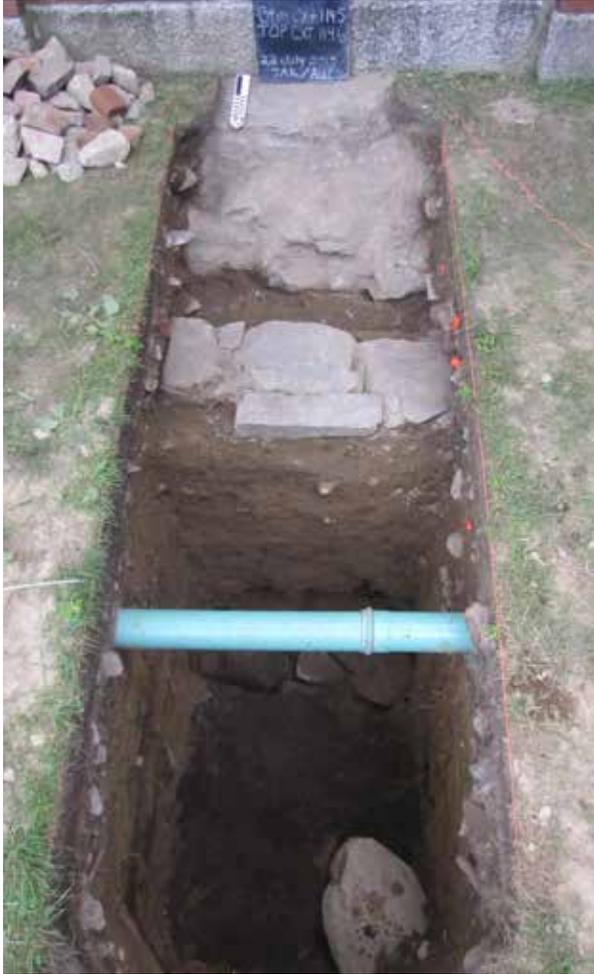
Figure 28. Door footer in EU206, north of a later concrete cap placed for foundation repair.

Chronologically, the next event that took place and was visible in the archaeological record was the construction and later abandonment of an old doorstep in the southern portion of the unit. Constructed out of green-gray slate, a single stone course was uncovered approximately 35cm below surface that extended east-west across the unit (Fig. 28). For stability reasons, the stones were left in situ and the soil underneath them was not excavated. Above the stones was a thin buried ground

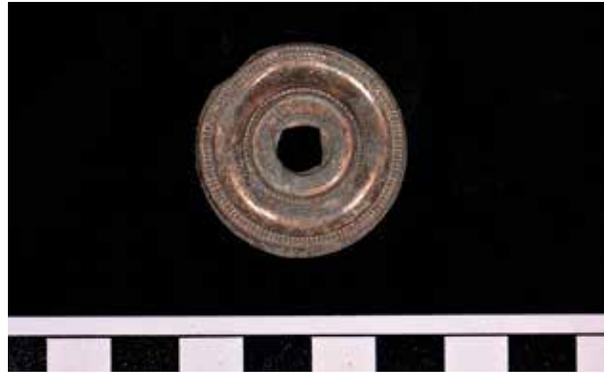
Figure 29. Gilt escutcheon that may have surrounded a furniture pull from EU205, context 1126. Scale in cm.

The next event visible archaeologically in both units was the deposition of architectural rubble and demolition debris. The demolition event(s) were separated into three different layers, contexts 1126, 1127, and 1128, that differ somewhat in color and composition (different types of architectural debris were predominant in each one) in EU205 and excavated as a single deposit in EU206 (context 1135). Context 1128 was located in the northern portion of the unit and was comprised of approximately 15 cm of 10YR 3/3 dark brown clay silt with dark brown and strong brown mottling. Large pieces of mortar, stone, and brick fragments were found in the layer, as well as nails, window glass, and marble chips. Context 1127 was located more centrally in the unit and consisted of between 16-2cm thick 10YR 3/2 very dark gray brown silt with olive brown and dark brown mottling. A large amount of slate was recovered, as well as nails, whiteware, tin-glazed tile, bottle glass, and window glass. One black basalt ceramic sherd with an incised line was found dating from 1750 to the 1850s (Miller 2000: 10). Context 1126 began 50 cm north of the south wall and extended for another 50 cm, measuring approximately 40 cm thick. The layer consisted of 10YR 4/6 dark yellow brown clay silt with brown mottling. Similar to the other demolition layers, large amounts of architectural debris were recovered, as well as a gilt escutcheon (Fig. 29), vessel and window glass,

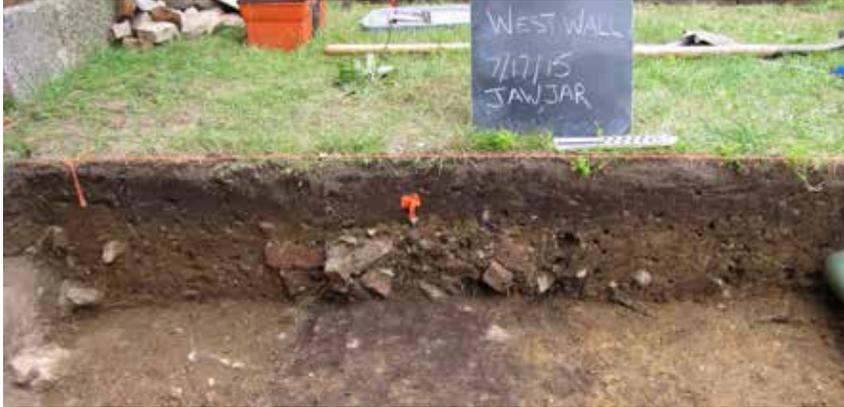
Figure 30. West wall of EU206 showing the small preserved remnant of the demolition layer (center), cut through on the south (left) by a trench to repair the foundation and on the north (right) by a trench to place a French drain.

The next stratigraphically visible alternation to the landscape seen in the units consisted of two separate events: the creation of a trench for a French drain, and the cut and filling of a builder’s trench for structural repairs to the house foundation (EU206) and window well (EU205). These events cut through the rubble/demolition layers (Fig. 30). The fill for the French drain was designated context 1132 in EU 205 and context 1138 in EU206. In both units the soil was noted as yellow brown with dark gray brown/black mottling. The trench was oriented east-west roughly parallel to the house and was approximately 50 cm wide. The cuts for the drain trench were vertical and straight sided, suggesting the use of mechanical equipment for its construction. At just under 1.3 m below surface, the trench gave way to voids in both units. The voids were later attributed to rodent burrows. Underneath the voids, large stones were piled within the trench to allow water to drain away from the structure (Figs. 31 and 32). Artifact density was generally low in the trench given its depth, with recovered artifacts including architectural debris, pearlware, nails, and bottle glass.

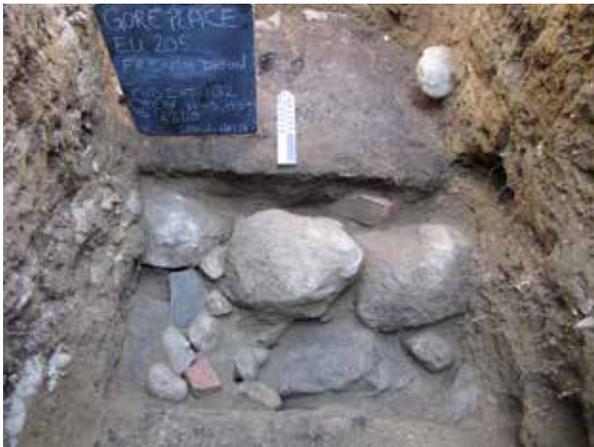
Figure 31. The rocks lining the bottom of the French drain trench in EU205.

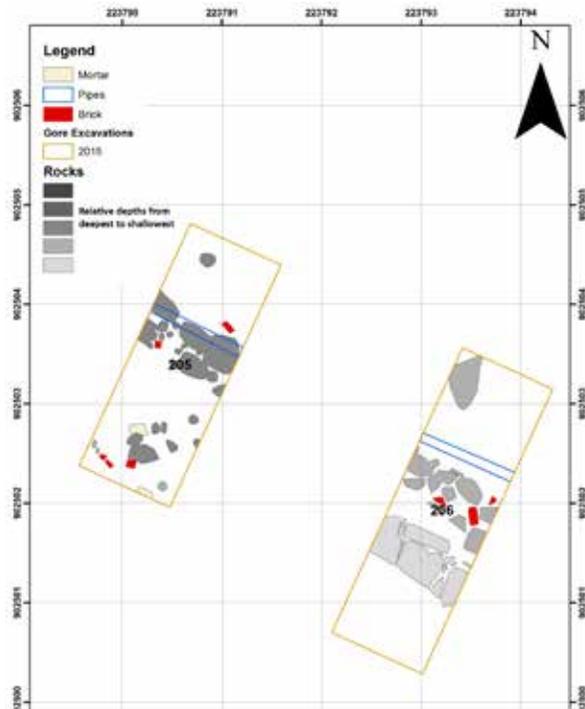
Figure 32. Plan of the features in units 205 and 206.

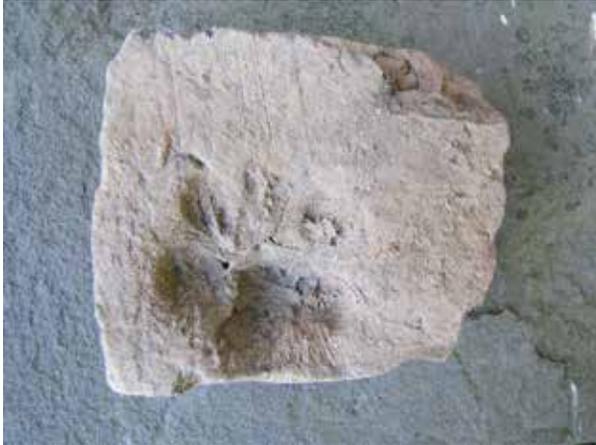
Figure 33. Brick with a dog footprint from demolition debris in EU205.

Among the broken bricks in the demolition debris in EU205 was one with a dog footprint impressed on it (Fig. 33). A footprint like this is

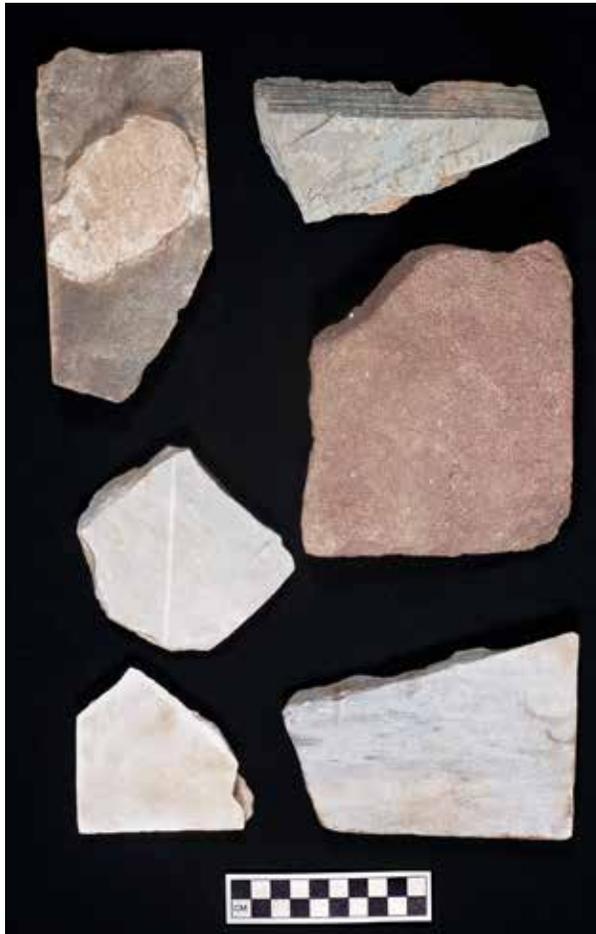
Figure 34. A sample of the architectural materials from contexts 1135 and 1136; top: gray slate with mortar, pale greenish slate; middle: red sandstone; bottom: three marble tile fragments, including one with an incised line.

We did not save all of this material, but did retain samples of each of the types represented. The layer of demolition debris beneath the topsoil in EUs 205 and 206 contained predominantly broken bricks, but also roofing slate, marble chips, and tin-glazed tile fragments. The volume of architectural rubble suggests a major episode of renovation involving a section of brick wall, duct or chimney that also affected some of the floor, as evidenced by the pieces of marble and slate flooring material. The amount of roofing slate indicates roof repair at the same time. The deposit in EU206 was relatively uniform, but the demolition debris in EU205 seemed to be composed of several dumping episodes, each containing a slightly different mixture and proportion of materials indicating repairs to different parts of the house. The least common material is the red sandstone, the single example of which is pictured in Figure 34. This material makes up the mansion's north porch.

Larger fragments of marble and slate floor tiles (Fig. 34) were also found in context 1136 in EU206, the trench cut for foundation repair. As one of the later features in this unit, the inclusion of flooring material could come from a later period of renovation, or it could have been re-deposited from the demolition debris that they had to cut through to access and repair the foundation. The dark gray roofing slate with a nail hole (Fig. 36) is from the French drain deposit in EU206 so could also be re-deposited from the demolition debris or incorporated later when the French drain was excavated.
