**Archaeological Investigation of the
Drive Circle and West Hyphen at Gore Place
Waltham, Massachusetts**

**Prepared by:
Christa M. Beranek and Alexandra U. Crowder
Fiske Center for Archaeological Research
University of Massachusetts Boston**

Cultural Resource Management Study No. 74

April 2016

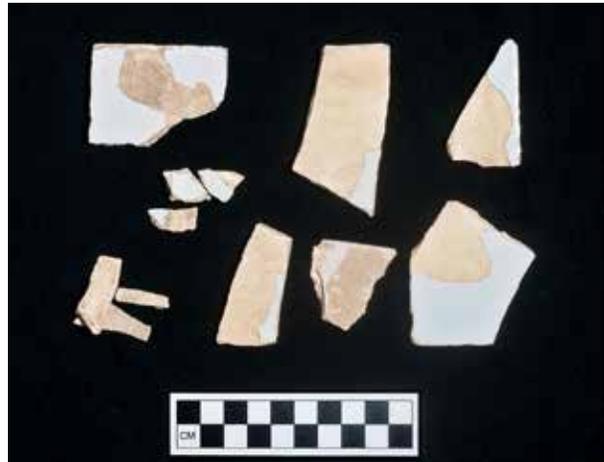
Figure 35. A sample of the tin glazed tile fragments from contexts 1120 and 1125.

The tile fragments recovered during the 2015 excavation (Fig. 35) were concentrated in the topsoil and demolition debris of EU205, with a smaller number found in EU206. They were relatively infrequent compared to the volume of material such as brick and slate that comprised the demolition deposit. Like those recovered by Smith, none of the tiles we found had mortar on them, suggesting they might have been discarded

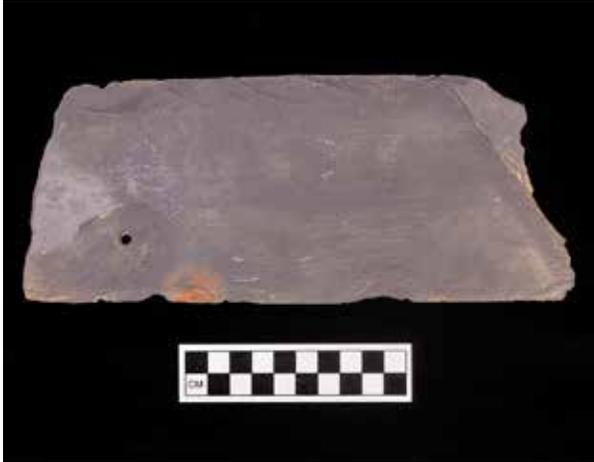
Figure 36. Gray roofing slate with a nail hole from the fill of the French drain in EU206.

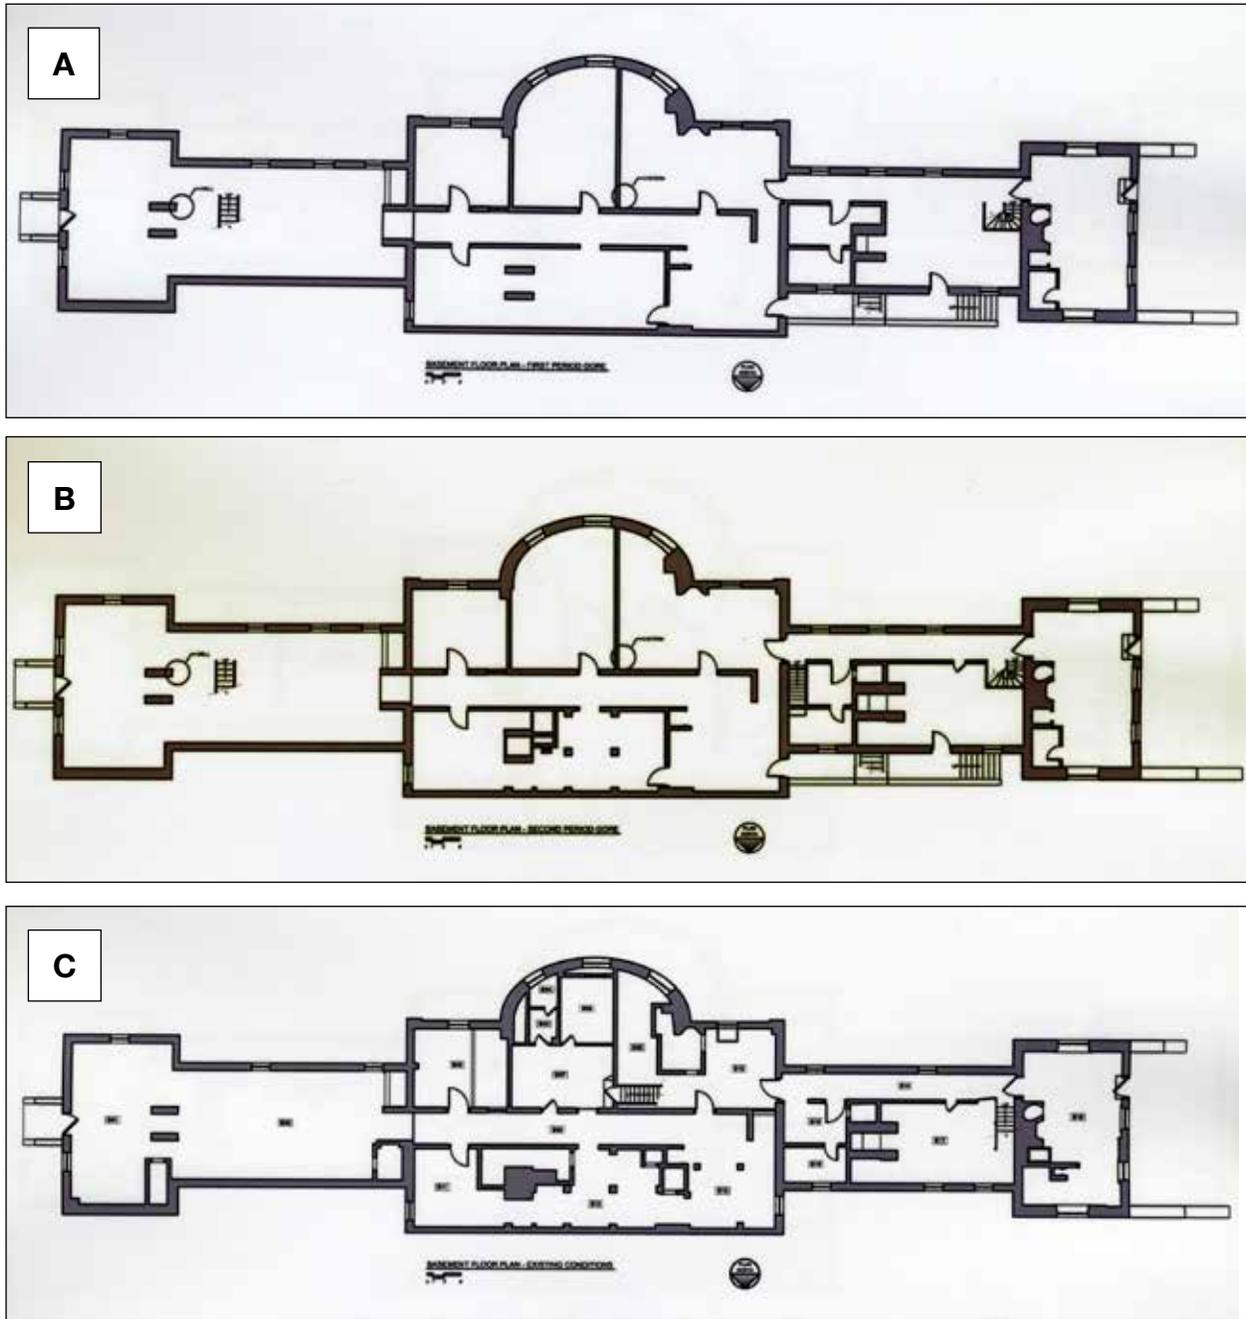
Figure 37. Cellar plan of Gore Place: A) first Gore period (1806-1817); B) second Gore period (after 1817); C) current conditions. From Mesick et al. 2008. Note that the archaeology suggests that the entrance to the cellar and the first floor on the west hyphen were sequential, not concurrent.

One of the major changes between the first and second Gore periods was in the configuration of the basement service space. The layout that exists today (Fig. 37), of a passage (B14) leading from the kitchen to the rooms under the main block of the house, was created with the 1817 renovations. In the first Gore period, one went from the kitchen to a large open room (now B17 and B14) that contained stairs to the first floor as well as a door to the exterior (Fig. 37a). That door is now a basement window, distinguished by having an arch in the exterior brickwork (Fig. 21). In the second Gore period, this large room was split up into a room (B17) and a passage (B14) and stairs accessed from the passage. The changes made this basement room much more enclosed, with more limited access from the interior. One of the archaeological questions is whether the exterior door to this room was closed off at this point, by Gore, as part of his reconfiguration of the service space, or later. There are not many diagnostic artifacts in the fill layer put in place to close off the cellar entrances, but one hand-painted pearlware sherd in a floral pattern gives the fill a TPQ of 1815 (meaning the fill event happened some time after 1815). This means that it is possible that the Gores were responsible for closing off the cellar entrances dur-

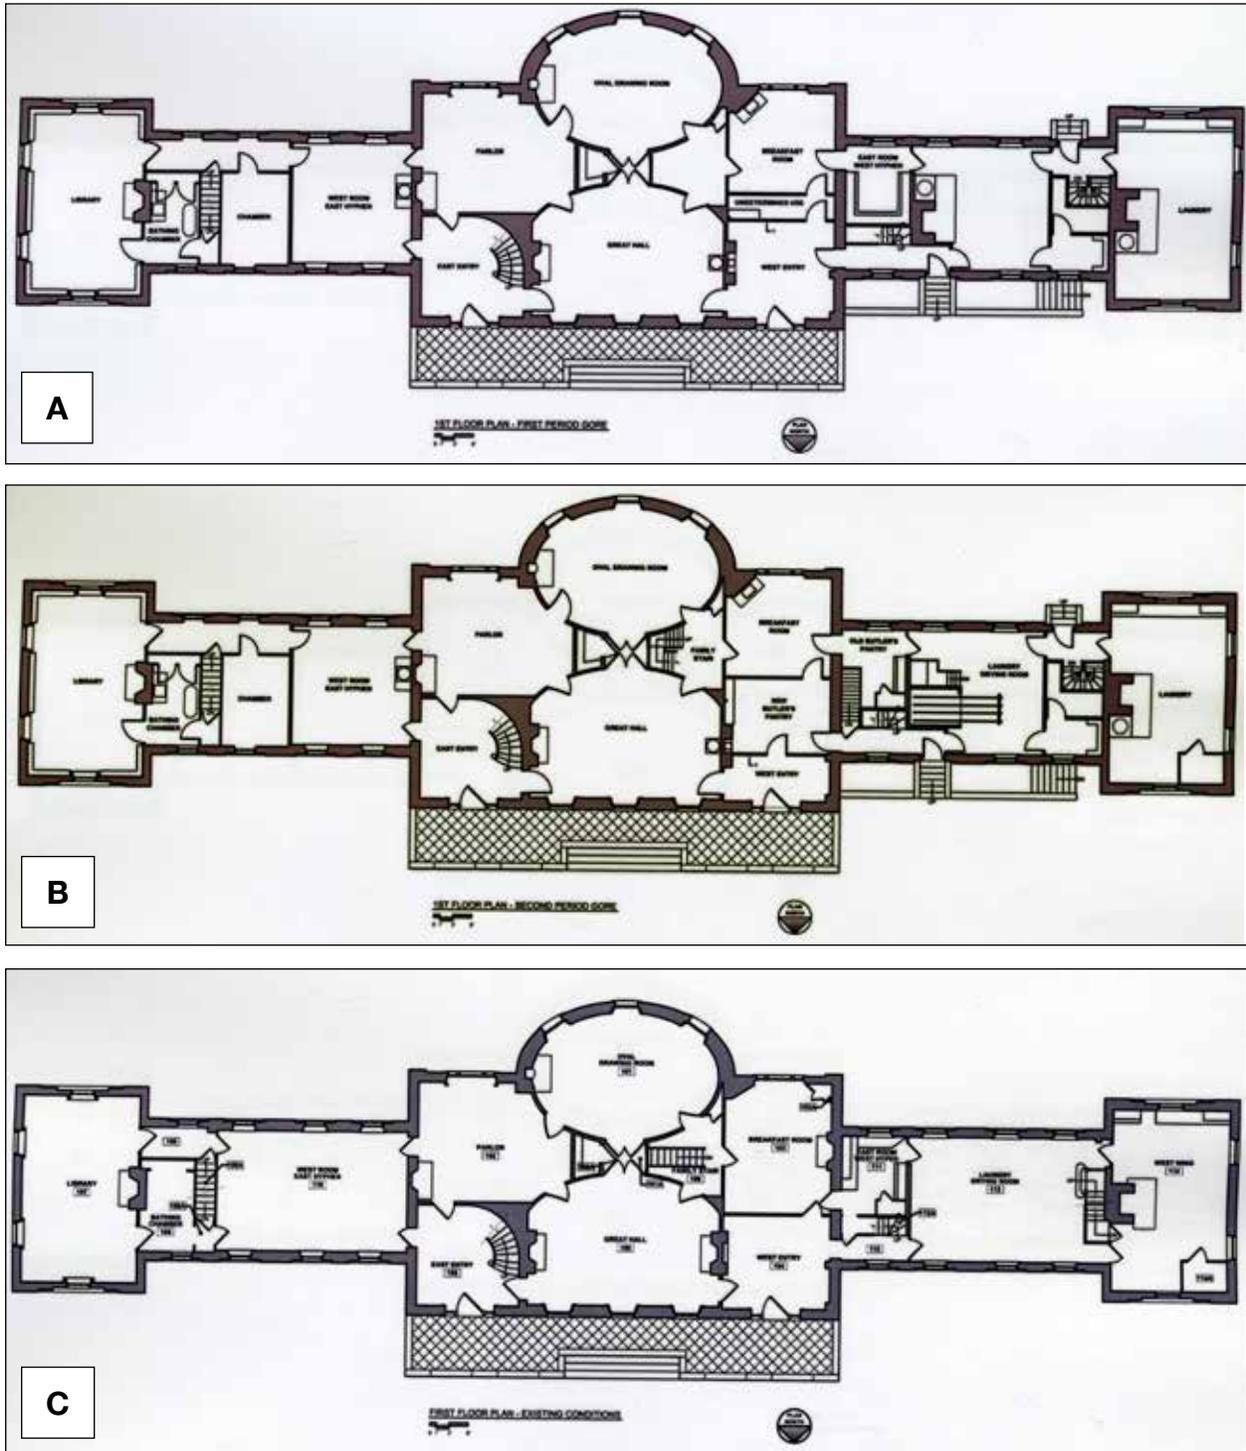
Figure 38. First floor plan of Gore Place: A) first Gore period (1806-1817); B) second Gore period (after 1817); C) current conditions. From Mesick et al. 2008. Note that the archaeology suggests that the entrance to the cellar and the first floor on the west hyphen were sequential, not concurrent.

At the first floor level, architectural analysis suggests that the west wing was a laundry room until the kitchen was moved to the first floor in the last two decades of the 19th century (Mesick et al. 2001: 28; Fig. 38). The west hyphen was unidentified service space in the first Gore period and converted to a formal laundry drying chamber in the second period. In both the first and second Gore periods, the connection between the main block of the house and this wing was through a hallway which was longer than the current hall (space 112) because of internal partitions in the west hyphen (space 113). These internal partitions may have remained until the country club period (1921), which is when Mesick et al propose that the laundry drying chamber was removed (2001: 31). The architectural plans in the partition analysis (Mesick 2008, see Fig. 38a and 38b) propose a first floor doorway into this narrow passage in both the first and second Gore periods. The archaeological excavations found a doorstep in this position (see above, EU206), but this doorway was almost certainly installed only after the cellar doorways were closed off, in the second Gore period or later. This may have been part of the Gores' reconfiguration of the service space, which included changing the access routes from a basement entry to a first floor entry.

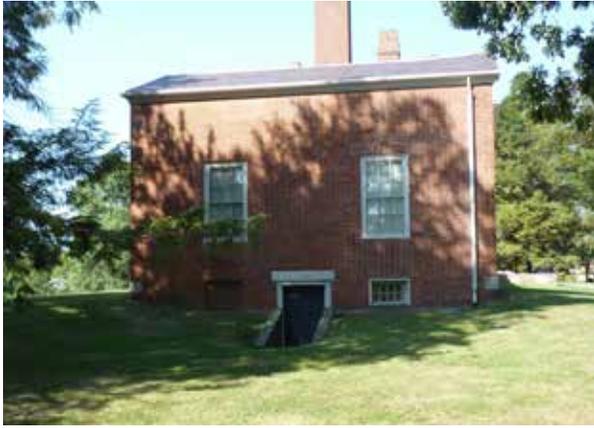
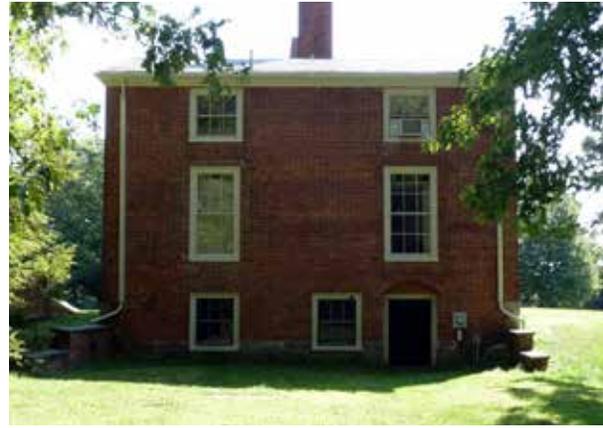
Figure 39. East (left) and west (right) ends of the mansion showing two different ways that cellar entrances are configured today. Note the courses of stone visible below the brick on the west end.

dow well, not out the house's foundation. The east and west ends of the house have some of the cellar story exposed, and they offer two different possibly appearances for the front of the west hyphen (Fig. 39). The existence of the cellar entrances also raises the question about symmetry between the east and west hyphens. If the west was exposed and the east was not, the house would not have appeared so symmetrical from the north side as it does today.
