**Data Recovery Excavations of the Carriage House,
Greenhouse, and Greenhouse/Carriage House Well at
Gore Place, Waltham, Massachusetts**

**Prepared by:
Christa M. Beranek, J.N. Leith Smith, and John M. Steinberg
With contributions by Michelle G. Styger, Heidi Krofft, and Rita A. DeForest
Fiske Center for Archaeological Research
University of Massachusetts Boston**

Cultural Resources Management Study No. 45

March 2011

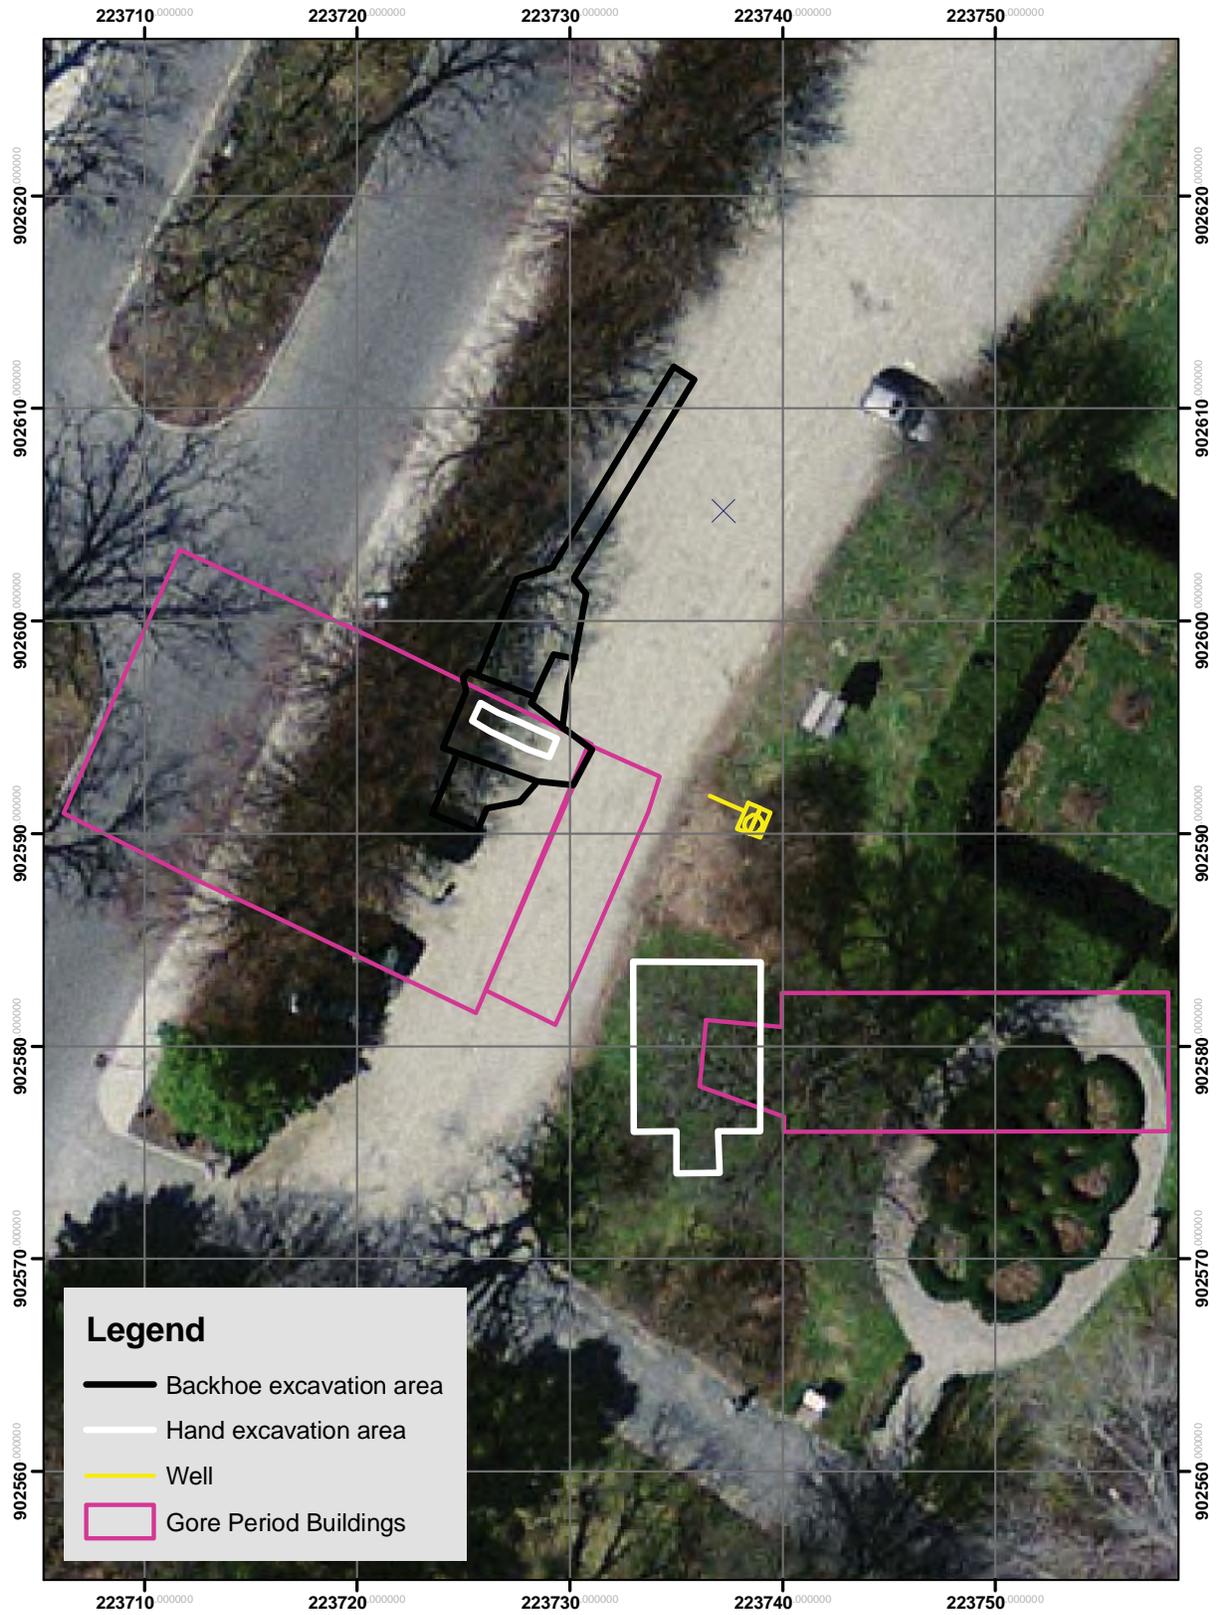
Figure 1.2. Locations of the original site of the Carriage House (to the west), the greenhouse (to the east), and the well near the entrance to the property, with excavation areas overlain.

This report covers the archaeological data recovery of the original locations of the Gore-period carriage house and greenhouse located near the entrance drive (Figure 1.2), both important elements of Gore’s agricultural and horticultural work on his farm. It also covers the excavation around

(Gore Street), on the north by the formal vegetable garden, on the east by a cart way, well, and the greenhouse, and on the south by the carriage house court yard adjacent to the formal entrance drive (see Figure 1.2). Across the drive, at least for a period of time, was an additional garden. The cel-

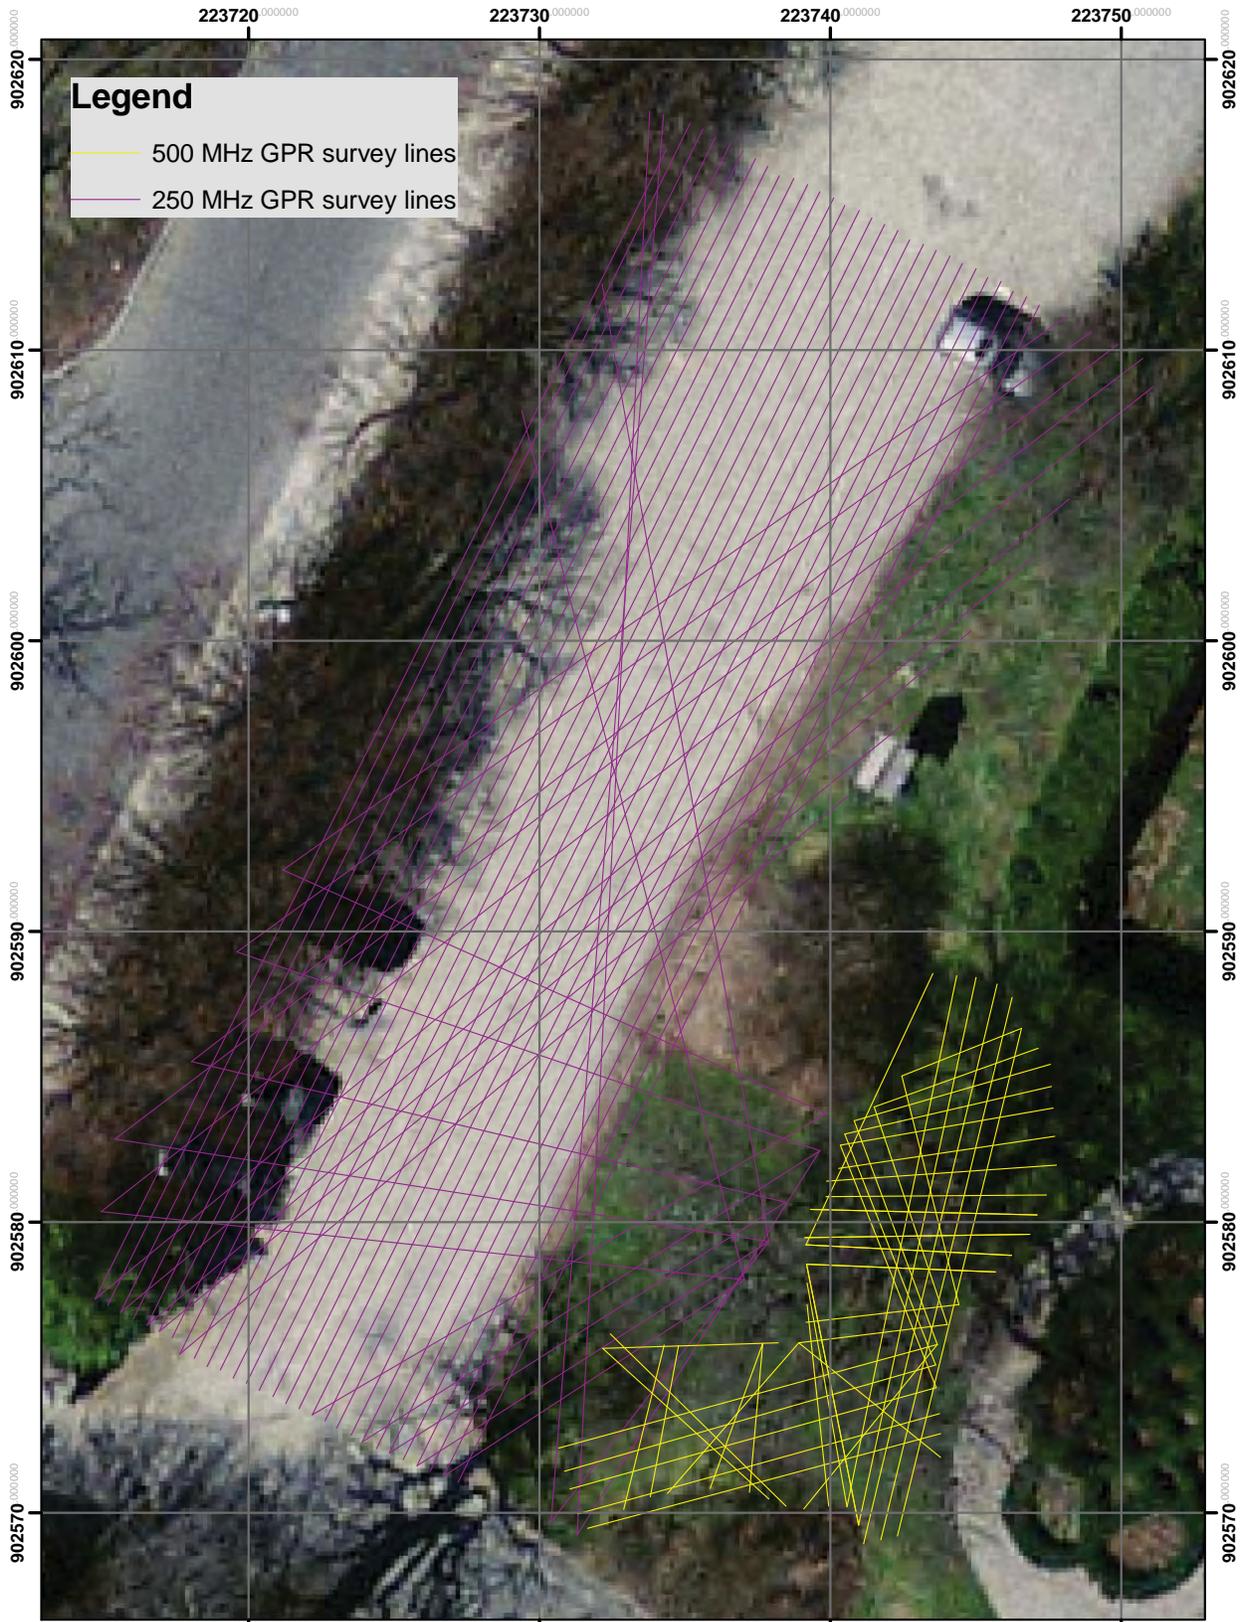
Figure 1.3. GPR transects.

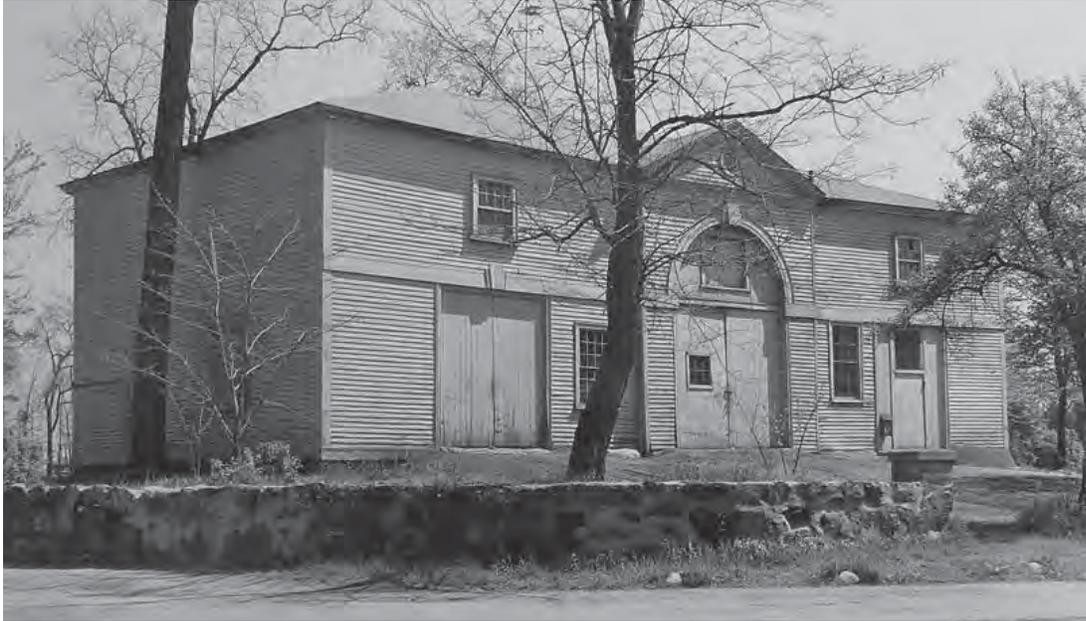
Figure 2.1. Carriage house as it appeared ca. 1937.

The carriage house, also known as the coach house or coach barn, is a large, two-story structure that was originally located on the north side of Gore's entrance drive adjacent to Gore Street (former Cross Road; Figure 2.1). It was built around 1793 of timber frame construction finished with clapboards and relatively high style Federal period detailing. It is one of a small number of such barns to survive intact from the late 18th century in New England and played an important role in the management of the estate. Its construction date is based on its similarity to the carriage barn at the nearby Theodore Lyman estate (The Vale) known to have been built at that time and designed by the accomplished architect, Samuel McIntyre of Salem, Massachusetts. The Gore carriage house measures approximately 70 × 40 ft, and according to Historic American Buildings Survey (HABS) records was set on a full, dry-laid fieldstone (rubble) foundation. The first floor consists of three bays, each with its own access door (Figure 2.2). At present, the western bay or coach room features plastered walls and ceiling with horizontal plank wainscoting. The central bay is formed by wood plank and stud partitions, while the east bay contains a harness or tack room and seven horse stalls. The stalls are constructed of match-board paneling with curved arches and numbered keystones that may have been installed in the mid 19th century. The second floor follows an open plan and is accessed via a wide staircase at the central rear of the building. The cellar was present under the entire structure and was accessed via a ramp and exterior opening in the east foundation wall. The ramp was protected from the weather by a shed addition that is clearly depicted on the Greene estate plan, and the ghosted image of its roofline was documented by the HABS drawings.

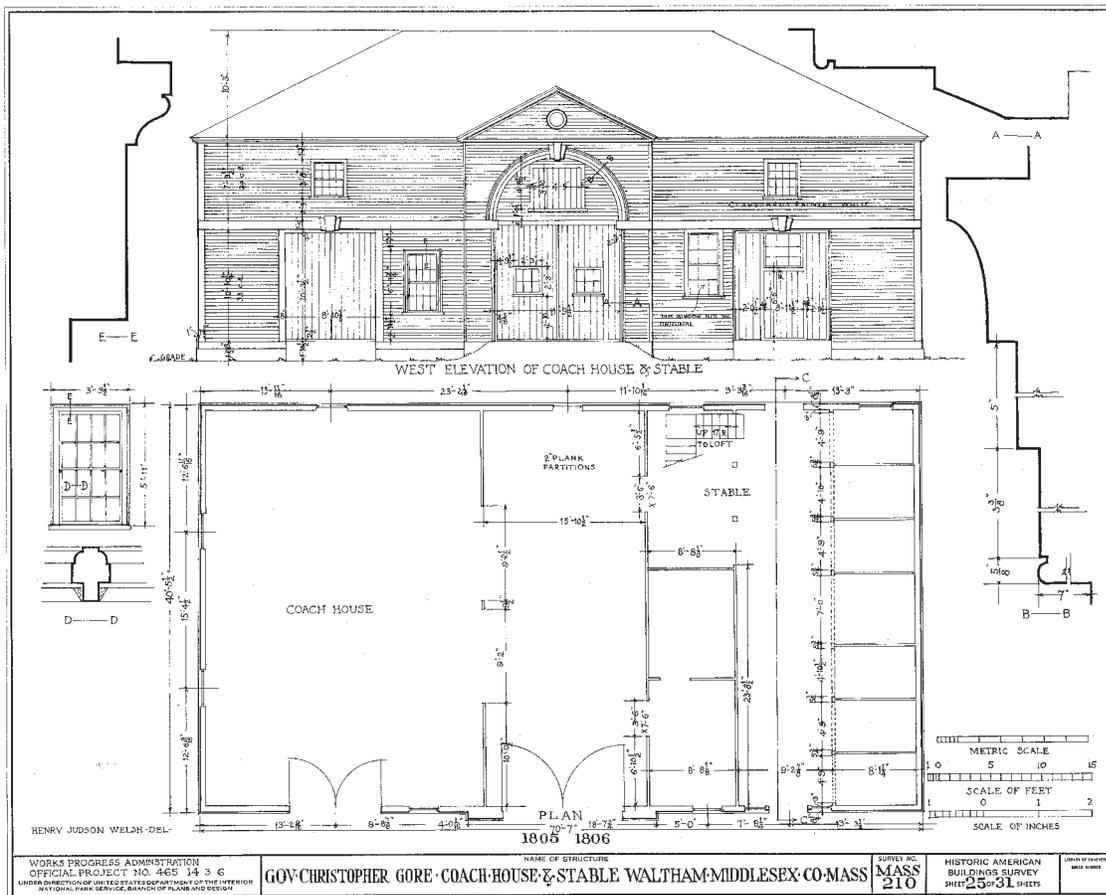
Figure 2.2. First floor plan of carriage house (HABS 1936).

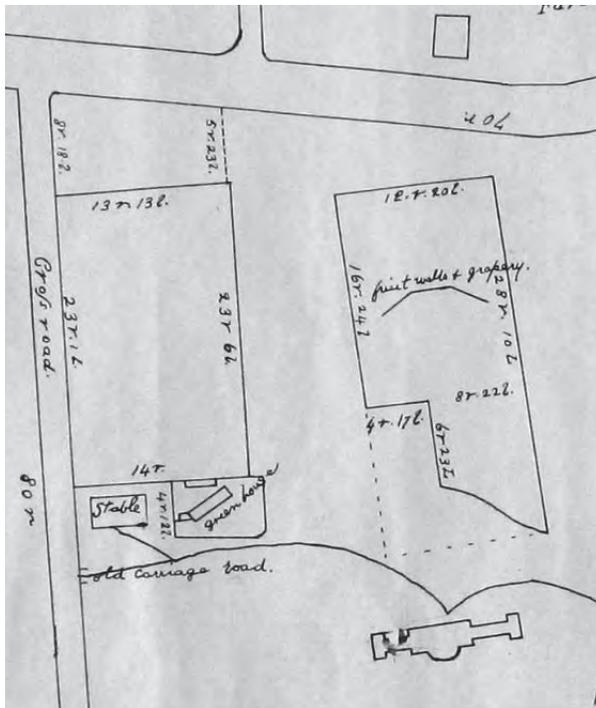
Figure 2.3. Detail of plan of Theodore Lyman Estate ca. 1834-38.

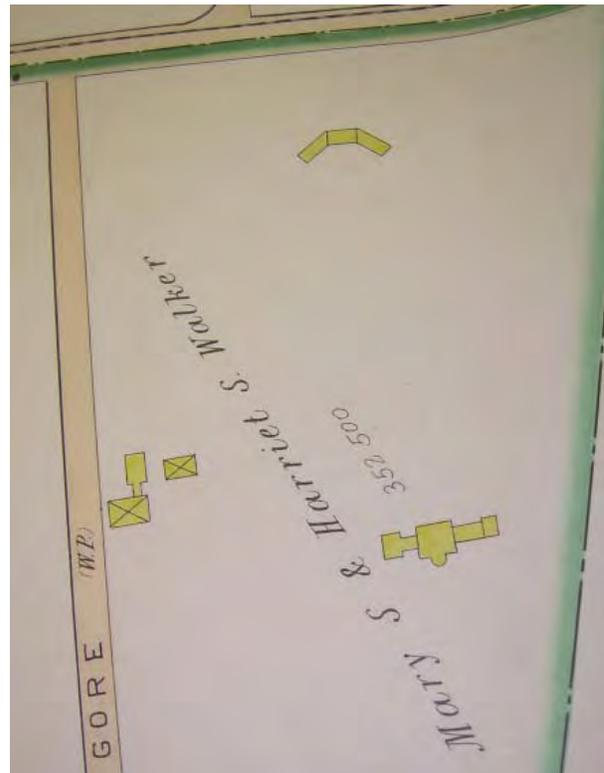
Figure 2.5. Detail of 1900 map from *Atlas of Middlesex County* (Anon. 1900).

With the death of the Gores and the sale of the estate to successive owners, no further details of the use of the structure are known. It is likely that manure production here ceased, if not by the time of the Lymans, then by that of the Greenes, potentially making the cellar available for the collection of horse manure and for general storage. The only documented changes to the building in later years were the removal of the shed over the cellar entrance prior to 1900 and construction of an ell or shed off the rear of the building (Figure 2.5). The

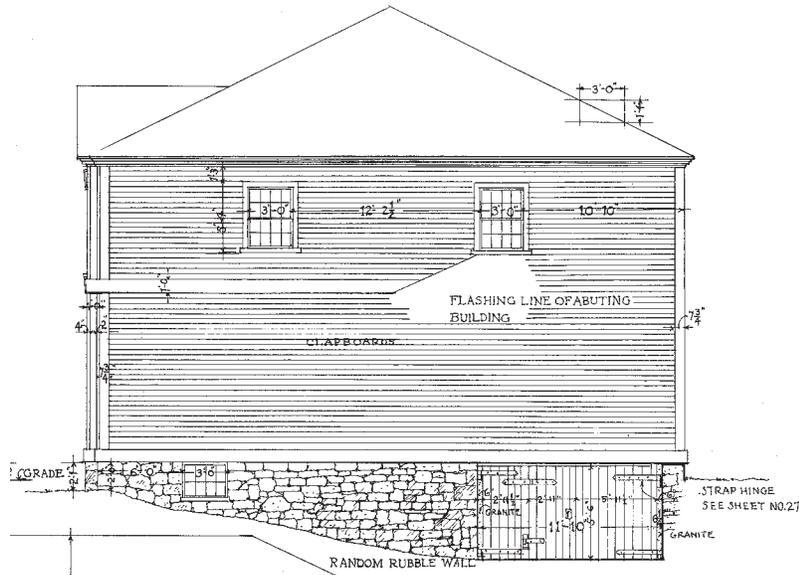
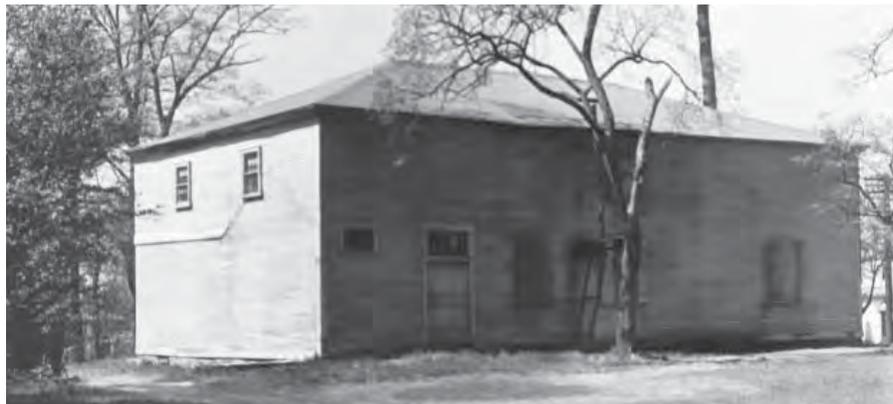
Figure 2.6. A) Detail of the east side of the carriage house; B) photograph showing the ghost image of the roofline (HABS 1936).

When the estate came under the ownership of the Gore Place Society in 1935, repairs were made to the roof of the building as a result of a second floor fire, but the cause of the fire is unknown. In the same year, the carriage house was documented along with the mansion house by HABS. This work provided detailed drawings as well as photographs of the exterior and some interior spaces. Particularly noteworthy was the depiction of the east carriage house foundation wall, ramp, and wooden cellar door (Figures 2.6 and 2.7). Dimen-

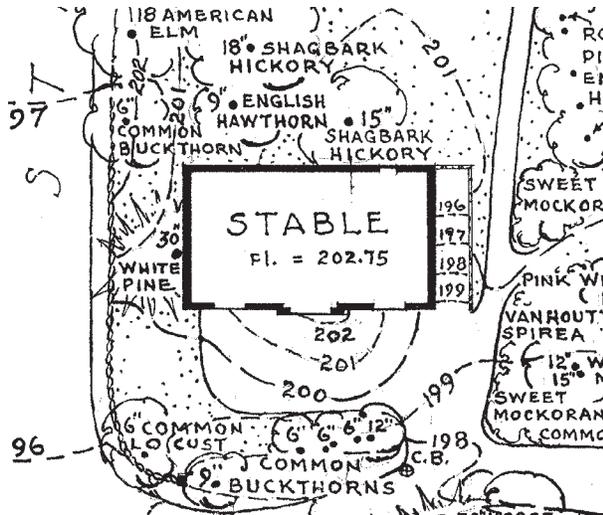
Figure 2.7. HABS plan of the carriage house, showing the slope of the ramp.

sions provided by the drawings reveal that the cellar was approximately 5 ft, 6 in deep, and may have provided slightly more headroom depending on the elevation of the first floor joists. This assumes that the cellar floor lies at the same level as the entrance lintel. This depth certainly would have made the use of the cellar space possible for working manure.

The entrance was a total of 11 ft, 10 in wide, and the door was constructed in three parts. The right or north door was 5 ft, 11 ½ in wide, indicating that the width of the entrance ramp was a minimum of 6 ft. It was hoped that archaeological investigations would reveal the actual width that would have allowed access for a cart or wagon. The south door was double hinged so that the ramp would not impede its opening. The ramp itself appears to have consisted of a soft surface since no pavement was noted in the HABS drawings. This surface may have allowed better purchase for horses while backing and pulling manure-laden wagons.

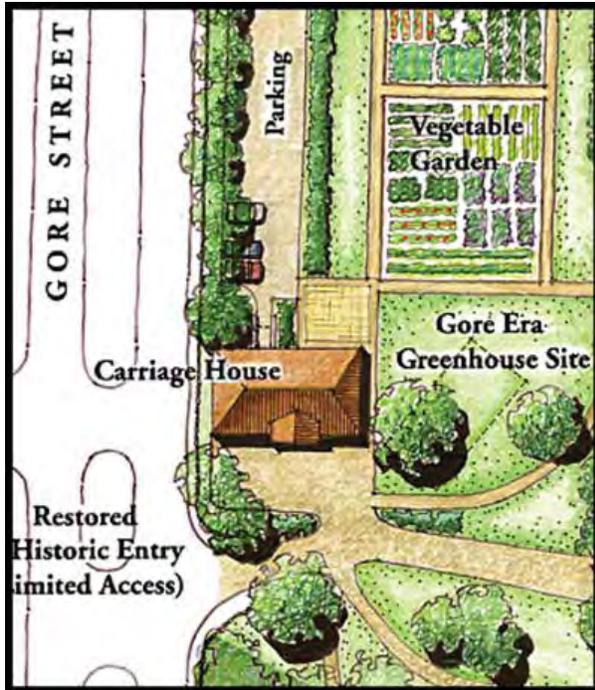
Figure 2.9. Proposed carriage house relocation plan, created prior to archaeological testing. Please note that our suggested relocation, after archaeological testing, is different; see Chapter 6.

from where was not known. The goal of the initial survey was to determine the structure's original location and the state of preservation of its foundation. This information was needed to consider the feasibility of returning the structure to or close to its original location as part of the landscape restoration plan (Figure 2.9).

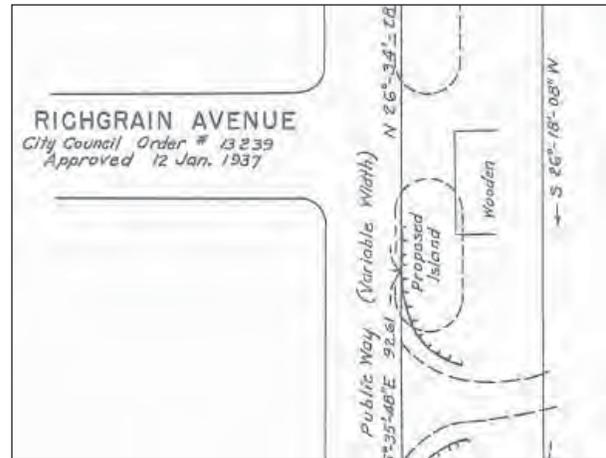
Figure 2.10. Detail of plan of proposed widening of Gore Street ca. 1967.

The most useful plans for determining the carriage house's original location were those completed by the HABS and a plan depicting the proposed widening of Gore Street from ca. 1967 (Figure 2.10). Both of these showed the north wall of the structure to be a little south of the center of

Richgrain Avenue. The street plan showed how the west end of the building extended well into the newly proposed road.

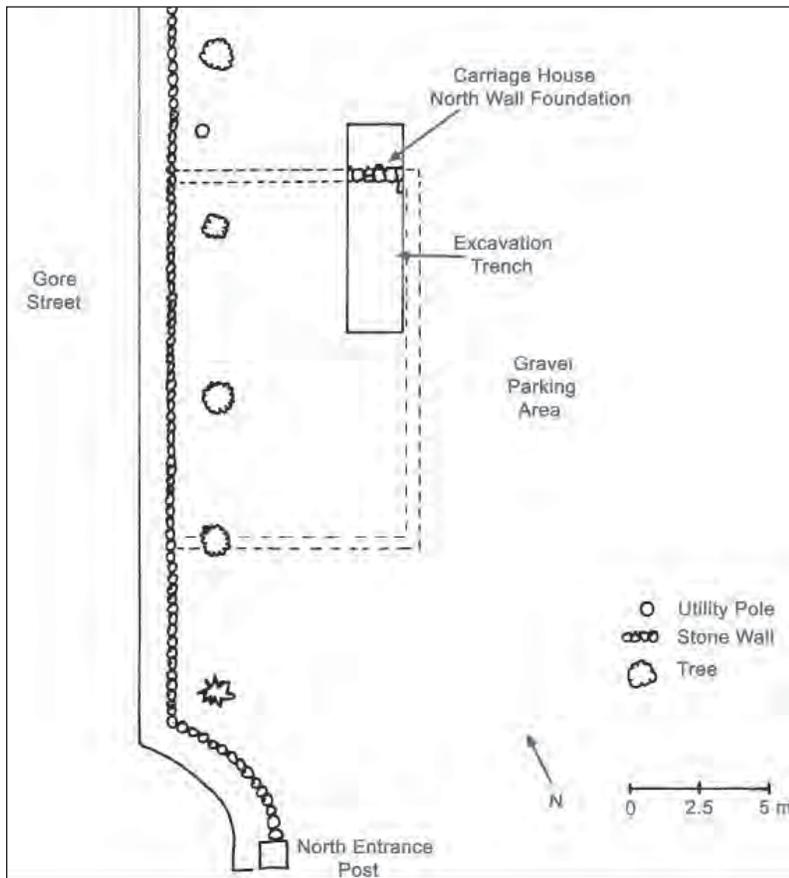
Figure 2.11. Plan of carriage house north wall location as discovered in 2004.

was found to lie approximately 23.75 m (77.92 ft) north of the north entrance post and 1.25 m (4.10 ft) south of an electric utility pole (Figure 2.11). The surface of the partially demolished wall lay between 1 m (3.28 ft) and 1.20 m (3.93 ft) below surface. Measurements suggested the east wall was located approximately 9 m (29.5 ft) east of the present stone boundary wall adjacent to Gore Street. The foundation wall was found to be constructed of large rounded boulders and angular field stones held together with mortar. Excavation revealed upper foundation stones to lie out of place on either side of the wall, with most having fallen or been pushed into the cellar's interior. A small section of collapsed brick wall, later determined to be an interior brick support post, was also present in this area. Cellar fill consisted of a loose, medium brown sandy loam that also contained stones and a few pieces of asphalt pavement. A small deposit of artifacts consisting of later 19th-century bottle and some window glass was encountered on

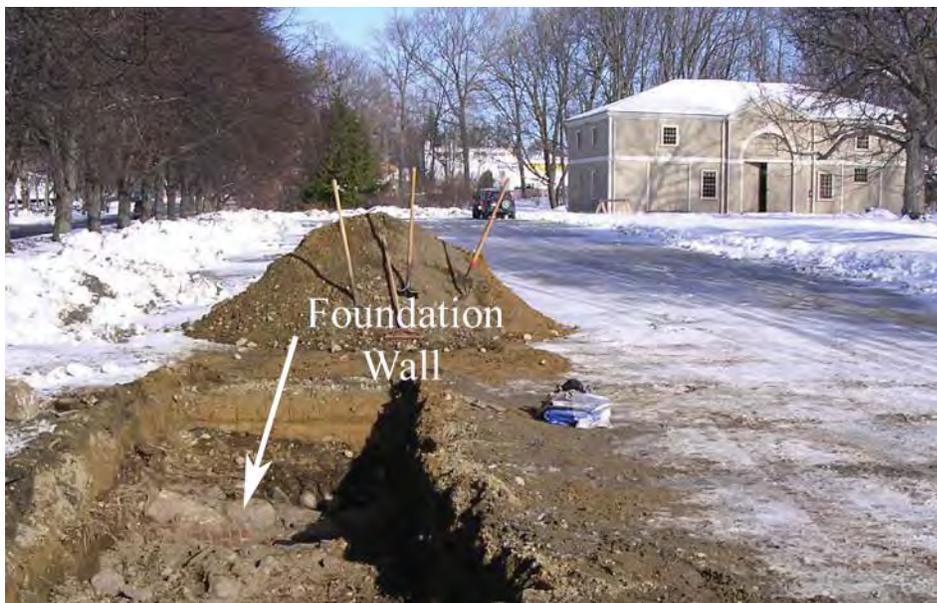
Figure 2.12. Excavation trench and north wall location in 2004 (facing north).

the north side of the foundation wall at an elevation between 70 cm (27.5 in) and 100 cm (39 in) below the parking lot surface (Figure 2.12). After the wall's location was recorded the excavation trench was backfilled.

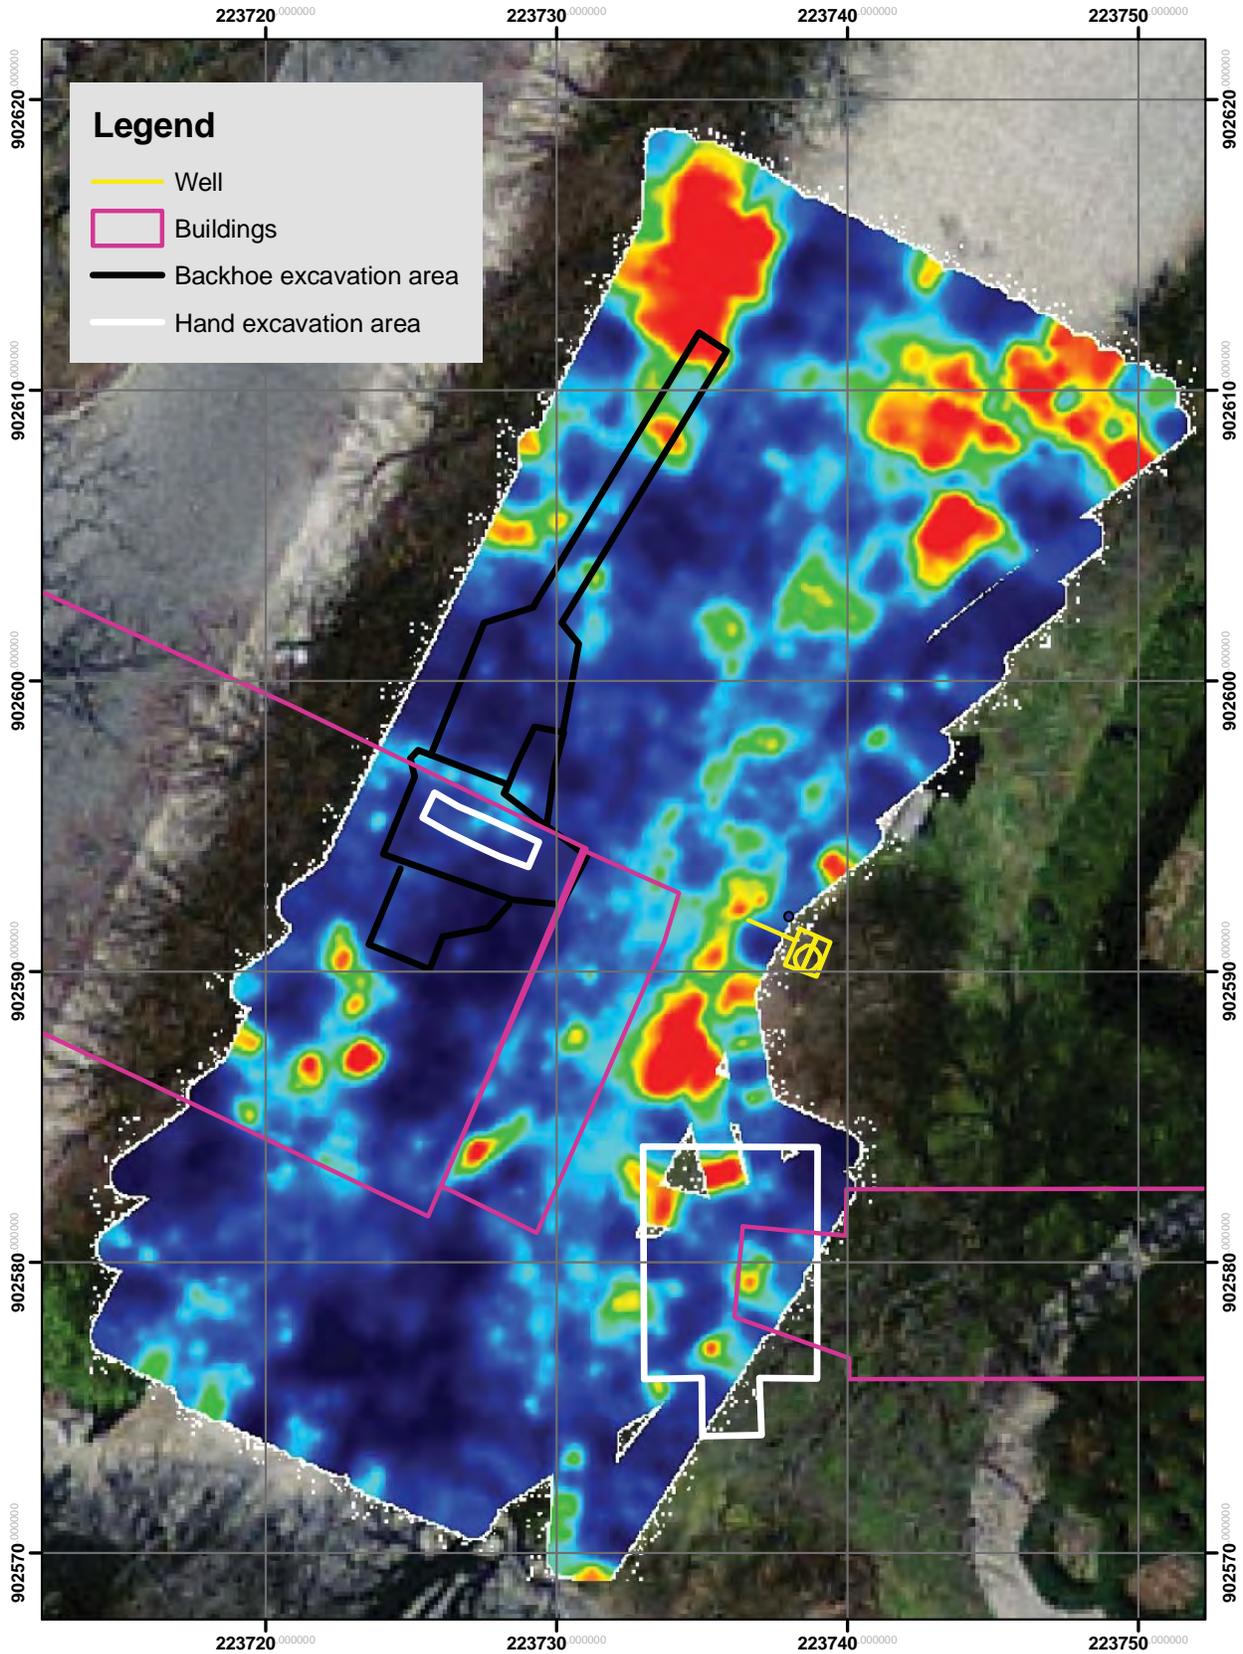
Figure 2.13. GPR slice at 20 cm below the surface. A reflection from the back wall of the carriage house is visible in light blue, and some faint signatures of the front wall are visible as well.

large split granite stones hidden within an elevated thicket on the edge of the parking lot (see Figure 2.13). The location of this well at the junction of the carriage house, greenhouse, and vegetable garden would have made it a vital and much used element of the landscape. The mounded appearance of the area immediately around the well was intriguing for the fact that it was thought to be the

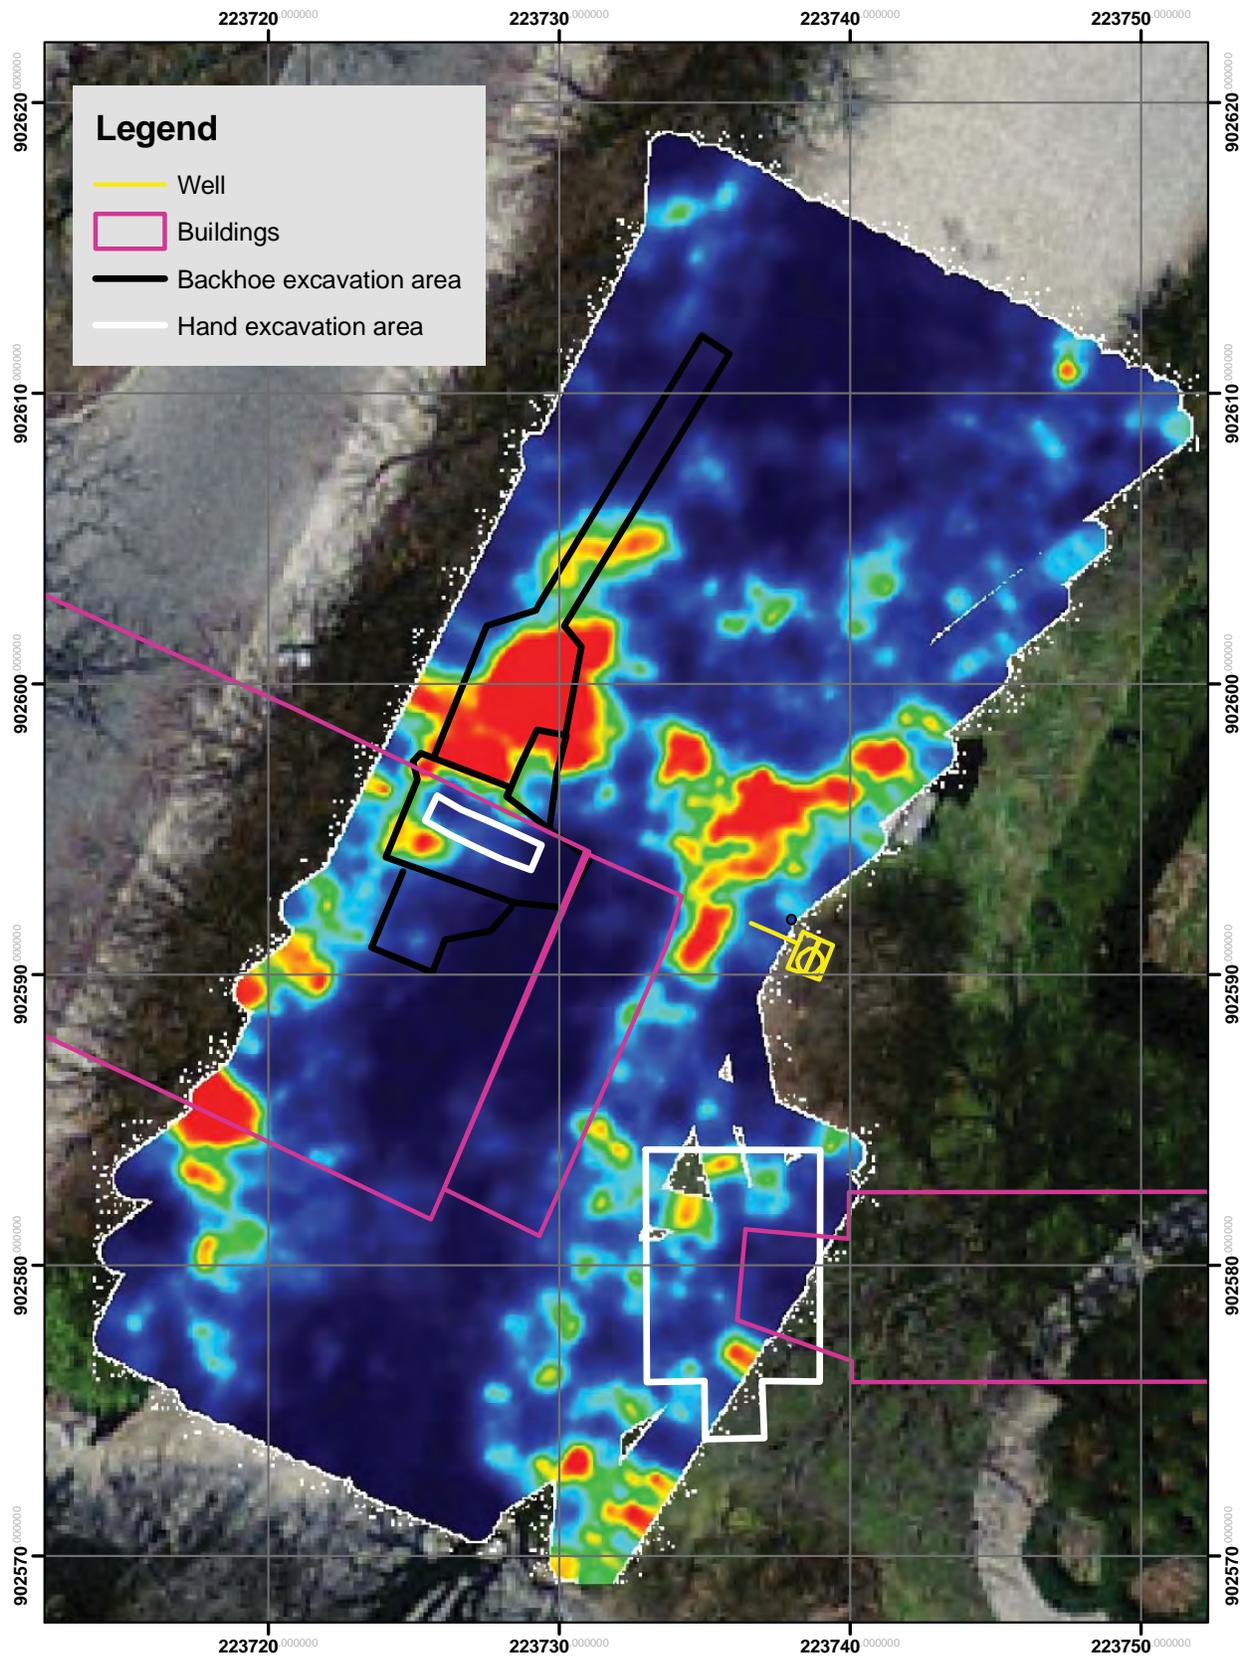
Figure 2.14. GPR slice at 50 cm below the surface showing the absence of reflectors that delimit the area of the carriage house cellar and ramp.

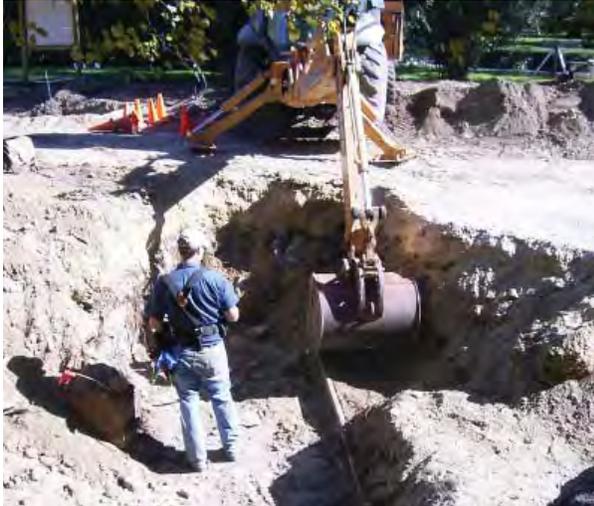
Figure 2.15. Backhoe removing fill from carriage house cellar, facing east.

The backhoe was repositioned to the east side of the excavation area to carefully remove remaining cellar fill and to expand the area eastward in hopes of encountering the east foundation wall (Figure 2.15). As soil fill was mechanically removed from west to east just inside the north foundation wall, a split granite post containing an iron pintle was revealed adjacent to the wall. It was immediately recognized that this was a support for the cellar door. Excavation in the area had to be ceased at that point in order to maintain a safe passage for cars to enter the rear portion of the parking lot. Thus, none of the ramp or ramp walls were exposed.

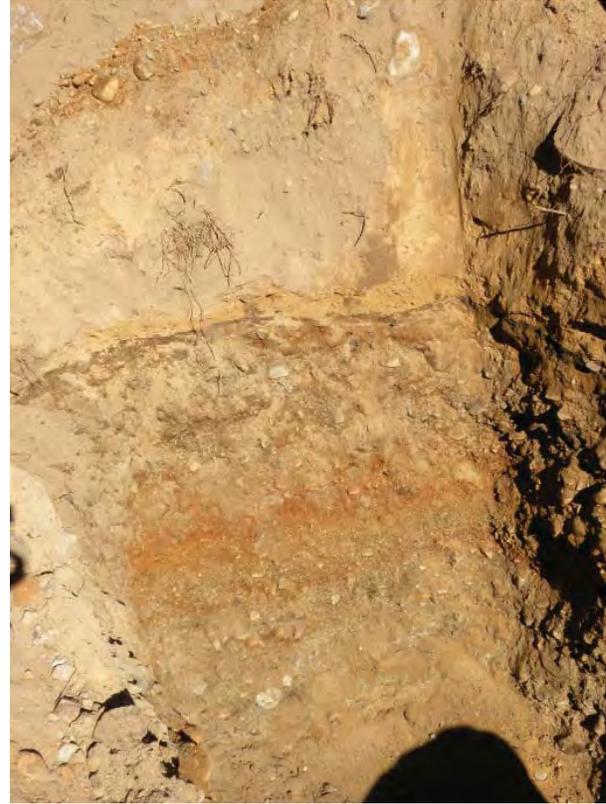
Figure 2.16. East wall profile of Test Trench 1.

and rounded gravel and stones were found instead. Interpreting this to represent possible feature fill, this trench (Test Trench 1) was expanded to 1.2 m in width and 2.5 m long, and was mechanically excavated to a depth of 2 m. This revealed four episodes of sand and gravel fill (Figure 2.16). Given this unexpected finding, the backhoe was repositioned immediately westward to open up a larger area to search for a possible feature border and for a buried ground surface if one still remained intact. Removal of the parking lot fill to a depth of 30 cm bs showed sandy gravel to be present across the entire area. A single trench (Test Trench 2) was extended northward to search for a border of the sand and gravel fill. Excavation proceeded to a depth of 40 cm and the trench was extended 17.5 m north of the rear carriage house foundation wall. Parking lot gravel, yellow sand bedding and sandy gravel fill was present for the entire length of the trench to a depth of 40 cm bs. Archaeological testing in this portion of the parking lot in 2004 showed parking lot gravel and sand bedding to range in depth between 35 and 50 cm.

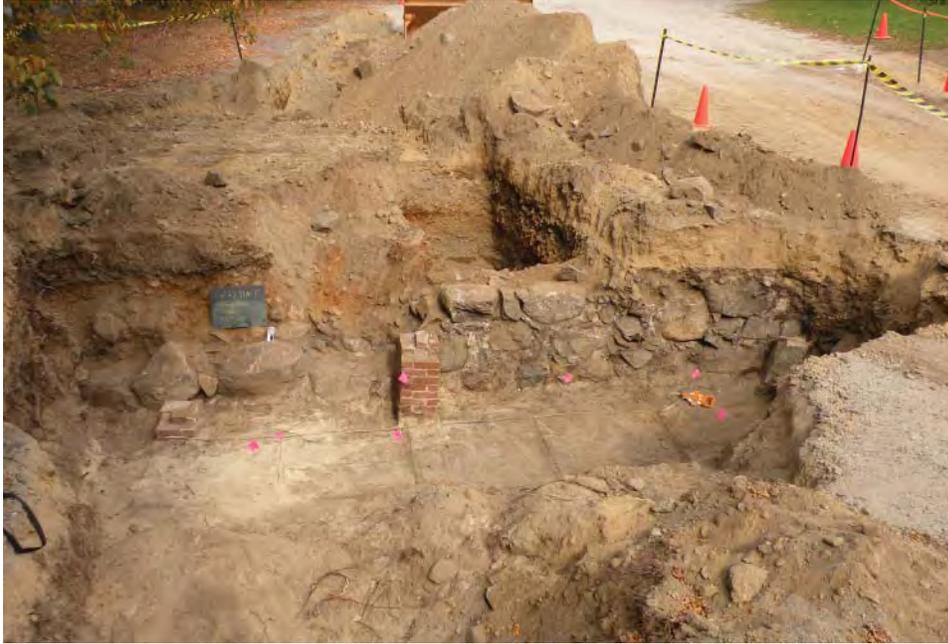
Figure 2.17. Northeast portion of carriage house cellar with fill removed, facing north.

With the completion of mechanical investigations, remaining fill in the cellar was removed by hand to reveal a hard-packed surface of grayish brown loamy sand with gravel (Figure 2.17). As the surface was cleaned of overlying fill, a ball clay tobacco pipe bowl was found at the junction of the floor and the rear foundation wall (Figure 2.18). The bowl displays a “TD” maker’s mark that was produced for much of the 19th century. The bowl shows little evidence of use and may have been deposited with household refuse used in manure production. It also may have been deposited after the Gore period by estate workers. Approximately 12 m² of floor surface was exposed by the excavation, bounded on the north by the rubble stone foundation wall, on the east by the cellar entrance, on the south by the galvanized steel water pipe and fill, and on the west by fill.

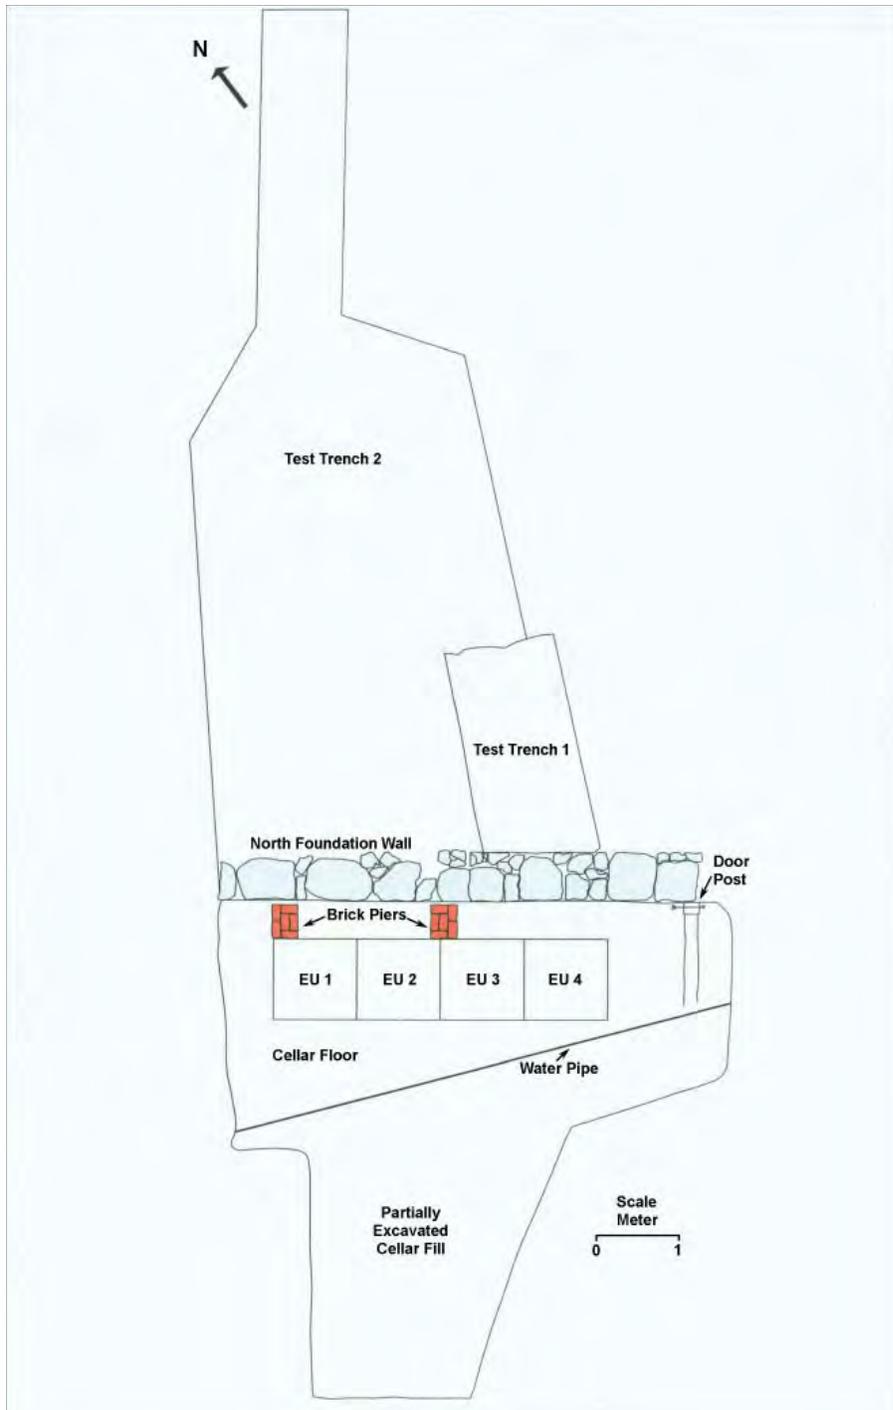
Figure 2.19. Plan of carriage house excavation unit locations.

A series of four contiguous 1 × 1 m excavation units were marked on the cellar floor parallel to the north wall to investigate floor deposits (Figure 2.19). EU 1 to the west, was aligned with the west edge of the western brick pier. The remaining three units extended eastward toward the cellar entrance. Soil profiles in all three units were identical, consisting of two fill layers over a series of seven more layers of C-horizon glacial

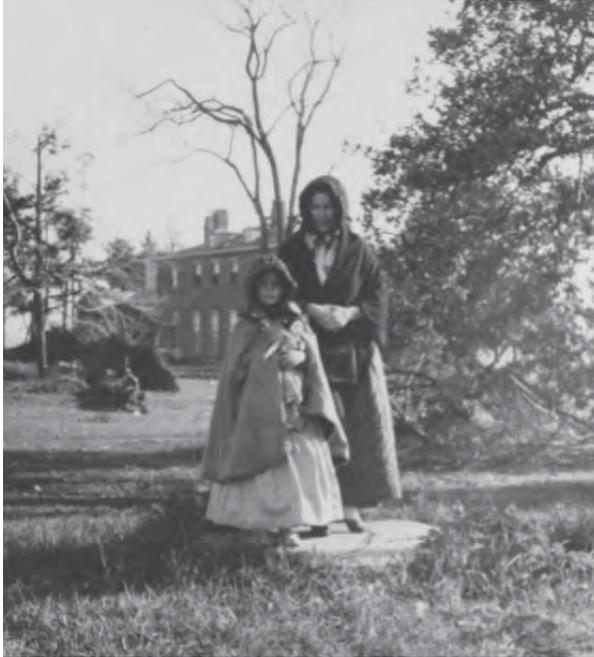
Figure 2.22. Photo of ca. 1927 depicting the two stones that cover the well.

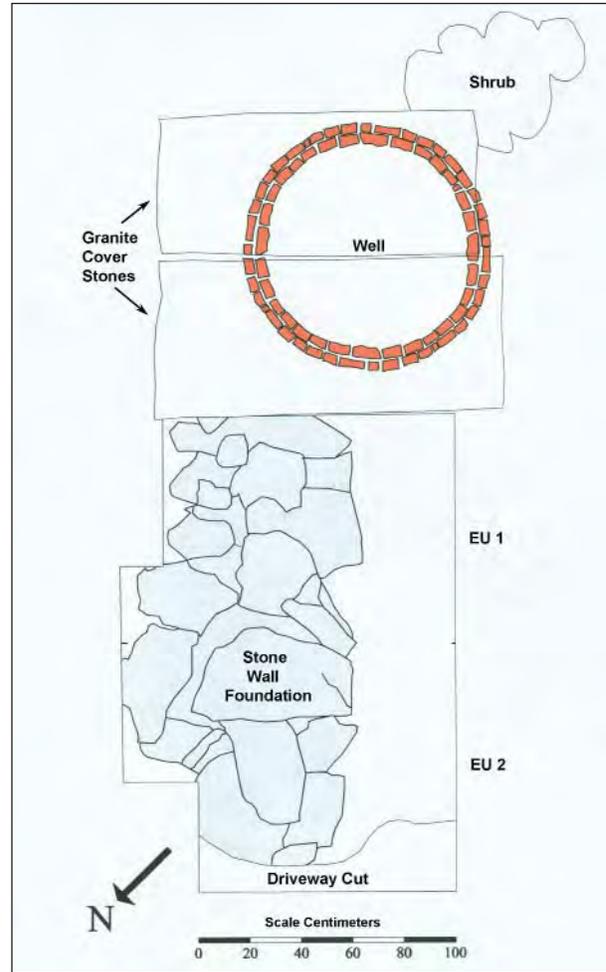
Figure 2.23. Plan of well excavation area.

Investigation of the well entailed laying out two contiguous 1 × 1 m excavation units extending from the west edge of the cover stones to the east edge of the parking lot (Figure 2.23). The ground surface sloped upward toward the well so excavation began in the higher EU 1. Approximately 6 cm of sandy loam landscaping fill overlay 12-14

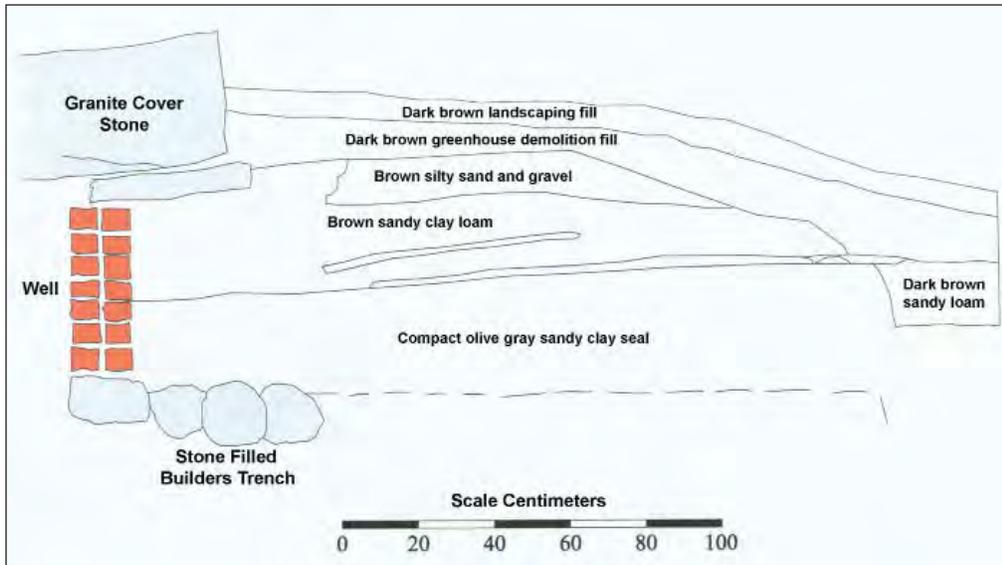
Figure 2.24. South wall profile of well excavation area.

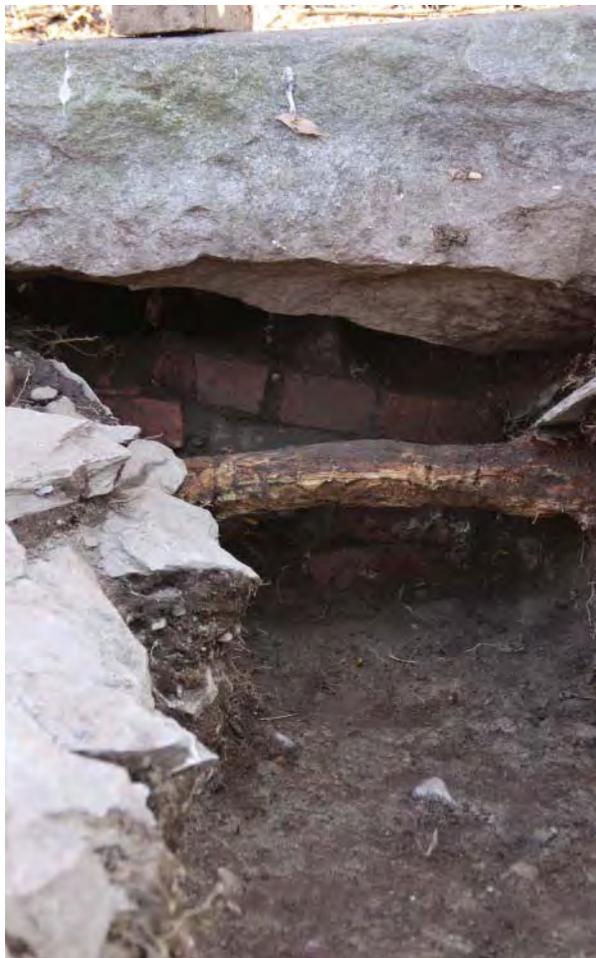
Figure 2.25. Brick wall of well (facing east).

for the well, identical to construction methods used for the drive circle well. The brick wall of the well, which was constructed of two courses of whole and partial bricks, transitioned to stone at the surface of the cobbles. The only artifact in the clay seal was a single fragment of creamware ceramic (ca. 1762-1820). The clay seal extended out from the well a distance of 1.85 m, again very similar to the drive circle well (Figure 2.26).

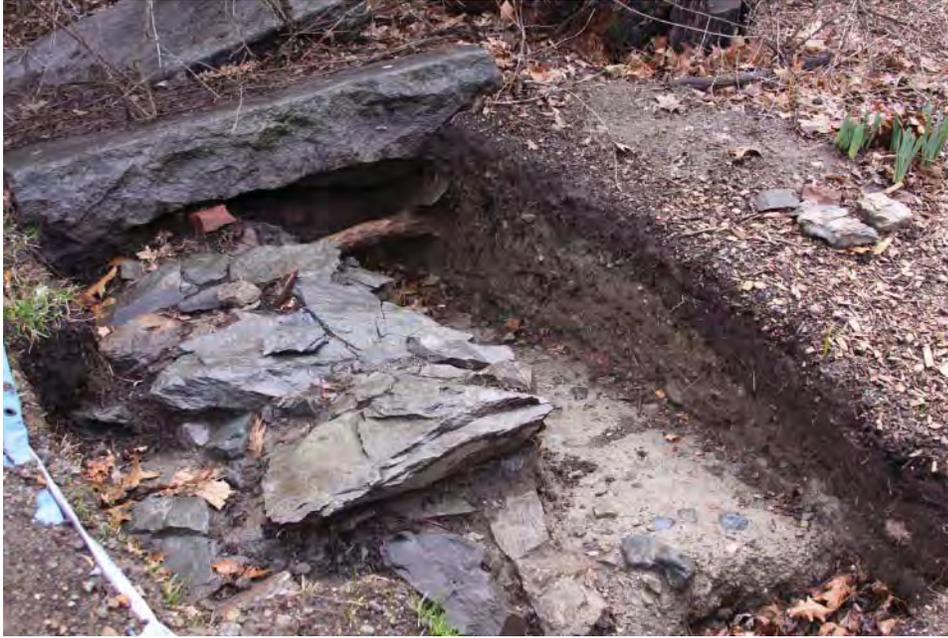
Figure 2.26. Well excavation area showing extent of clay seal.
