**Data Recovery Excavations of the Carriage House,
Greenhouse, and Greenhouse/Carriage House Well at
Gore Place, Waltham, Massachusetts**

**Prepared by:
Christa M. Beranek, J.N. Leith Smith, and John M. Steinberg
With contributions by Michelle G. Styger, Heidi Krofft, and Rita A. DeForest
Fiske Center for Archaeological Research
University of Massachusetts Boston**

Cultural Resources Management Study No. 45

March 2011

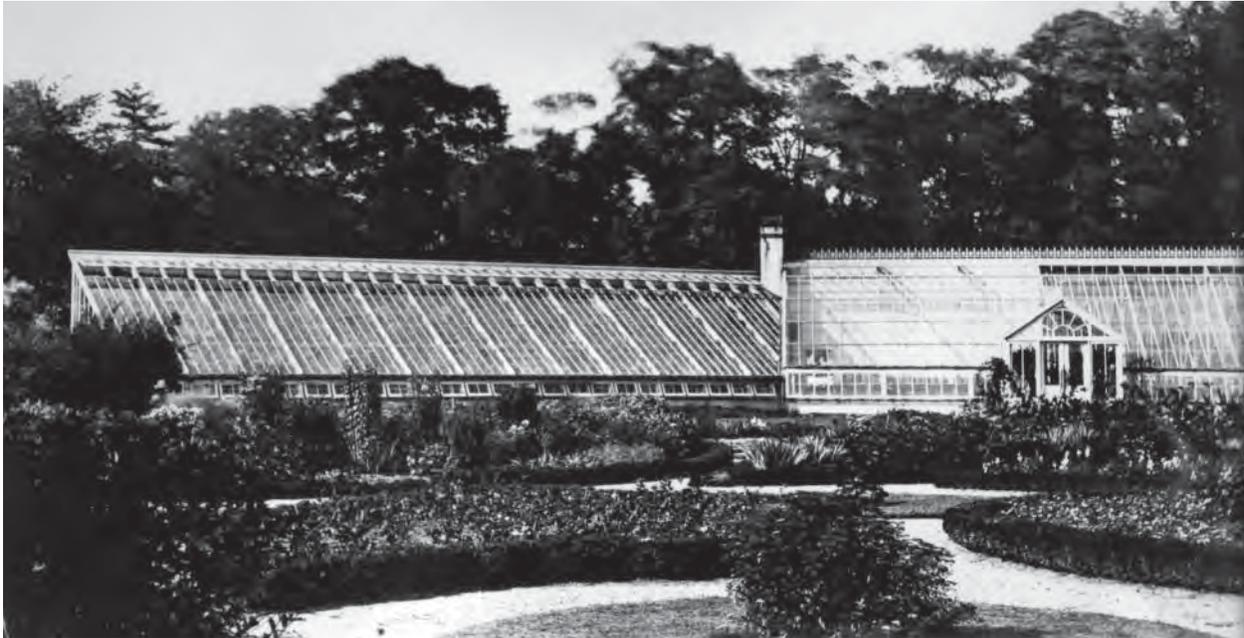
Figure 3.3. The greenhouses along the fruit wall, seen in an early 20th-century photograph. Original on file at Gore Place.

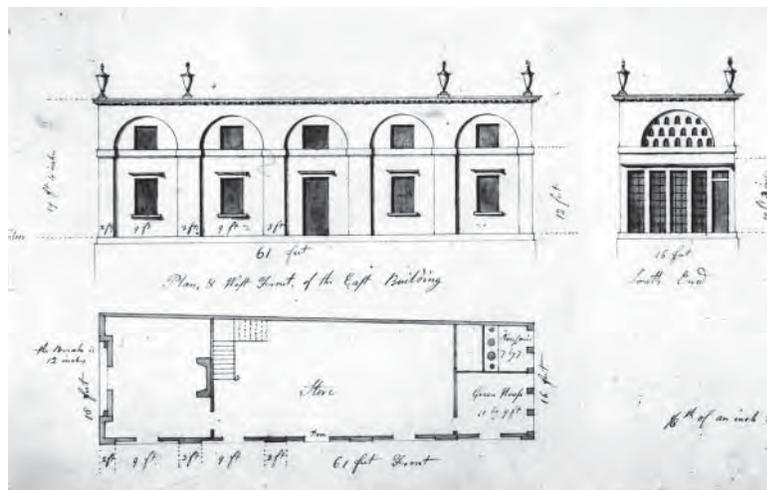
Figure 3.4. Samuel McIntire's drawing of the late 18th-century Derby greenhouse in Salem, Massachusetts (Woods 1988: 85).

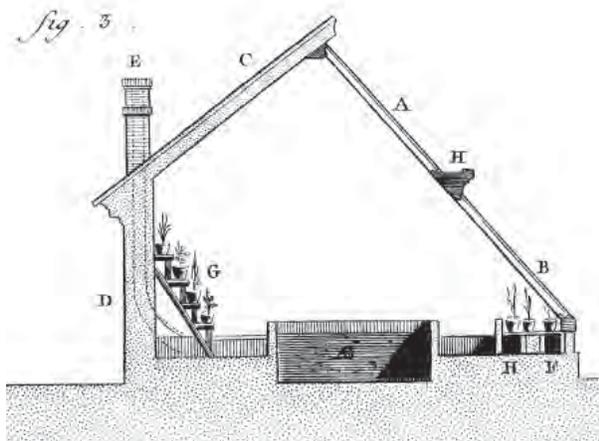
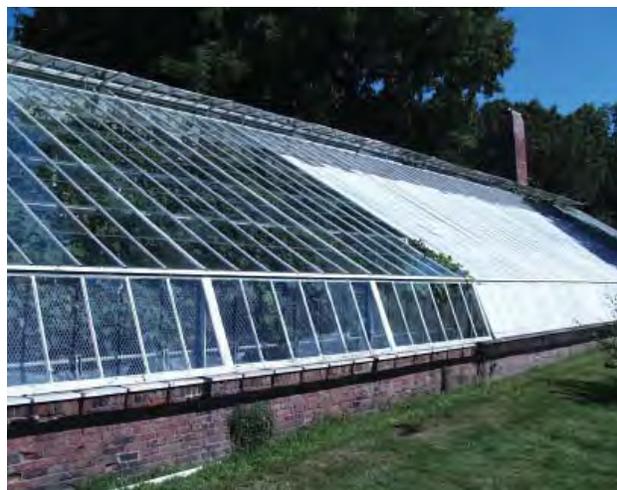
Figure 3.5. A) Profile of a greenhouse with a substantial back wall and short front knee wall from Diderot's *Encyclopedie*; B) Detail of greenhouse at the Vale using this construction method.

The second type, introduced near the end of the 18th century (Pogue 2009) was designed to take more advantage of the sun's energy and had a substantial back wall and a sloped roof and front constructed mostly of glass, resting on a shorter and less substantial knee-wall in front, sometimes called a lean-to style greenhouse (Figure 3.5). Examples of this type were built at the Lyman Estate in Waltham, Massachusetts, and Oatlands Plantation in Virginia. M'Mahon suggests that the piers between the sashes be made of wood to let in more light and that a half to a third of the roof be glazed, the rest roofed in slate (1806: 80).

On the interior, plants could either be planted in built-in beds (as they are in the late 18th-century Lyman greenhouse) or placed in pots on tiered shelves (Loudon 1825: 12) as illustrated in Figure 3.5. A third option was to have a sunken section of the floor, known as a "bark pit" (Figure 3.6). The pit was filled with pieces of bark and plant pots were set into the bark medium so that the decaying bark could provide a moist heat (M'Mahon 1857: 104-109). Jacob Farwell's *Farm Journal* notes that on occasion he hauled loads of oak and cherry tree bark (April 5, 1823); he does not specify whether this is for a bark bed, other aspects of soil preparation, or another purpose, such as tanning hides (possible since Farwell also mention leaching pits, likely also for tanning). On two occasions, he specifically states that he was getting the bark "for Mr. Gore" (March 4, 1823; June 22, 1824).

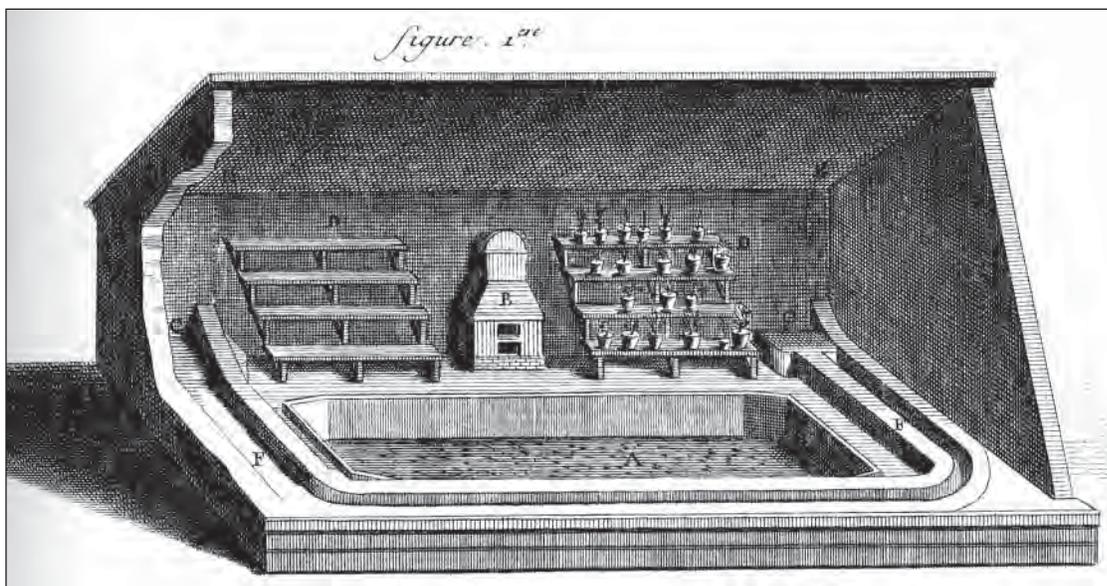
Figure 3.6. An example of sub-floor flues circling the greenhouse interior, from Diderot's *Encyclopedia*.

The size and layout of flues was also a subject of frequent discussion; much of Loudon's 1805 publication is devoted to improved schemes for flues. Flues could run under the greenhouse floor or through the walls, sometimes snaking back and forth in the tall back wall several times (Figure 3.6). Hibbert and Buist advise that if using coal, the flues should be 6 inches wide and 8 inches deep, plastered only on the bottom; if using wood, the flues should be larger by half (1834: 346).

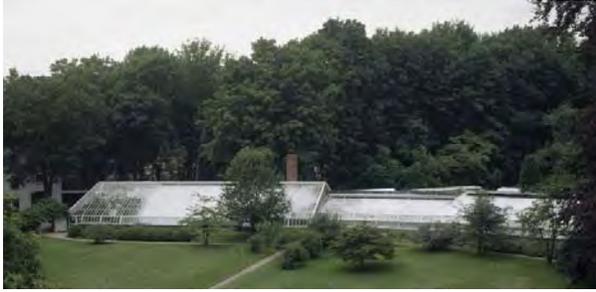
Figure 3.7. Overview of the Lyman greenhouses at the Vale, Waltham, Massachusetts.

additional heat. This greenhouse was later transformed into a grapery, at which point beds were added for the grape vines. The original configuration of the interior is not known. In 1820, Lyman built another lean-to greenhouse along the peach wall, now known as the Camellia house, but apparently originally built to grow peach trees (Historic New England). In 1840, the space between these two greenhouses was filled with a third greenhouse, intended to grow flowers to be cut for use in the house, creating a connected complex (Figure 3.7).

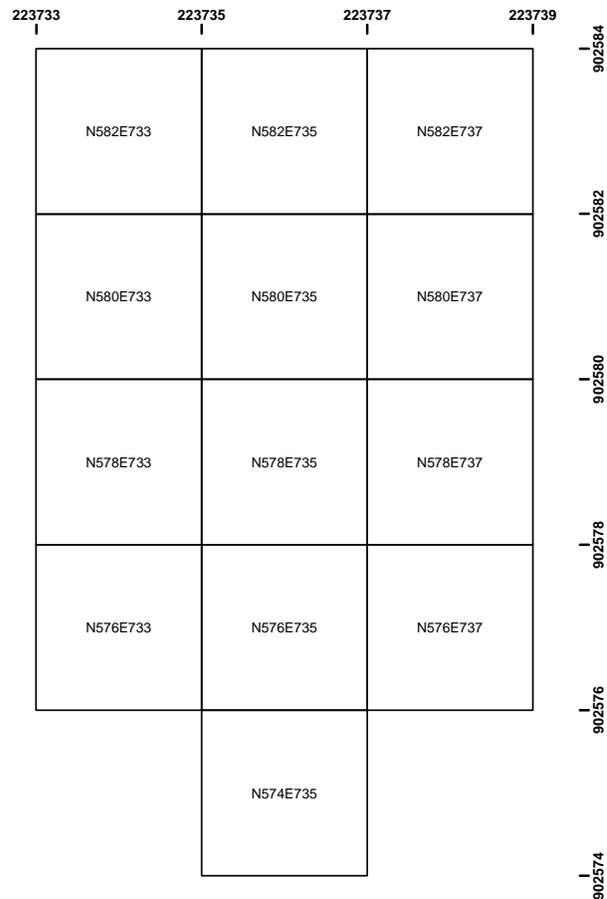
Figure 4.1. Units excavated around the greenhouse extension in 2008. Axes labeled with UTM coordinates.

The 2008 excavations consisted of thirteen 2×2 m units (a total of 52 sq m), covering a 6×8 meter area with one additional unit to the south (Figure 4.1). Units were labeled with the coordinates of their southwest corners. With the exception of unit N576 E733 and parts of N574 E735, all of the units were excavated to subsoil or until architectural features were encountered. Intact architectural features such as the greenhouse floor and the stone drain were left in place; we did excavate all or part of the two French drains in the area, however.

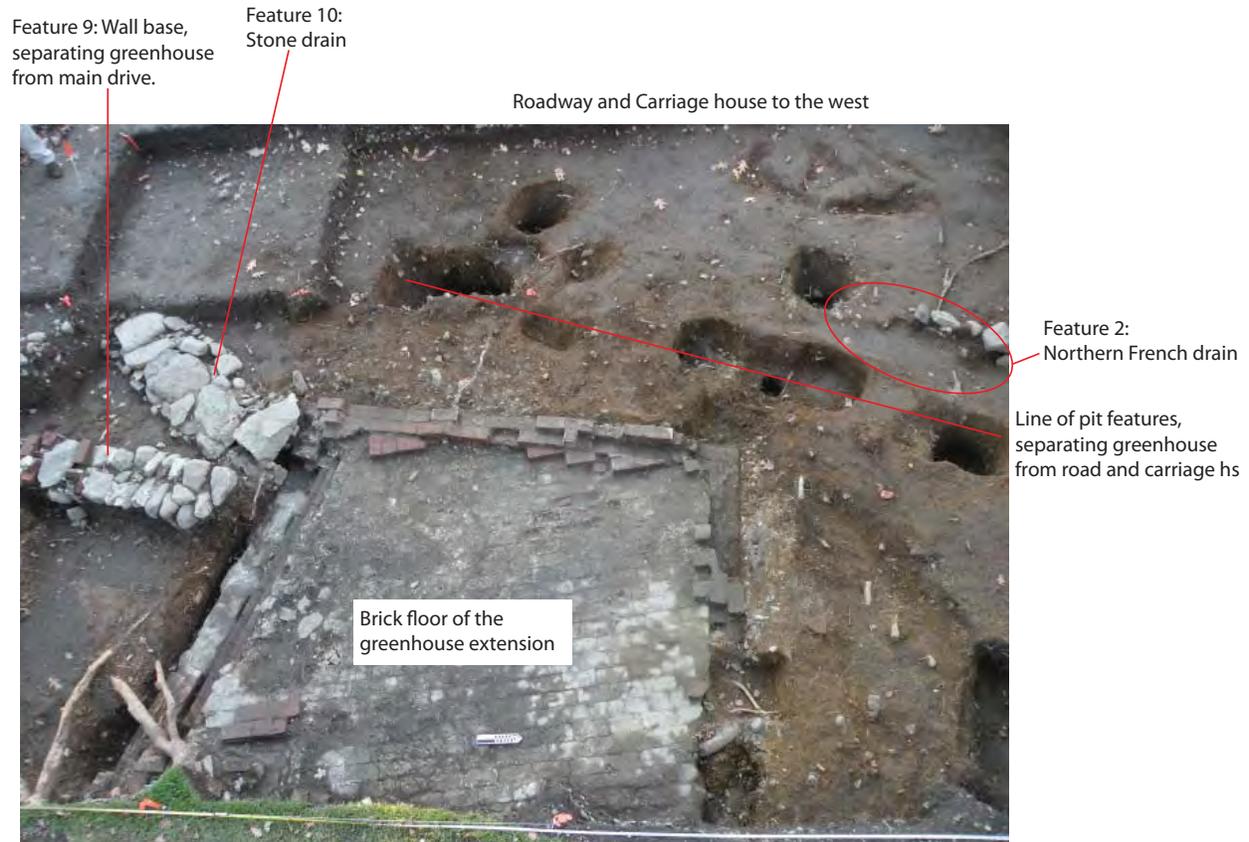
Figure 4.2. The greenhouse area at the end of the 2008 excavation, facing west.

The excavation uncovered a roughly 3×3 meter trapezoidal brick floor, interpreted as the greenhouse extension depicted on the 1834 Lyman map (Figure 4.2). This floor was surrounded by a prepared ground surface and a number of features that seem to have been contemporary with the operation of the greenhouse, including a roadbed that passed between the greenhouse and the carriage house. A row of large post holes separated

The northern French drain ran roughly north-south through unit N582 E735 into units N580 E733 and E735 (see Figures 4.2 and 4.11). It was located between the edge of the roadway and the line of postholes that delimited the greenhouse area, placing it outside the greenhouse area. It is not clear what it was intended to drain, but it may have carried away water that ran off the roadway, since the edge of the roadway sloped down to the east. The west side and south end of the feature had been disturbed and cut away by later activity associated with the destruction of the greenhouse (see below). The drain cut through layers that had built up over the old ground surface, burying Feature 3, the clay pathway. Therefore, the drain is later than Feature 3, and later than the construction of the greenhouse. The drain was a sloping trench, up to 50 cm deep and 90 cm wide in the north, with a relatively flat bottom that had been lined in places with the same kind of marine clay used on the road bed (described above) and around the Drive Circle well. Its width at the south end cannot be determined because the feature was cut through by later activity at the site. The feature was filled with some large cobbles at the bottom, whole planting pots, large bones, sheets of window glass, and large metal tools including three shovel

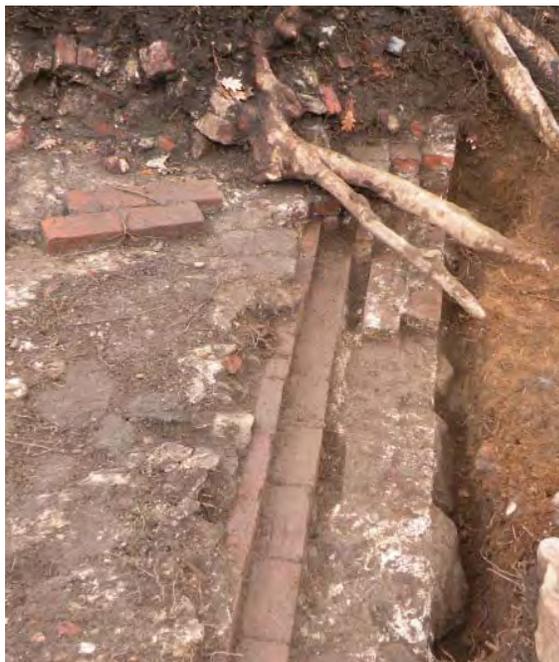
Figure 4.3 Brick channel at the south edge of the greenhouse extension floor, facing east. The fieldstone base of the south wall and the narrow builder's trench are visible at the right.

of the floor (Figure 4.4). The lowest course rested on a bed of mortared stone rubble which extended just slightly beyond the bricks. The mortar on the exterior of the bricks was very rough, suggesting that these courses were below the ground level while the building was in use and were not visible. The southern wall, on the other hand, was built of bricks set in mortar on a fieldstone foundation (see Figure 4.3).

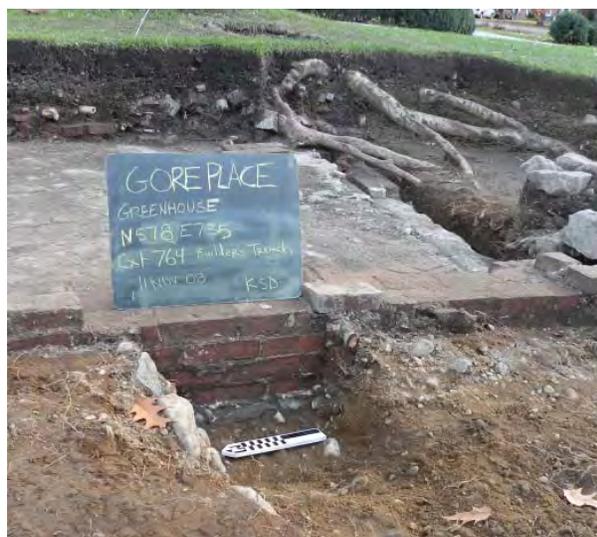
Figure 4.4. West edge of the greenhouse, exterior. Note unfinished mortar joints, as these would have been below grade and not visible.

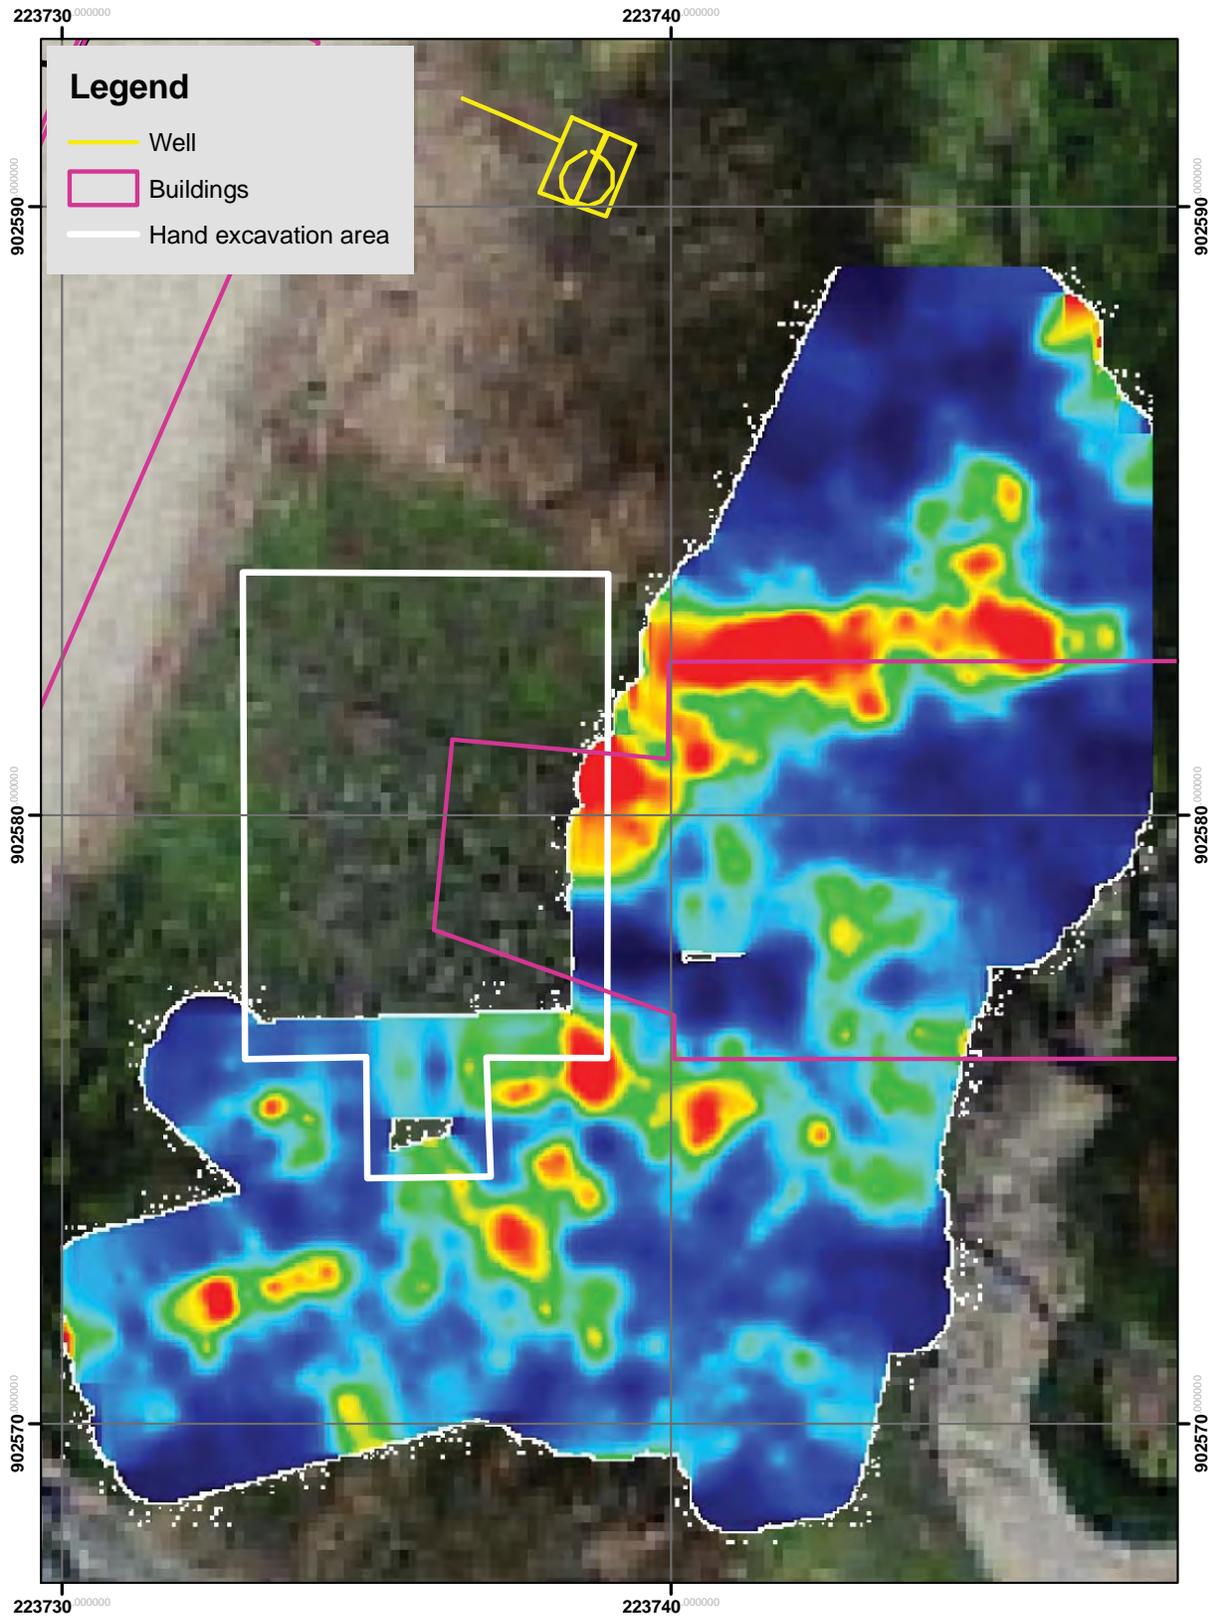
Figure 4.5. GPR slice at 55 cm below the ground surface showing the rear wall of the main body of the greenhouse (strong reflector [red] feature running east-west).

almost directly east-west, north of the brick floor (Figure 4.5). We interpret this as the remains of the rear wall of the main body of the greenhouse, which would have been more substantial than the south wall. Some more of the brick floor, which covered the whole area of the west extension, can also be seen as a hard reflector (red) in the unexcavated portion of the extension.

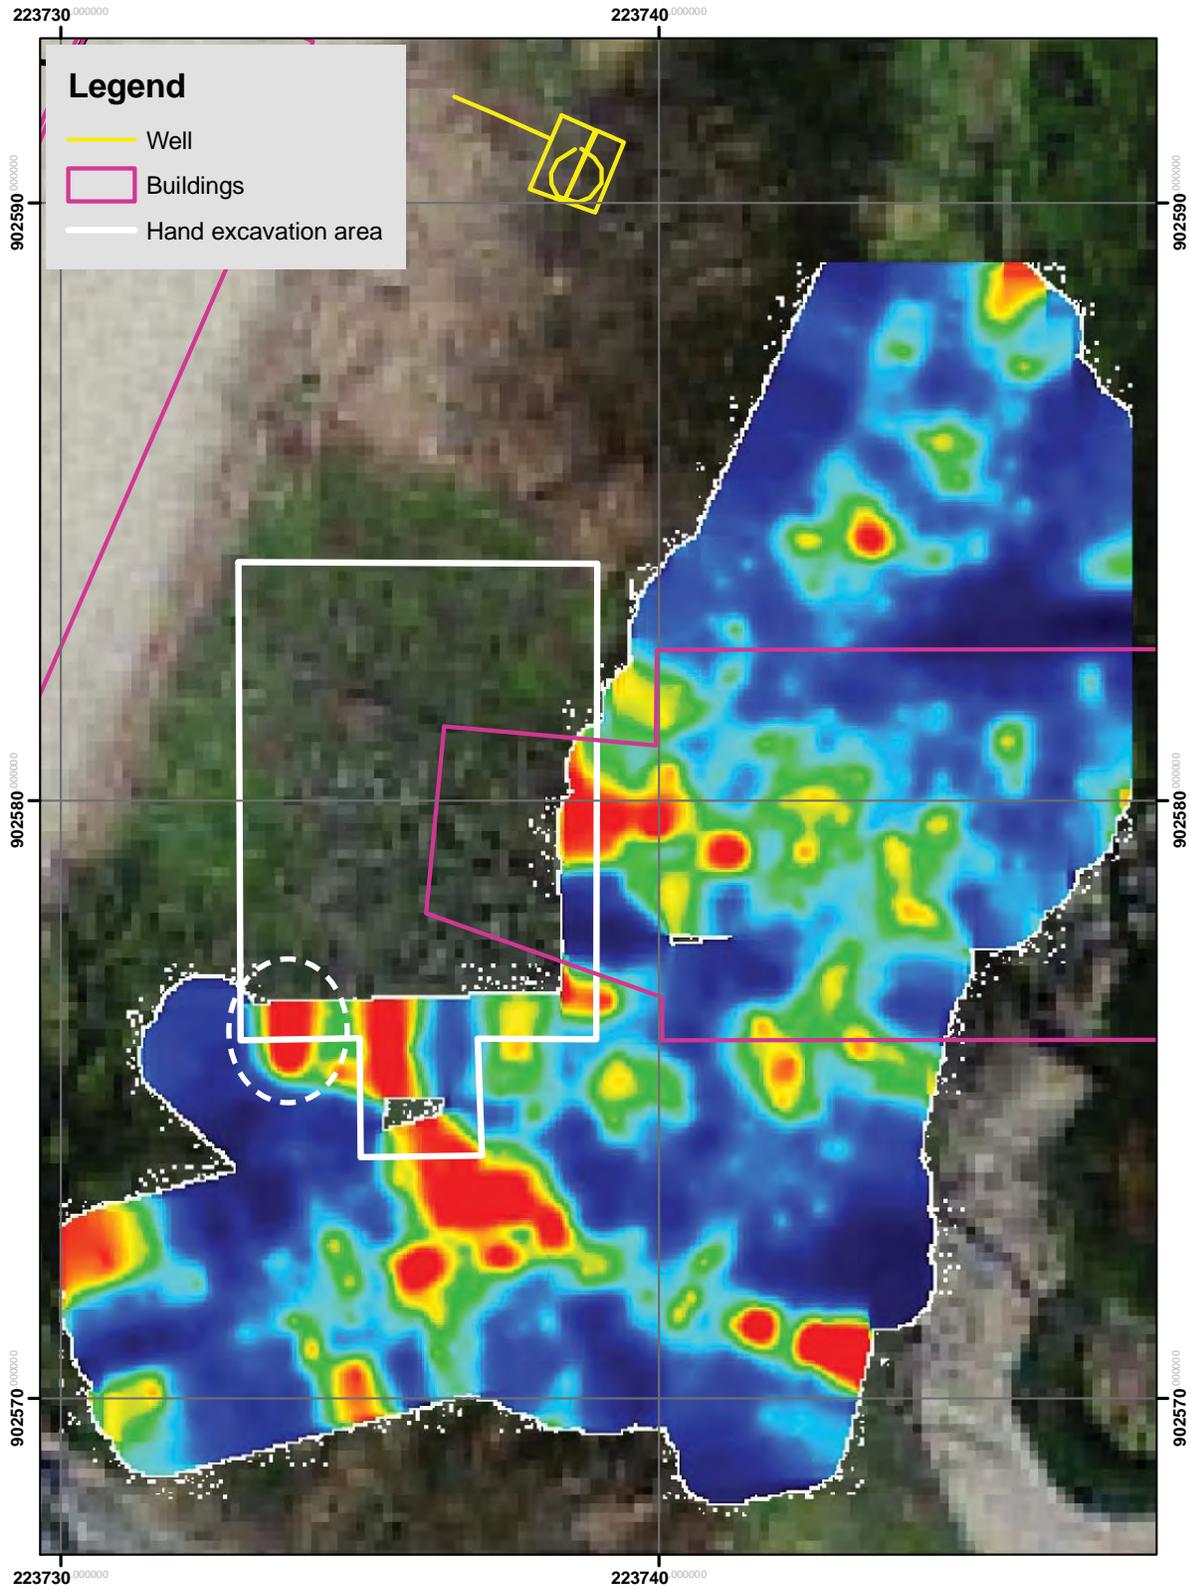
Figure 4.6. GPR slice at 40 cm below the ground surface showing the stone drain (circled) extending from south from the southwest edge of the excavation area. To the right (east) is the curving wall base, discussed below.

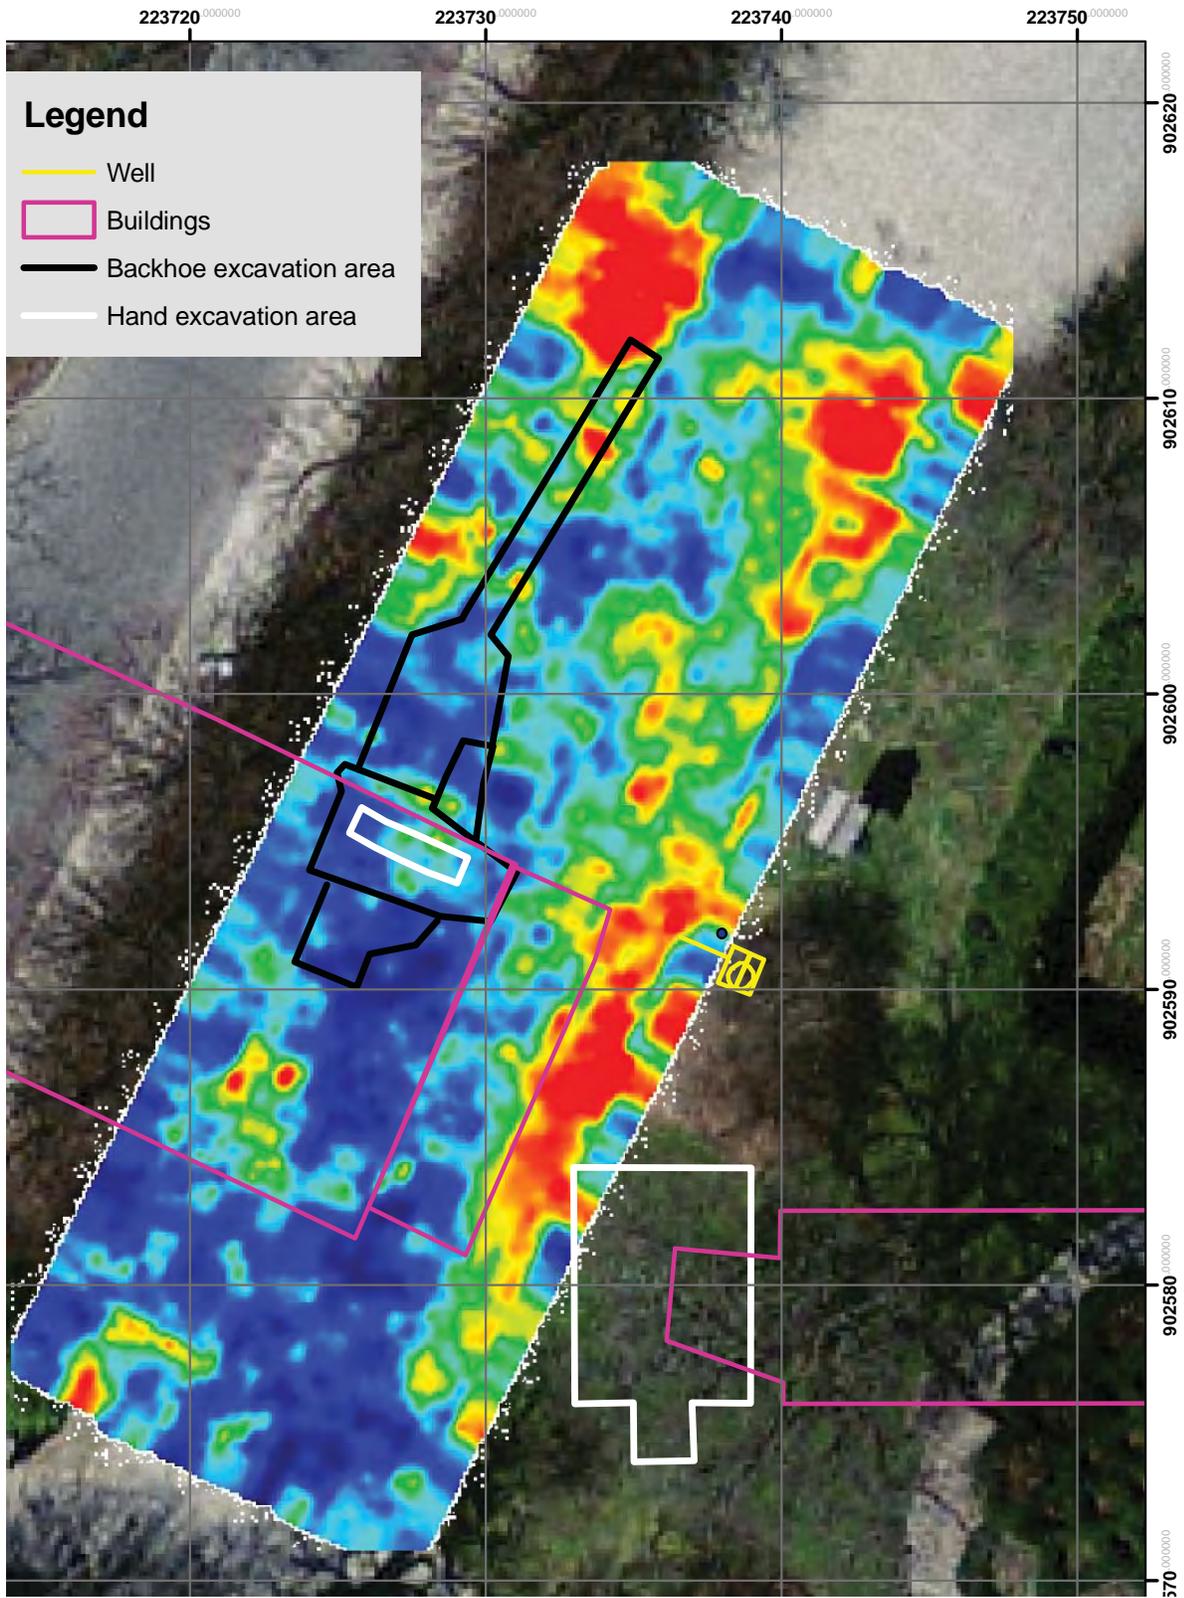
Figure 4.7. GPR slice at 35 cm below the ground surface showing the roadway between the carriage house and greenhouse.

transects separately (one example is used in Figure 4.7). In general, the separate and grouped slices showed the same pattern.

The road can probably be seen in some GPR slices (Figure 4.7). The 35 cm below ground surface slice shows a strong (red) reflector running southwest to northeast between the carriage house and greenhouse, ending or possibly turning east immediately north of the well (outlined in yellow). The interpretation of this GPR signature is difficult because it is near the edge of the survey area and the roadbed is shallow and parallel to the transects. This interpretation is made less secure by the fact that the angled lines (not used to generate the slice in Figure 4.7) do not bring out this feature. The identification of this feature as the road is our best interpretation of this strong signature; however, other possibilities exist. Note the eastern edge of the GPR slice, which shows alternate areas of red and blue. The source of this varied signal is not clear. It may represent the reflection from the sloping edge of the road, which we encountered in the excavation units. Or it may be that the predominantly blue area along the eastern edge represents the remains of a roadway which ends at the well. North of the well, the reflections are less consistent, and it is not clear if the broken yellow, red, and green area represents a continuation of the roadway or not.

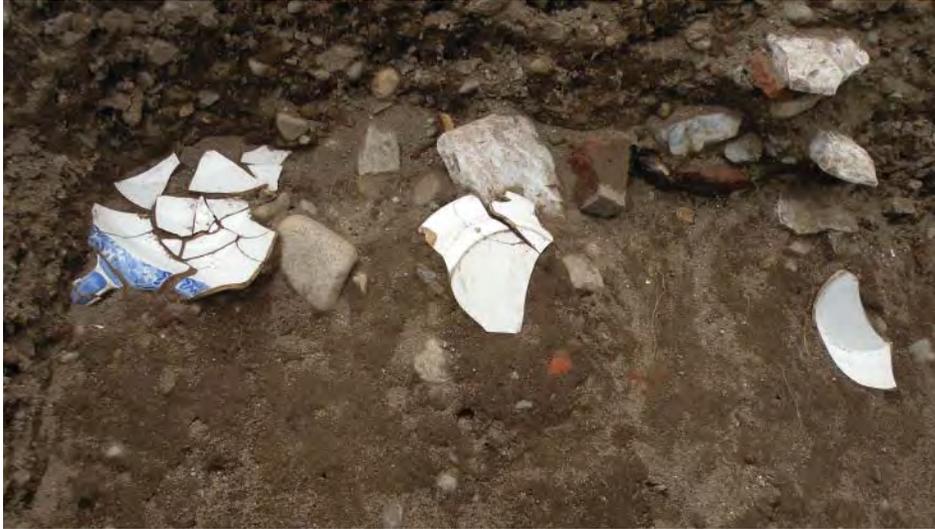
Figure 4.8. The artifact cluster (cxt 650) at the upper surface of the deposit over the roadway (cxt 686); pearlware pitcher, creamware plate, and marble floor tile fragments. North is to the top.

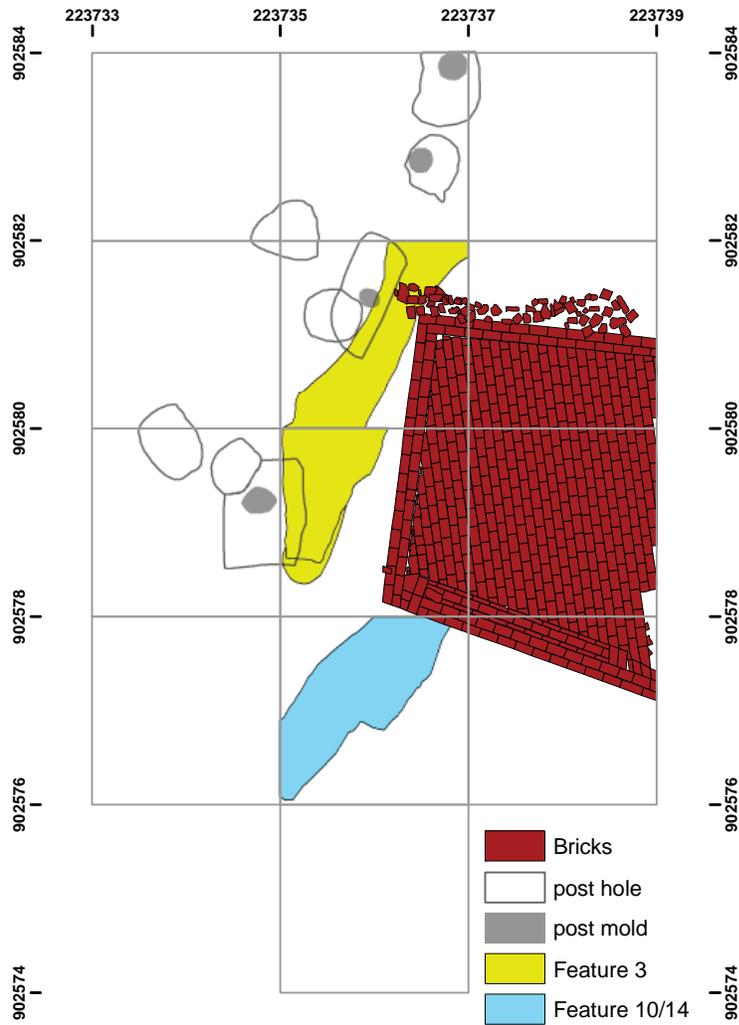
Figure 4.9. Features contemporary with the greenhouse: the brick floor of the extension; Feature 3, a band of compact sandy clay; Features 10/14, the stone drain, and the post holes and post molds.

Feature 3, excavated as context 684, was a long patch of very compact sandy clay with small angular gravel that ran roughly north-south, just outside the west end of the greenhouse extension (Figure 4.9). It sat directly on the old ground surface. It was preserved for 420 cm of length, was 45 cm wide, and 3 cm thick. It had few artifacts associated with it, with the exception of 31 nails and 16 pieces of window glass, not surprising given its location adjacent to the building. At only 45 cm wide, the feature seems to be a little narrow to have been a walking path; it may have been some form of surface treatment immediately outside the greenhouse to prevent mud from developing along the drip line of the eaves or to prevent grass and weeds from growing close to the building.

A line of post holes and molds (the indication of the post itself) runs in a northeast to southwest direction and divided the greenhouse area from the roadway discussed above and the carriage house (Figure 4.9; Table 4.4). Four of these appear to run in a single line with two in a second line to the west. These two lines might represent a fence and a gate; from the size of the post holes, the fence that they supported would have been substantial with posts 20 to 30 cm (8 to 12 inches) in diam-

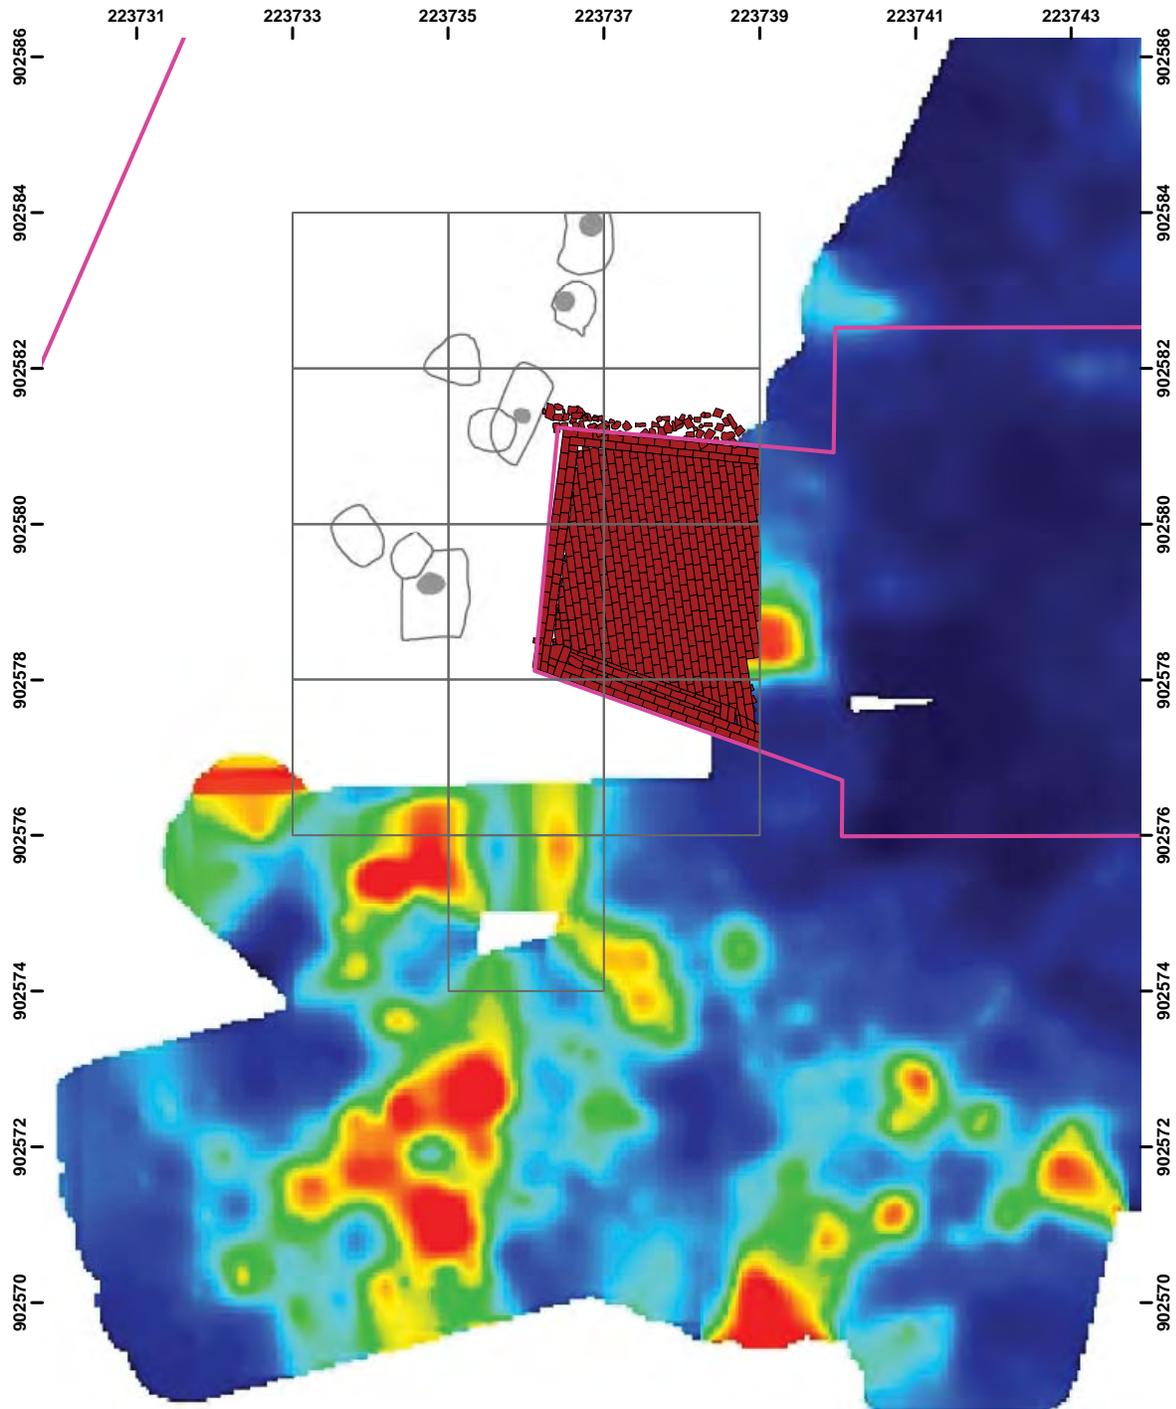
Figure 4.10. Excavated post holes and signatures of possible post holes south of the brick floor, visible in the GPR slice at ca. 90 cm below the surface.

Additional post holes south of the greenhouse extension may be visible in the GPR slice data. These appear as a series of four or five reflective features in a line south of and parallel to the brick floor of the greenhouse, forming a right angle with the existing post holes discovered west of the greenhouse (Figure 4.10). Further excavation is needed to confirm that this GPR signature is, in

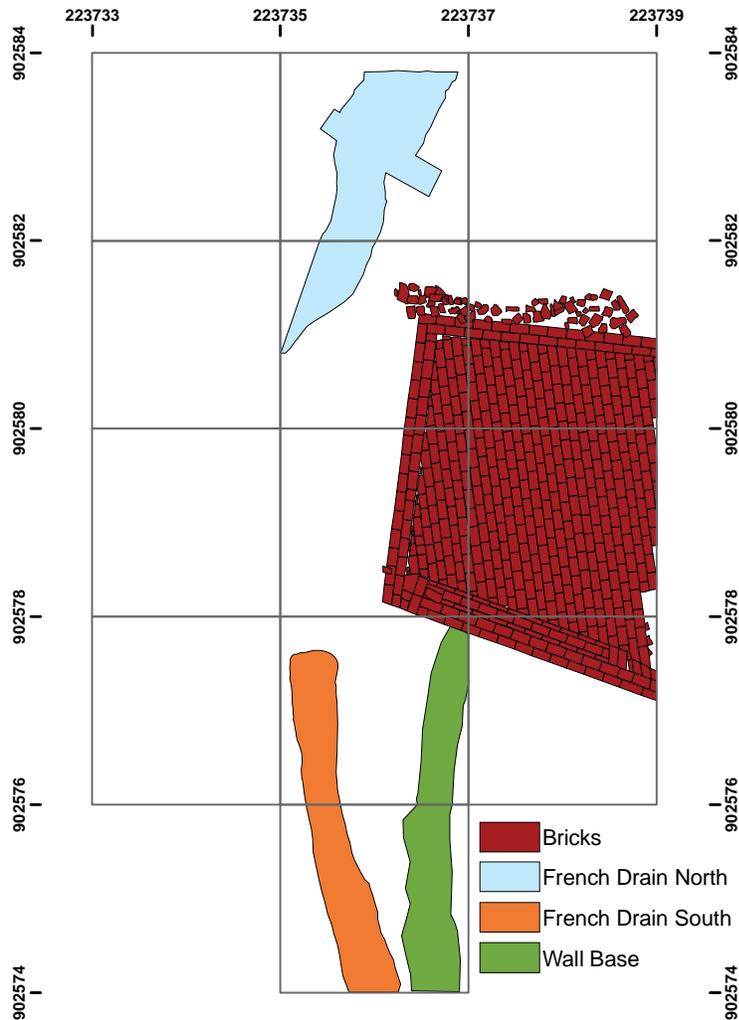
Figure 4.11. Later features around the greenhouse extension: the northern French drain (Feature 2), the southern French drain (Feature 8), and the curving wall base (Feature 9).

This curving support for a wall begins at the southwest corner of the greenhouse extension (near the stone drain) and curves away to the south and slightly east (Figures 4.11 and 4.12). The foundation consists of a single course of a rather irregular assortment of stones, bricks, and mortar that is 45 to 50 cm wide. We exposed 3.75 meters

called “French drains” (Feature 2 in the north; Feature 8 in the south; see Figure 4.11). Agricultural drainage channels can be divided into three types: open ditches, covered channels (which are filled with a loose material to allow water to percolate through), and hollow channel drains (Baugher 2001-2002). The Gore Place drains are the second type: channels or trenches cut into the surrounding ground surface and filled with large debris to allow water to percolate through them then probably filled back over with dirt. The two drains had very different kinds of material as fill and seem to be unrelated to each other and created at different dates. These drains are more recent than all of the features discussed above because they cut into layers that bury the old ground surface and other features. In the north, a new ground surface built up around the greenhouse extension, burying older landscaping features. The area was then re-landscaped and the northern drain was dug. The southern drain seems to have been installed later, after the curving wall surrounding the greenhouse was taken down. Drains such as these are common on 19th-century agricultural sites, and farm journals and agricultural improvement literature described the methods and benefits of constructing them. Although agricultural drainage was probably employed in the 18th century, covered drains are first mentioned in the advice literature in 1790 (Baughner 2001-2002: 27).

ments, mortar, bone, and oyster shell (Figures 4.11 and 4.15, Table 4.6). Only a section of it was excavated, yielding only 20 ceramic fragments including small pieces of redware planting pots, blue painted pearlware, and green transfer printed whiteware.

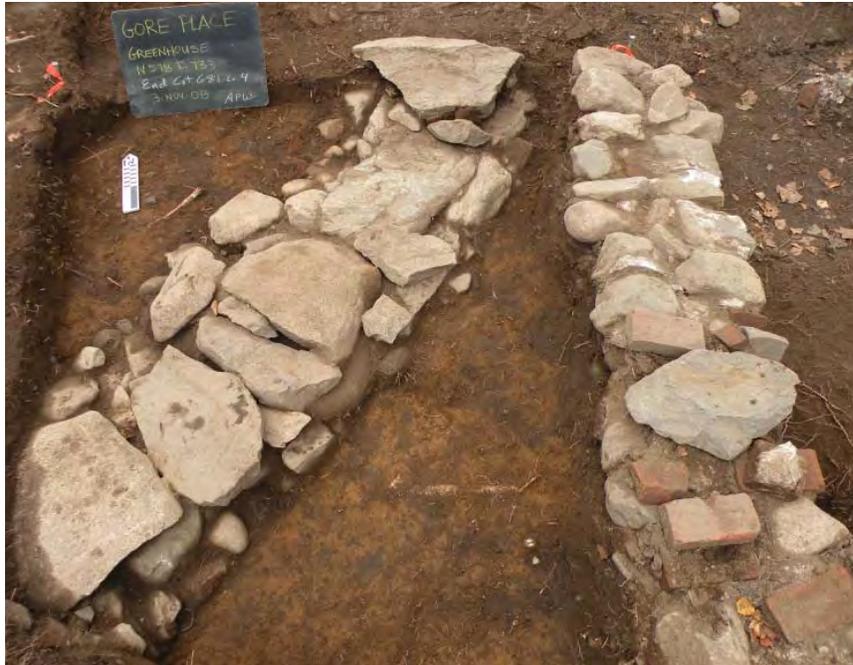
Figure 4.12. Feature 10, the stone drain (left) and Feature 9, the curving wall base (right). North is to the top. See Figures 4.2, 4.9, and 4.11 for the relationship between these features and the greenhouse extension floor which had not yet been uncovered when this photograph was taken).

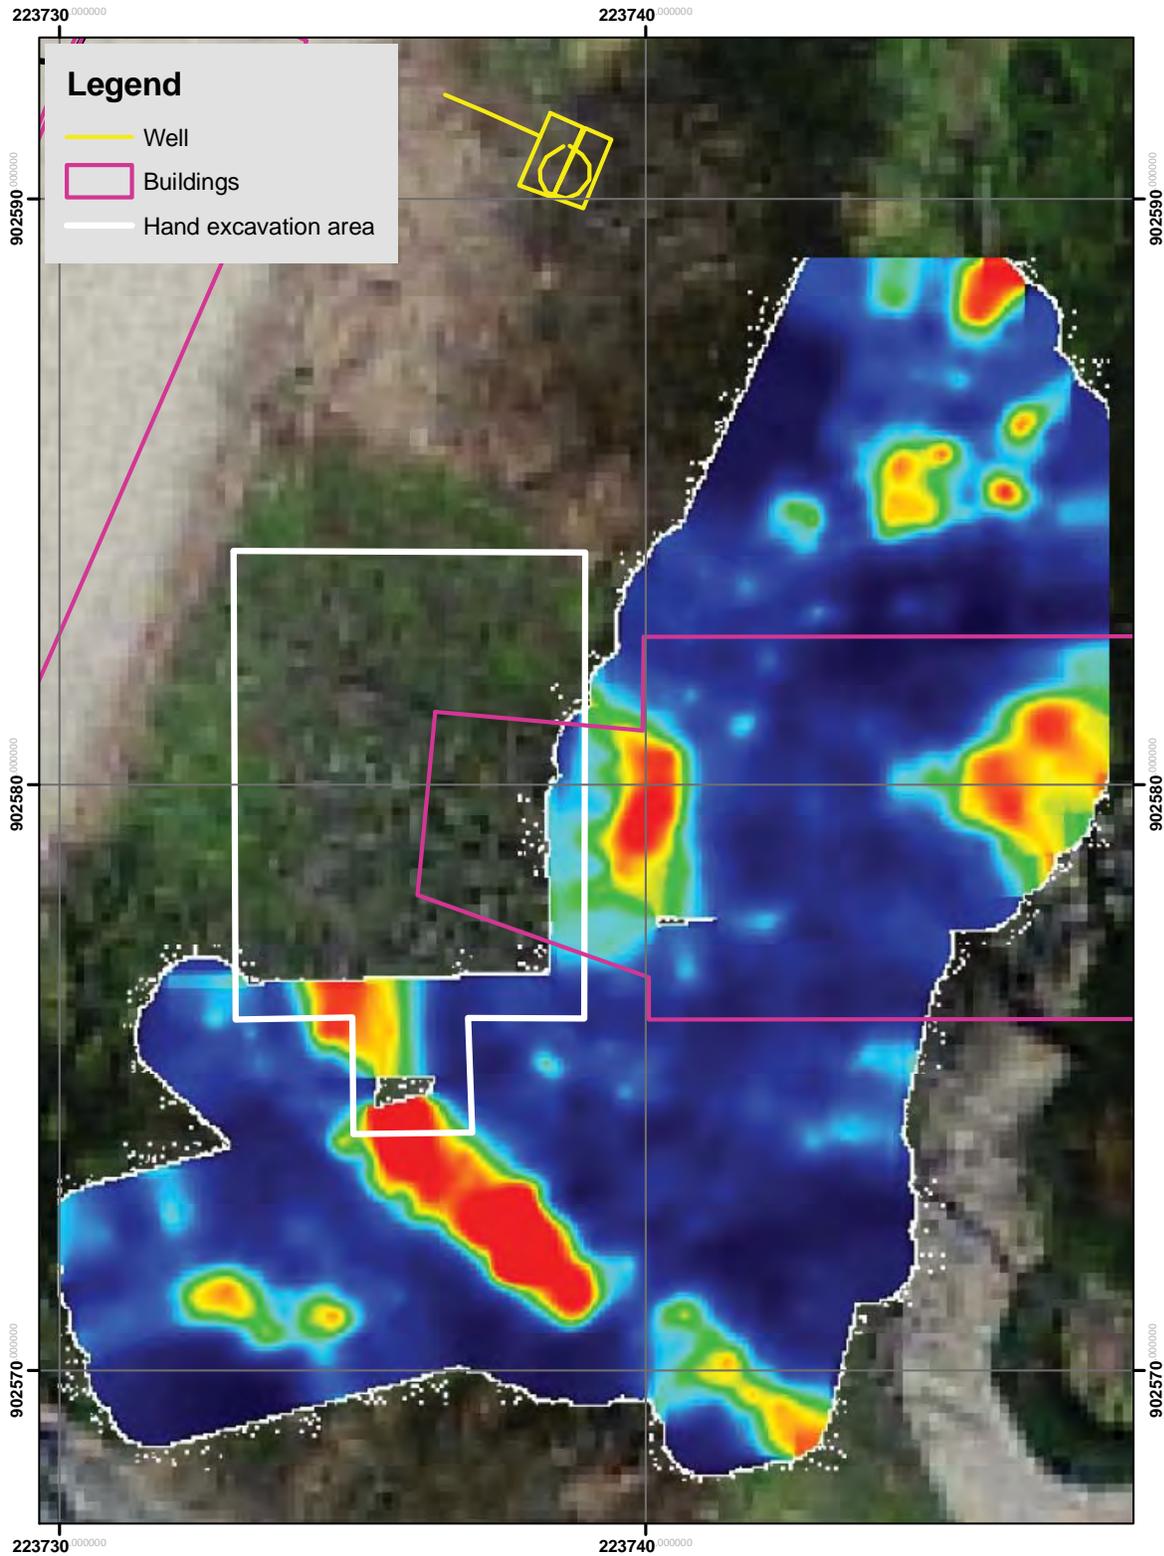
Figure 4.13. Continuation of the curving wall in the GRP-slice data (the curving red feature south of the excavation area). At just 20 cm below the surface, this was the shallowest feature that we detected. The continuation of the brick floor to the east of the excavation area is also visible in this slice.

of it in the excavation; probing and ground penetrating radar (Figure 4.13) indicate that the wall continues for several additional meters to the south east. The irregular construction suggests that it was a foundation for an enclosure or retaining wall. There is a light colored silty sand deposit (contexts 674 and 709) that occurs only inside the wall.

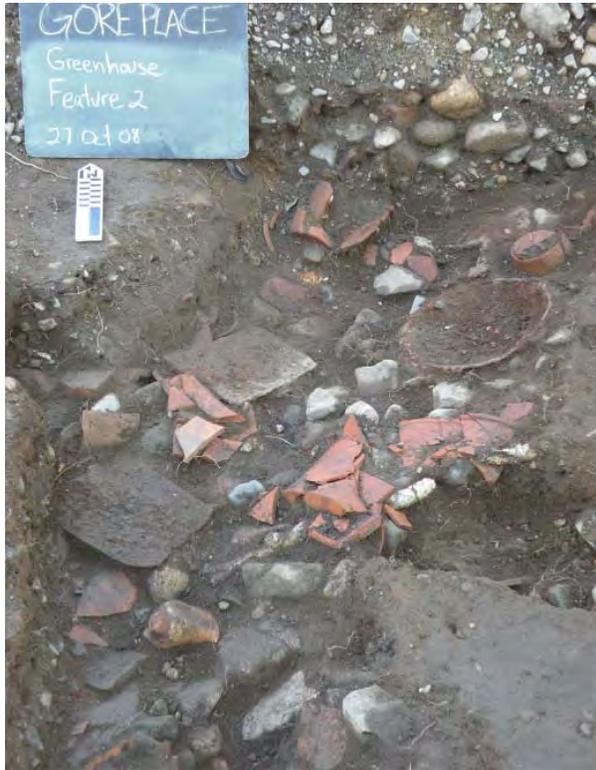
Figure 4.14. Objects placed in the fill of the northern drain to allow water to pass through, including shovel blades and planting pots.

blades and a colander, and then covered with a layer of smaller cobbles and broken bricks (Figure 4.14). Other objects in the fill included an ox shoe, lock pieces, nails, bottle glass, slate and marble tile fragments, creamware, pearlware, porcelain, fragments from glass tablewares, and stoneware bottle fragments. While the planting pots, agricultural tools, and other items associated with the greenhouse such as window glass seem to have been deposited in large pieces, the other ceramic fragments of refined earthenware and stoneware were in very small fragments, as if they were incidental or secondary to the fill.

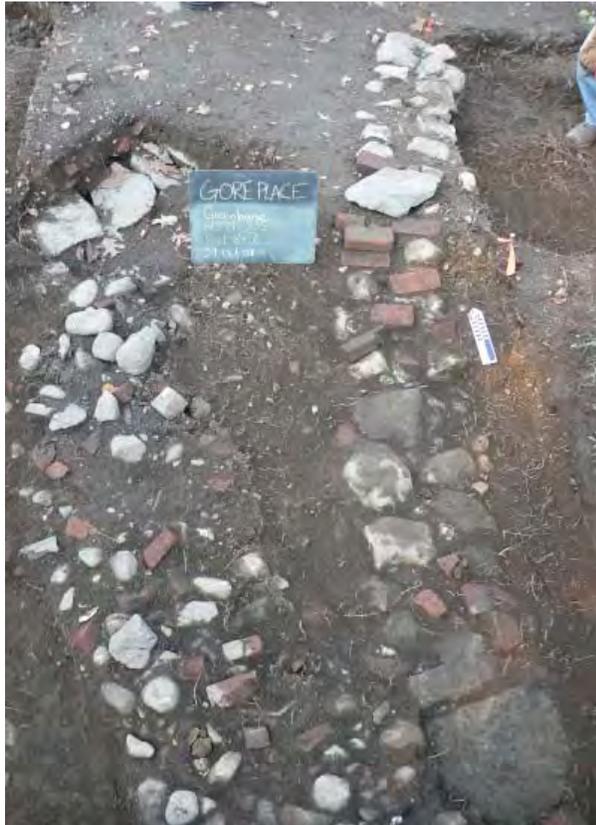
Figure 4.15. The top of the southern French drain, Feature 8 (left), which crosses on top of the curving wall base, Feature 9 (right).

It was uncovered primarily in unit N574 E735 and the unit to the north and was 60 to 70 cm wide and 3.5 m long. It ran over both the curving wall base and the stone drain leading away from the greenhouse, indicating that it was dug after the wall was dismantled, and therefore, presumably after the greenhouse had been taken down. The fact that it did not include the same kinds of specialized greenhouse material as the northern French drain suggests that it was put in at a different time, possibly later, after the greenhouse material had already been disposed of. It also does not have the same clay lining as the northern French drain. The GPR slice data show this drain as a hard (red) reflector running north-south in the southernmost excavation unit and continuing beyond the excavated area to the south and southwest (Figure 4.16).
