**Data Recovery Excavations of the Carriage House,
Greenhouse, and Greenhouse/Carriage House Well at
Gore Place, Waltham, Massachusetts**

**Prepared by:
Christa M. Beranek, J.N. Leith Smith, and John M. Steinberg
With contributions by Michelle G. Styger, Heidi Krofft, and Rita A. DeForest
Fiske Center for Archaeological Research
University of Massachusetts Boston**

Cultural Resources Management Study No. 45

March 2011

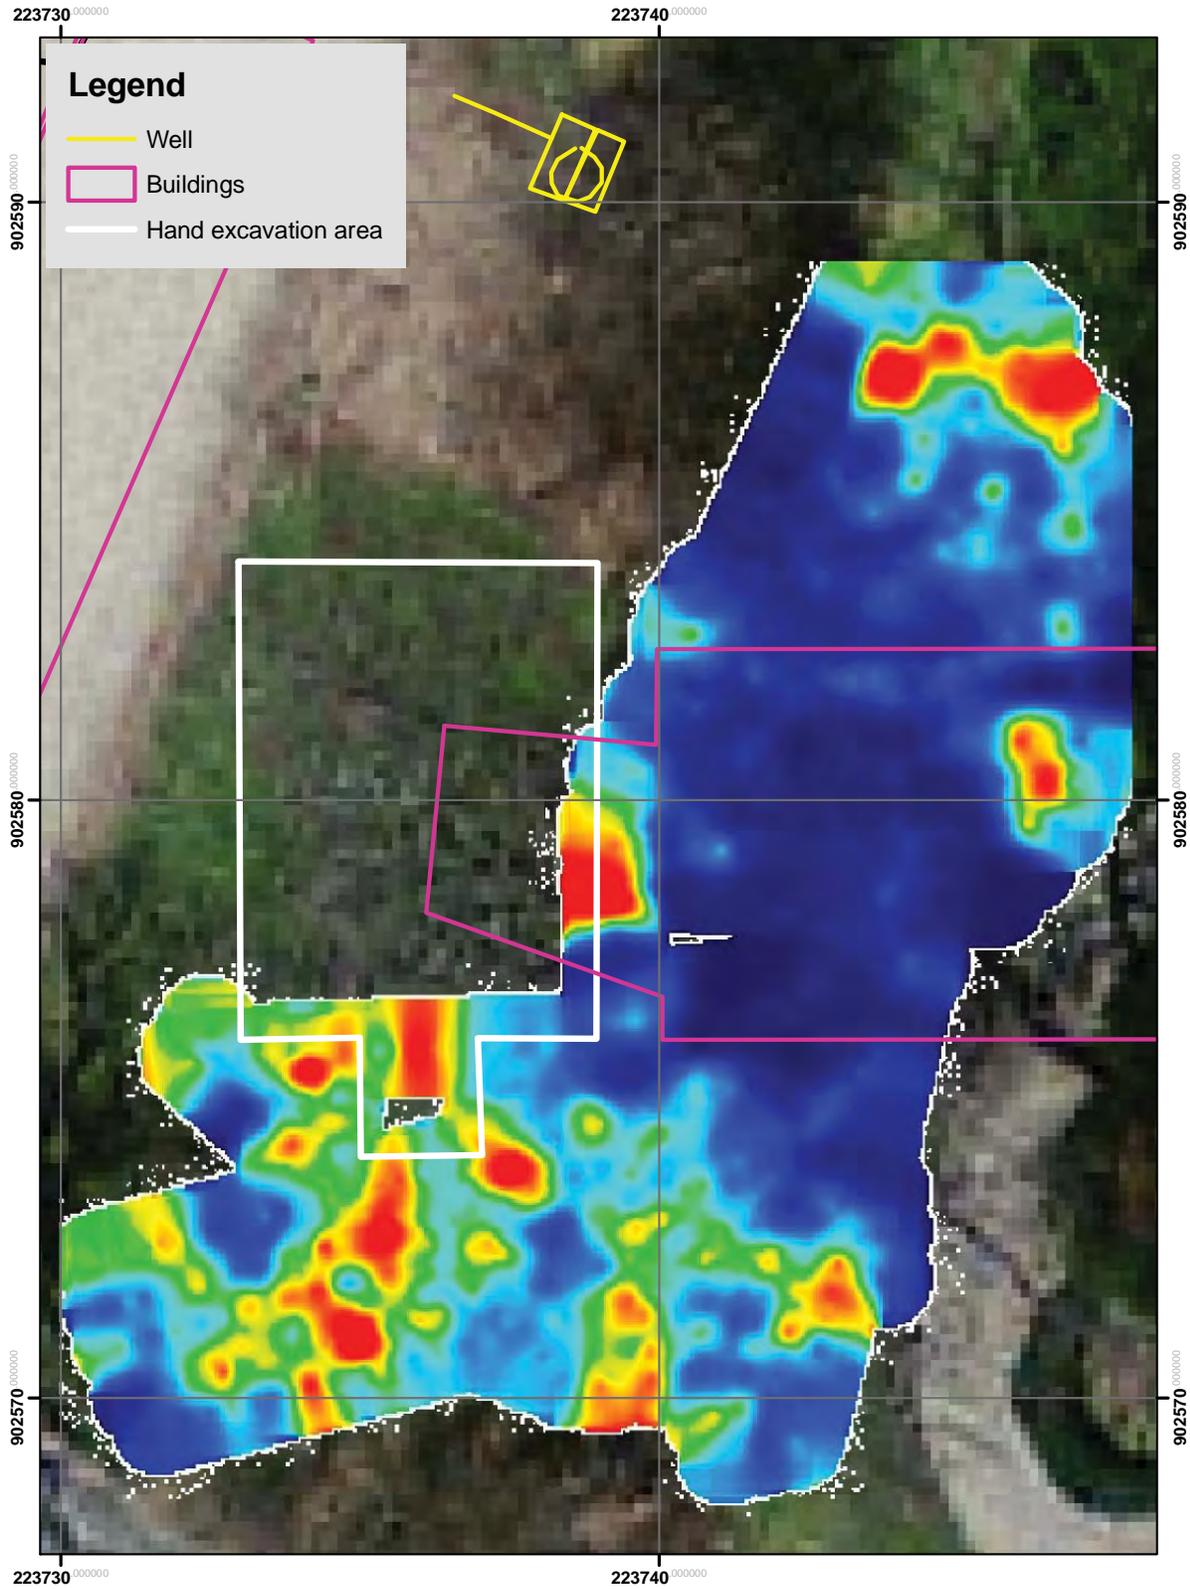
Figure 4.16. The continuation of the southern French drain in the GPR slice data at 90 cm below the surface, seen as the red reflector running N-S in the southernmost excavation unit and continuing south and slightly west.

It was uncovered primarily in unit N574 E735 and the unit to the north and was 60 to 70 cm wide and 3.5 m long. It ran over both the curving wall base and the stone drain leading away from the greenhouse, indicating that it was dug after the wall was dismantled, and therefore, presumably after the greenhouse had been taken down. The fact that it did not include the same kinds of specialized greenhouse material as the northern French drain suggests that it was put in at a different time, possibly later, after the greenhouse material had already been disposed of. It also does not have the same clay lining as the northern French drain. The GPR slice data show this drain as a hard (red) reflector running north-south in the southernmost excavation unit and continuing beyond the excavated area to the south and southwest (Figure 4.16).

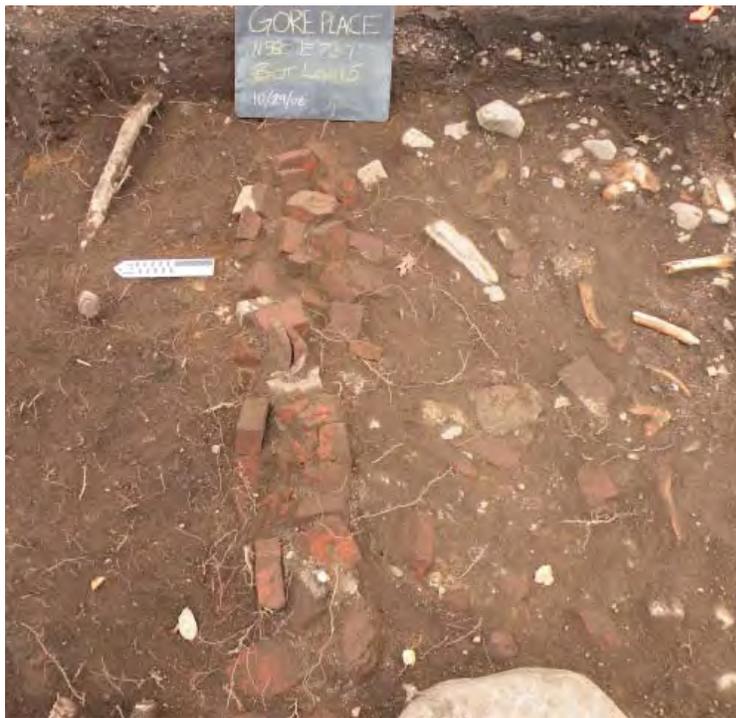
Figure 4.17. The top of the rubble deposits over the greenhouse extension floor. The line of broken bricks (Feature 11) marks the north edge of the floor. Compare the relatively clean deposit outside the greenhouse (Feature 6, left) with the brick, rubble, and bone laden deposit over the floor (right).

low in most places. Along the north wall, a distinct deposit of broken bricks (Feature 11, contexts 680, 745) was left along the line where the wall had once been (Figure 4.17). There was a similar deposit of rubble (Feature 17, context 701, 708) along the west wall boundary. The deposits that covered the brick floor of the greenhouse extension were varied and contained different types of rubble and artifacts (Table 4.7). Some were broad, covering most of the interior area, and others seemed to represent individual bucket loads of fill. There were also large pieces of bone throughout these deposits. The faunal collection is analyzed in Chapter 5. Immediately on top of the brick floor of the extension were dense deposits of coal (Figure 4.18).

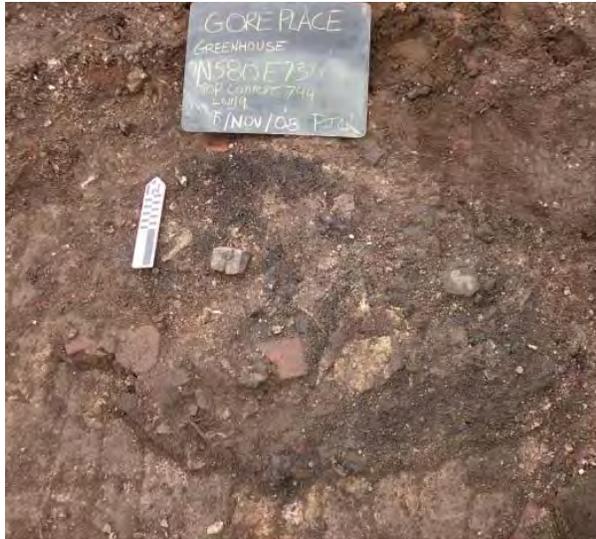
Figure 4.18. Coal deposits immediately on top of the greenhouse extension floor.

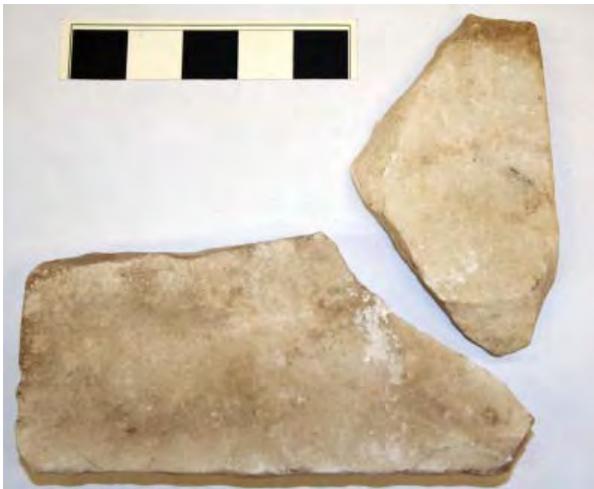
Figure 5.2. Fragments of white marble floor tiles. Scale is in inches. Photograph by Heidi Krofft.

The floor of the greenhouse extension that was uncovered in 2008 was paved in brick. Pieces of white marble tiles (and one piece of black slate tile) provide evidence that the floor of the main body of the greenhouse, however, was paved with marble (Figure 5.2) and possibly some slate. Additionally, pieces of mortar with brick and stone rubble aggregate were found with marble tile impressions. This may have been an attempt to lift the floor above ground level as suggested by the historical literature. The difference between the brick floor of the extension and the marble tile believed to have been used in the main body of the greenhouse underscores the difference between the functional work and storage space and the more formal or display oriented main space.

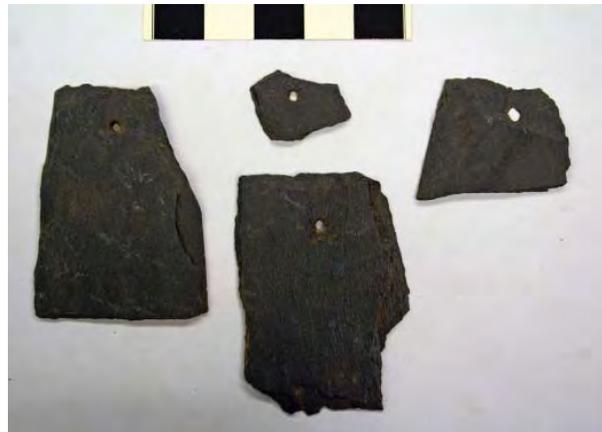
Figure 5.3. Roofing slate with nail holes. Photograph by Heidi Krofft.

The greenhouse excavations yielded 128 slate fragments of various sizes. Historically, slate was used for both paving and as a roofing material and the fragments suggest that both were present in the greenhouse. Several of the larger fragments of slate possessed nail holes (Figure 5.3), suggesting

that the roof of the extension and possibly portions of the main structure had slate shingles.

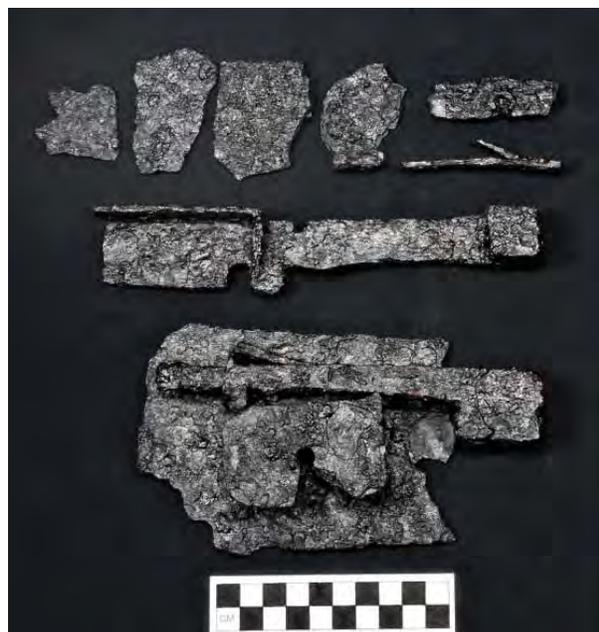
Figure 5.4. Rim and stock lock fragments.

A stock lock consisted of several iron parts creating the lock mechanism and attached to a wooden housing. Stock locks are mounted to the surface of the door and usually consist of only one bolt, the dead bolt. Although stock locks are not often found intact, according to Priess, their parts are distinctive and are not found on other types of locks (2000: 83). Three different parts of a stock lock were recovered: the lock bolt, the main ward,

and the spring. It is also possible that a portion of the tumbler is attached to the lock bolt by iron corrosion.

With a rim lock, another surface-mounted lock, the components of the lock are fastened to an iron main plate with rims or sides to complete the housing. These locks were also attached to the surface of the door and often required keepers or a staple for the bolt to lock into. At the very minimum, a rim lock needed one bolt, a lock bolt or dead bolt, to function and was called a dead lock or a closet lock (Streeter 1974: 67). Often times, rim locks also had latch bolts and sometimes even another lock bolt. The rim lock from the greenhouse excavations is simple in its form and only has one bolt (Figure 5.4).

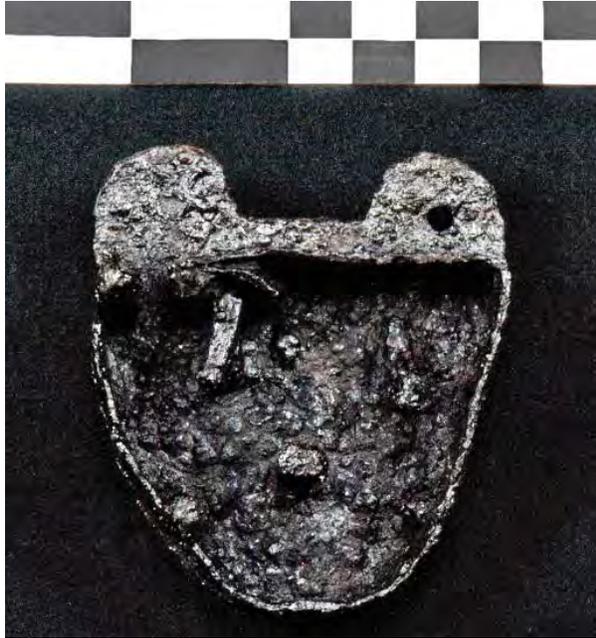
Figure 5.5. Padlock.

The padlock (Figure 5.5) is different from the stock lock and the rim lock in that it was portable. The padlock consists of a main housing enclosing the locking mechanism and a curved bow to secure the lock (Priess 2000: 79). The example from the greenhouse excavations is symmetrical with its widest dimension at the top of the lock. It has two lobes at the top to accommodate the bow. The lobe on the right has a hole where a pin would have passed through to attach the bow and to create a

pivot point. There is a void in the top of the housing where the opposite end of the bow would have been engaged in the mechanism to secure the lock closed. The general shape of the padlock dates it roughly to the 19th century (Priess 2000: 81). In addition, the presence of a pivoting brass keyhole cover also provides evidence for a date. According to Noël Hume, the brass keyhole covers were not used on iron padlocks until the 19th century with most of them dating after 1840 (1969: 251). Although the keyhole cover is not attached to the padlock, it was recovered from the same context and the two are likely associated with one another.

Padlocks of this size and simplicity would not have been very secure. Because more secure, surface mounted locks were also recovered, it is likely that this padlock was not used on an exterior door. Instead, it could have been used to lock an interior door or a small compartment door, possibly relating to storage.

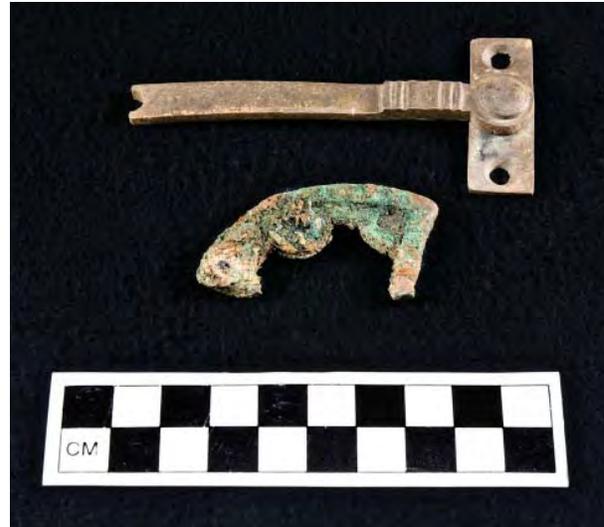
Figure 5.6 Copper alloy latch (top) and escutcheon (bottom) recovered during the 2005 excavations.

The 2004-05 survey of the greenhouse area also recovered some more decorative hardware that might also be from doors: a copper alloy latch and escutcheon (Figure 5.6). The latch came from an STP located on the north side of the greenhouse, and was probably discarded after it broke at the point where a small knob would have been

present to move it up or down. A second STP yielded a portion of a cast brass escutcheon. It is difficult to determine what type of hardware this fragment is from. It may be an attachment for a drop pull or the top end of a door handle. Regardless, it represents another example of the hardware potentially used in the greenhouse. The escutcheon in particular is one of the more ornamental pieces of hardware found on the greenhouse site. Therefore it is likely that it would have been used in a publicly visible space.

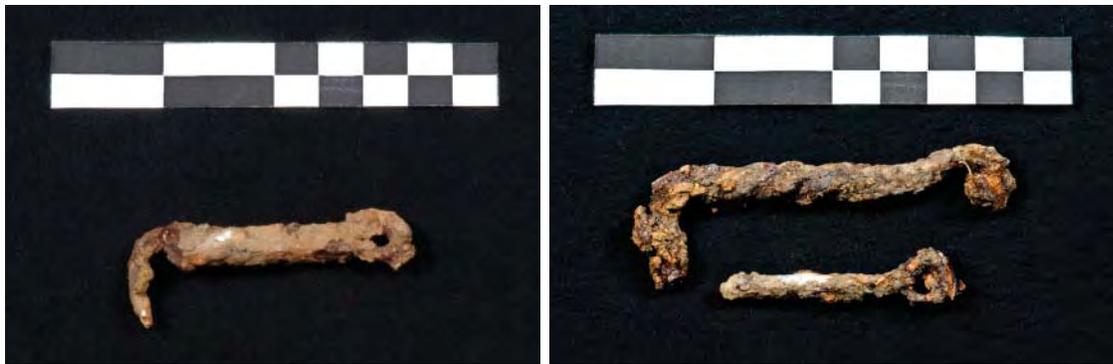
Figure 5.7. Two simple iron latches, context 614 and 714.

Hardware was also necessary to secure the shutters in a closed position. It is possible that the two latch hooks that were recovered from the excavation could have served this purpose (Figure 5.7). Although both of the latch hooks that were recovered were wrought iron they are in different styles. One of the latch hooks is plain and is about

The different styles and sizes of the latch hooks may represent a difference in use. Latch hooks may also have been used to hold cabinet or small compartment doors closed. Although both latch hooks are hand wrought, their different styles may also represent different periods of use. Although the potentially older hook is not broken and does not show obvious signs of wear, it may have been replaced if the entire door or shutter it was attached to was replaced.

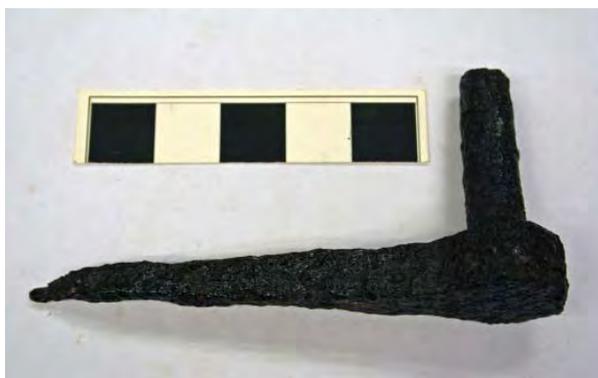
Figure 5.8. Iron pintle, context 669. Photograph by Heidi Krofft.

Overall, the excavations of the greenhouse area resulted in the recovery of at least six different hinges of three different types: strap hinge, H-type hinge, and snipe hinge. The strap hinge is represented by a wrought iron pintle (Figure 5.8). An iron strap would be attached to a shutter or door and had a joint that would fit over the pin of the pintle. The pintle would have been driven into the window frame or door frame or directly into the masonry work to fix the hinge in place.

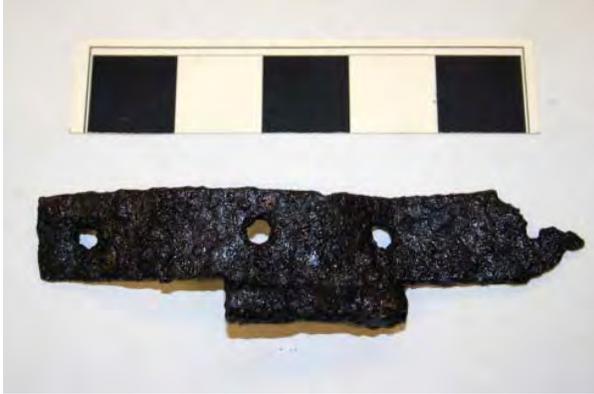
Figure 5.9. Strap from an H-hinge, context 669. Photograph by Heidi Krofft.

Fragments from at least five different H-type hinges were also recovered, none of them complete (Figure 5.9). These hinges are all made of iron and are hand wrought and represent two different sizes. The fragments provide evidence of at least two hinges of a similar size and may be a pair

of hinges from the same door or shutter. The straps measure about 16 cm (6.3 inches) long and about 2.2 cm (1 inch) wide. Both straps have four holes used to affix the hinge to a door or to a doorframe. Both of these examples are the side of the hinge with a single knuckle measuring about 4.9 cm (2 inches) tall. H-type hinges commonly had 3-part joints, so the associated strap would have had two knuckles that straddled this one (Priess 2000: 59). This center knuckle would have carried the weight of the door (Streeter 1973).

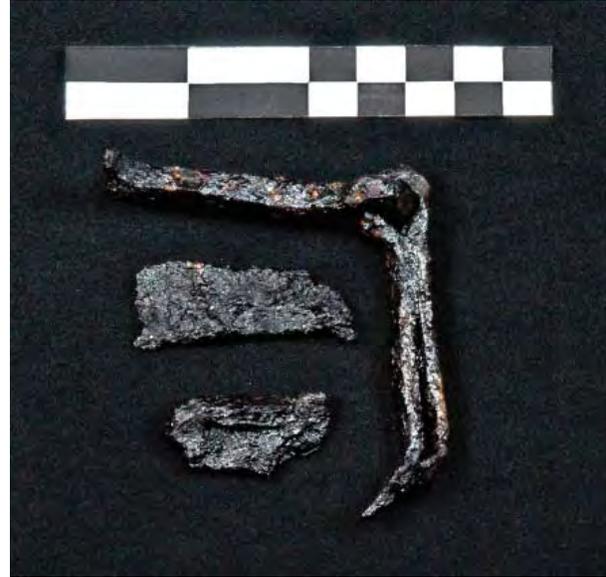
Figure 5.10. Snipe hinge, context 683.

The final type of hinge that was recovered is a snipe hinge. This consists of two eyes that are connected and form a pivoting point (Figure 5.10). These eyes would be driven into the door edge and the frame. One complete snipe hinge was recovered from the greenhouse excavations. This example shows evidence of clinching on the eye that was driven into the frame. Another snipe hinge was found during the 2005 survey. Only one eye from this hinge remains and due to the lack of clinching most likely represents the eye that was driven into the door. This type of hinge is much smaller than those previously discussed and it is unlikely that it would have held the weight of a full sized door or even a large shutter. It is more likely that this hinge would have been used for a small cabinet or compartment door. The presence of small cabinet or compartment doors indicates a need or desire to organize or separate tools in the workroom.

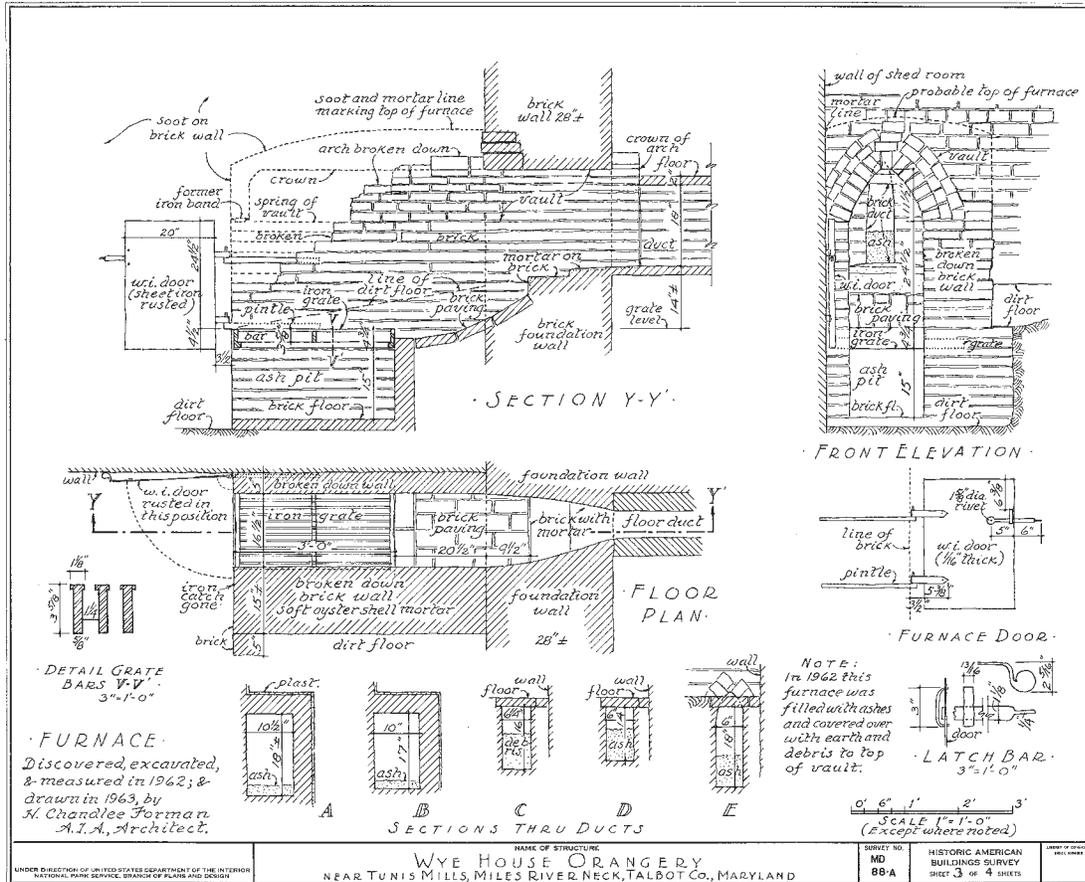
Figure 5.11. Diagrams of the Wye House Orangerie furnace, Maryland. Drawn by the Historic American Buildings Survey.

The arrangements of heating systems varied a great deal. An 18th century heating system survives at the Wye orangerie in Maryland (Figure 5.11). The main body of the furnace measures 16.5 inches wide and extends 3 feet deep. At that point it begins to rise and narrows as it becomes a flue. The furnace itself consists of an iron grate roughly at floor level. Below the grate is an ash pit that extends 15 inches into the floor and has a brick floor. This furnace has a wrought iron door that measures 20 inches wide by 29 inches tall.

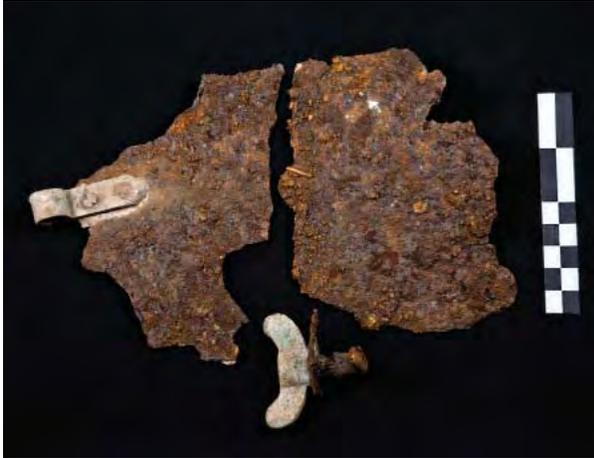
Figure 5.12. Possible furnace door fragments. Compare to the furnace door depicted in Figure 5.11.

Context	Unit Number	Level	Object	Material	Comments
651	N2580 E3733	3	sheet	iron	possible furnace door
651	N2580 E3733	3	sheet with brass fitting	iron and brass	possible furnace door (at least 26 cm tall)
651	N2580 E3733	3	wing nut latch?	brass and iron

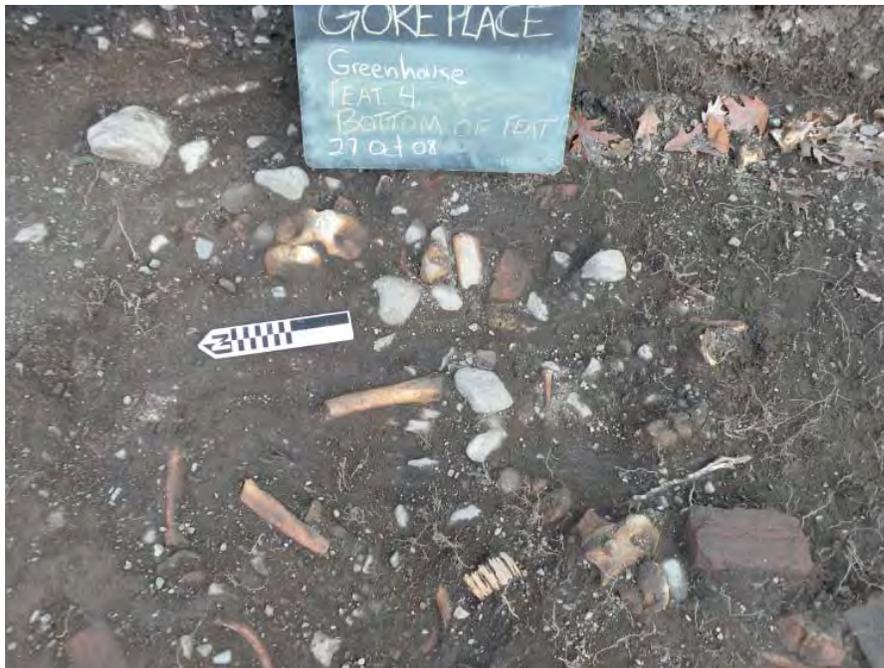
Figure 5.13. Artifacts and faunal remains *in situ* in the interior greenhouse rubble deposit.

well as other refuse associated with the activities of the greenhouse (Figure 5.13). Before considering in depth the bones comprising the 19th-century assemblages, a few quantitative methods are discussed to understand the processes involved in the analysis of the faunal remains from the northern French drain, the deposits associated with the roadway, the destruction layers, and the rubble on the interior of the greenhouse. Standard calculations employed by zooarchaeologists, including NISP (number of individual specimens) and Skeletal Part Representation, were used to move from a summary of raw data to an examination of activities associated with the production of bone manure or fertilizer.

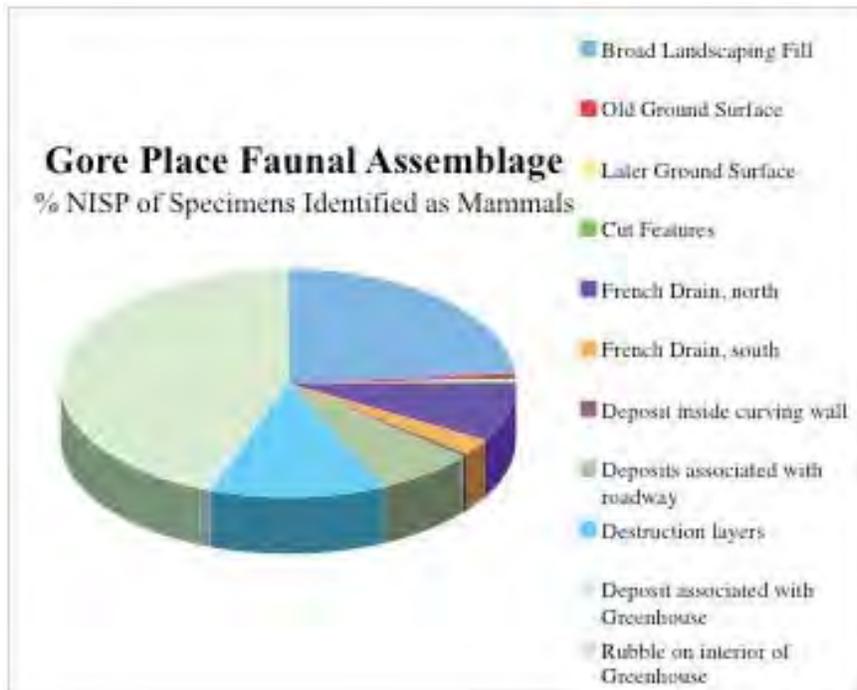
Figure 5.14. Distribution of the identified specimens among the 11 analytical units.

The faunal remains from the 11 analytical units, which included 1067 specimens, represent various time periods, household occupations, and activities in the history of the Gore Place property. Figure 5.14 shows the percentages of bones comprising each unit with the five largest assemblages found in the layers of broad landscaping fill, the French drain north, the deposits associated with the roadway, the destruction layers, and the rubble on the interior of the greenhouse.

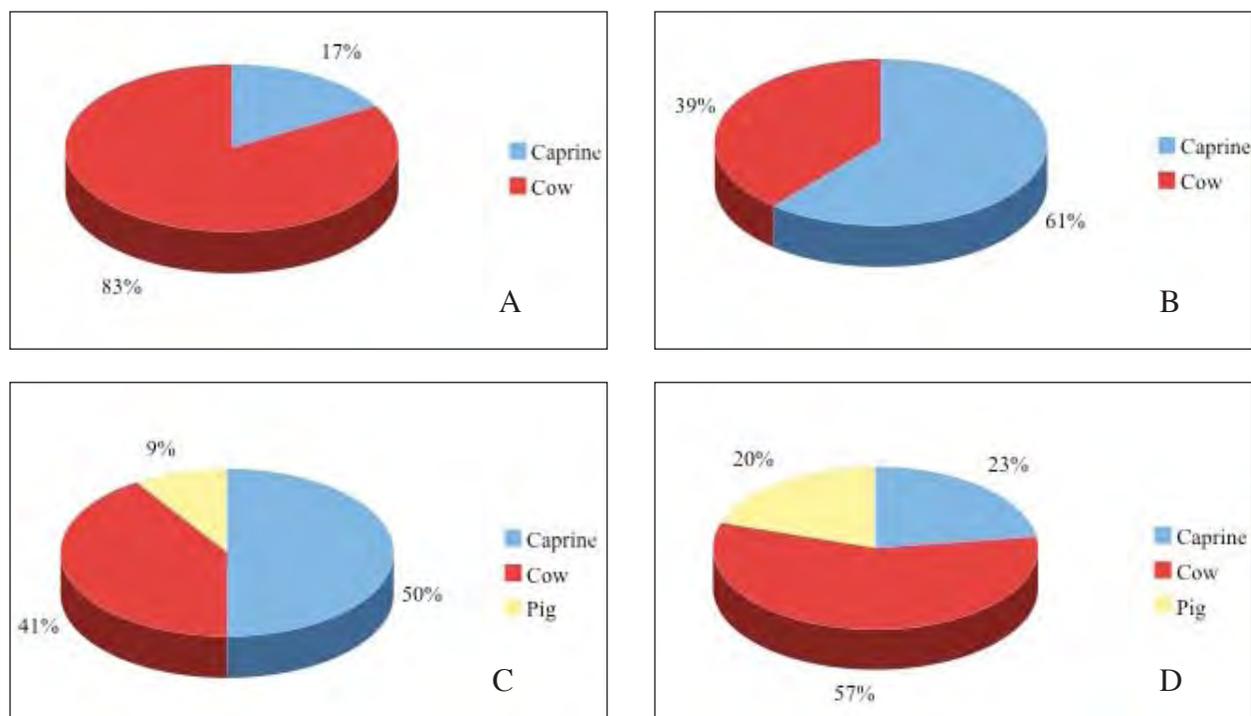
Figure 5.15. Percentages of cow and caprine bones in the different deposits. A) Northern French drain; B) deposits associated with the roadway; C) destruction deposits outside the greenhouse; D) destruction deposits over the greenhouse floor.

The vertebrate taxa found in the northern French drain included two caprine and ten cow bones (Figure 5.15a). The caprine bones were identified as two nearly complete right astragali. The identifiable cow bones in the collection included two complete carpals, one complete atlas, four ilia, one radius fragment, the proximal end of a tibia, and a piece of a sacrum. Minor butchery marks were noted on four of the ten cow bones. It is difficult to draw any specific conclusions from the small collection of bones in this context.

The deposits associated with the roadway contained 59 specimens identified as mammals, two described as birds, and an additional 74 bones recognized only as the remains of vertebrates. The two bird bones, which were the only bird remains found in the entire Gore Place assemblage, were identified as the proximal and distal ends of chicken humeri. Caprine bones comprised 61% of the mammal bones identifiable to class (11 specimens) (Figure 5.15b). These included one astragalus, one calcaneus, one carpal, three femur fragments, two

A total of 109 bones were found in the destruction layers associated with the greenhouse demolition sometime after 1841 (Figure 5.15c). The assemblage contained 11 caprine bones, including one complete astragalus, one calcaneus, one metatarsal, one complete tarsal, a distal and proximal tibia, one proximal femur, the shaft of a humerus, one pubis, a complete calcaneus, and a fragmented ischium. Additionally, nine cow bones were found in these layers. The bones were identified as the fragment of an axis, a distal humerus, two tibia pieces, three tooth fragments, and one ilium. Pig bones were also present in this context and included a right proximal femur and a proximal metapodial.

The rubble layers found on the interior of the greenhouse contained the largest assemblage of faunal remains with 376 bones identified as mammal and seven bones described as the remains of vertebrates. A total of 195 bones or approximately 52% of the mammal remains were cataloged as unidentifiable bones. The rubble layers yielded a total of 17 caprine bones constituting various skeletal parts, including one innominate, one complete right femur, two distal femurs, a fragmented femur shaft, one complete phalange, four ischium fragments, a proximal metatarsal, two pubes, the shaft of a right radius, a right proximal tibia, one fragmented scapula, and one piece of a right ulna (Figure 5.15d).

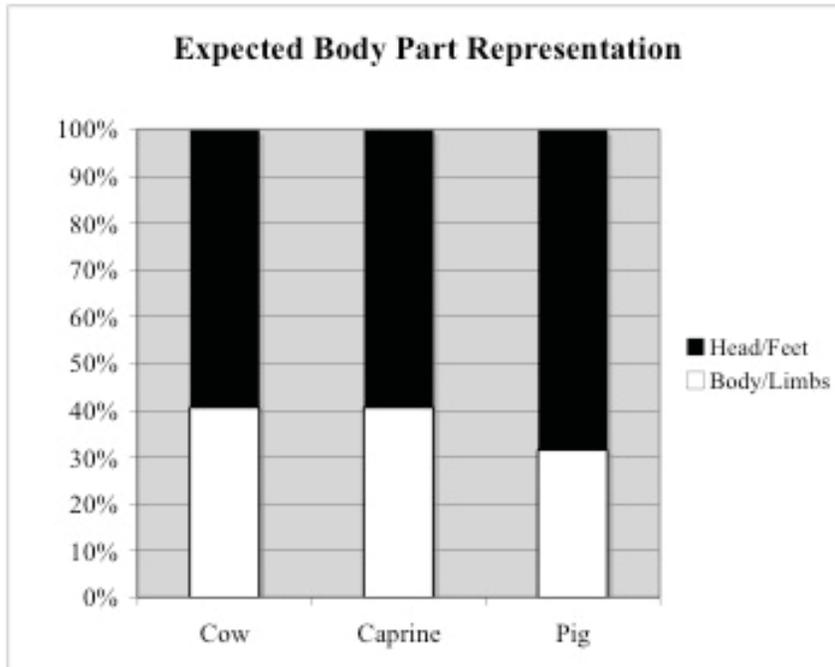
Figure 5.16. Expected anatomical proportions for complete skeletons of cows, caprines, and pigs.

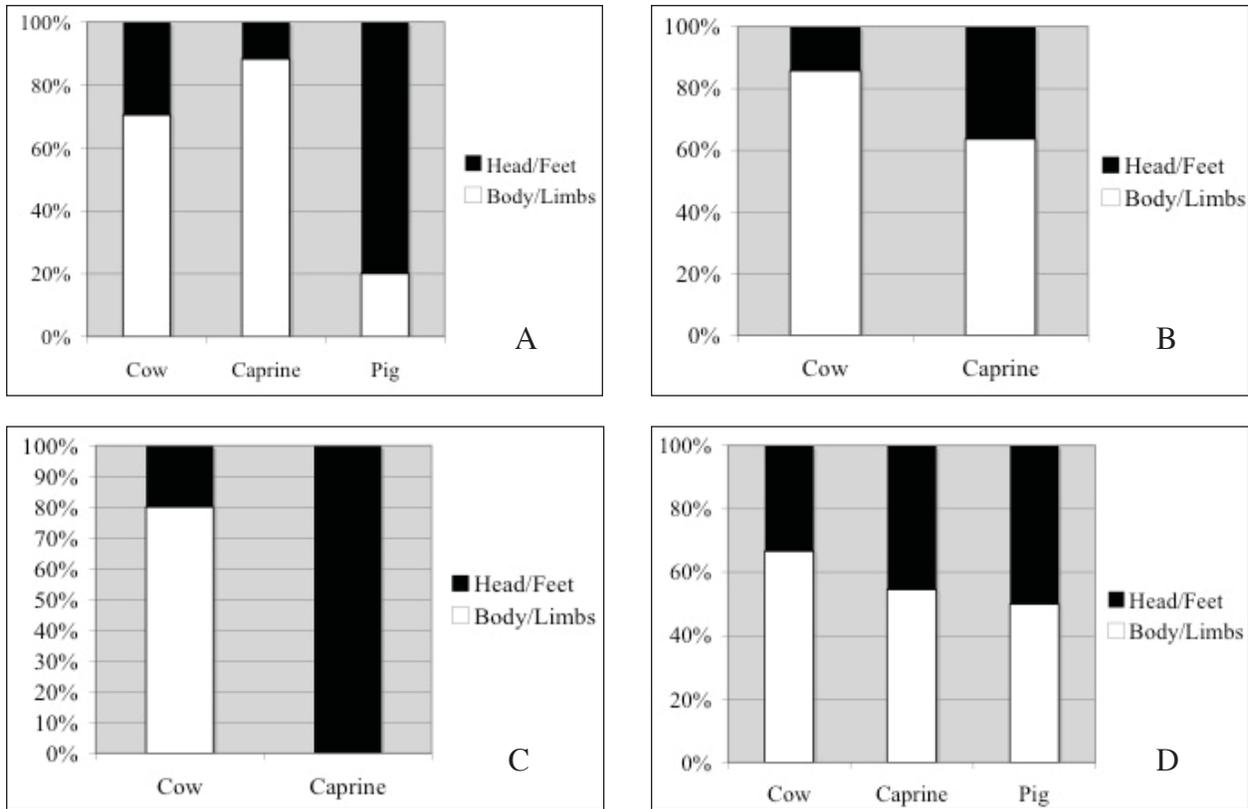
Figure 5.17. Body part distribution in the different deposits. A) Destruction deposits over the greenhouse floor; B) roadway; C) northern French drain; D) destruction deposits outside the greenhouse.

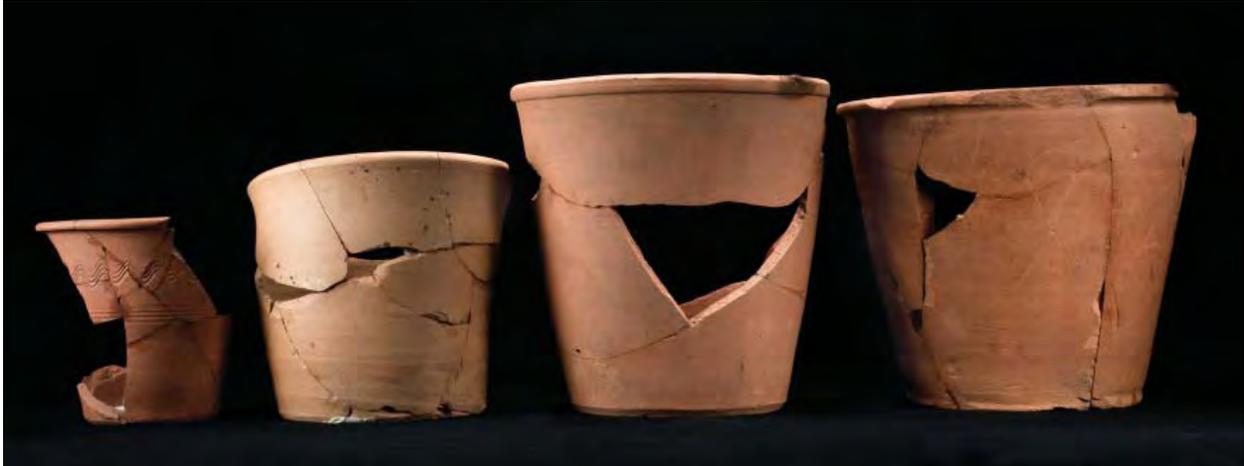
Figure 5.18. Reconstructed planting pots; left to right, vessels 41, 50, 36, and 35.

The 2008 excavations yielded 2083 planting pot sherds from at least 149 separate redware pots which constitute a large collection of a common yet little studied artifact type (Figure 5.18). The fragments from the 2005 STP survey are not included in these counts. Based on both archaeological and documentary evidence, the greenhouse seems to have fallen out of use in early 1840s. The

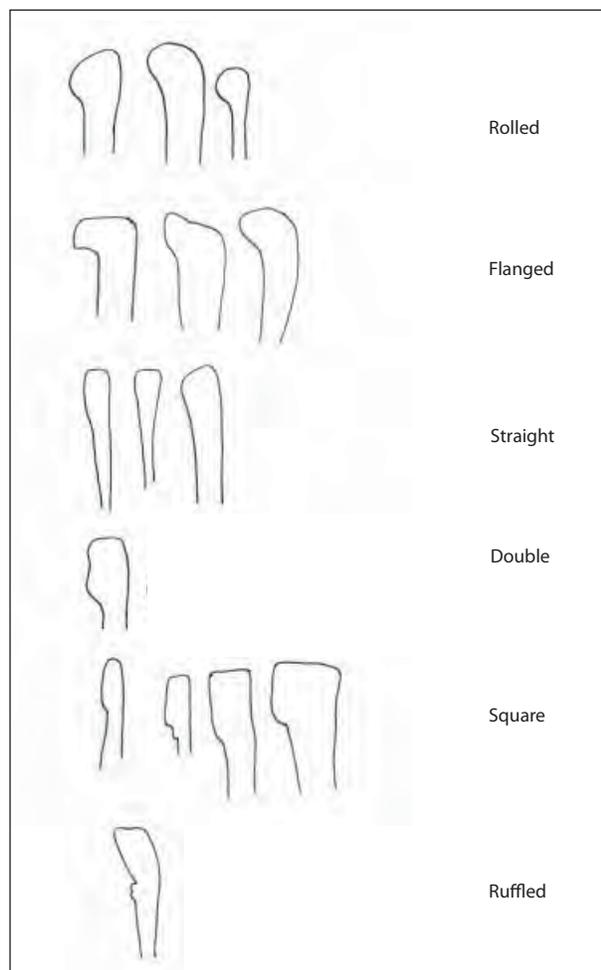
Figure 5.19. Representative planting pot rim profiles.

yellow or yellowish red with no inclusions visible to the naked eye. Based on variations in rim style and diameter, there are at least 149 pots represented (see Appendix B). There are six different basic rim profiles, but significant variation within each of those categories (Table 5.7; Figure 5.19). The pots range in diameter from 2 to 30 cm with most of the intervening values represented by at least one pot (Figure 5.20). Twelve of the 149 identified vessels are decorated (Figure 5.21): 11 with tooled or engine-turned bands of straight and/or wavy lines (none in identical patterns, however) and 1 with texturing that seems to have been created by sponging the exterior. Additional fragments not associated with one of the 149 distinct rims are also decorated, most with similar combed patterns. One unassociated sherd, however, is painted with white and black slip; the fragment contains part of a white circle, surrounded by black dots, with a white band at the top (Figure 5.22). One vessel had a combination of letters, numbers, and symbols scratched onto the exterior, presumably during its use-life (Figure 5.23). Another shard from a different vessel is scratched with an X. The meaning of these scratches is not clear, but they may have recorded information about the plant, as advised by gardening manuals.

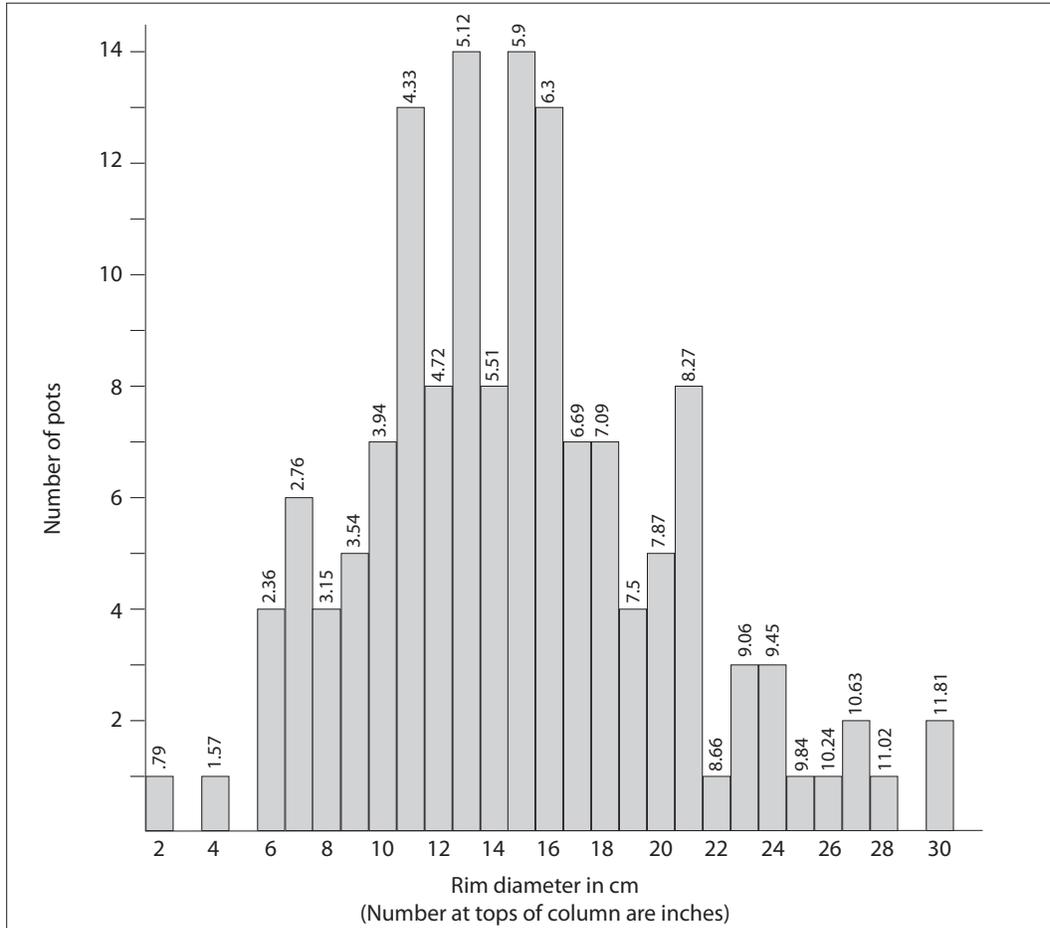
Figure 5.20. Planting pot rim diameters.

Most of the pots in the Gore Place collection were between 10 and 21 cm (roughly 4 to 8 inches) in diameter at the rim, with the biggest concentration between 12 and 16 cm (or 4.3 to 6.3 inches). Having a range of mid-size pots was important for proper re-potting; 19th-century gardening manuals recommended constant repotting into gradually, incrementally larger pots as a process integral to plant health (e.g. Henderson 1884: 61).

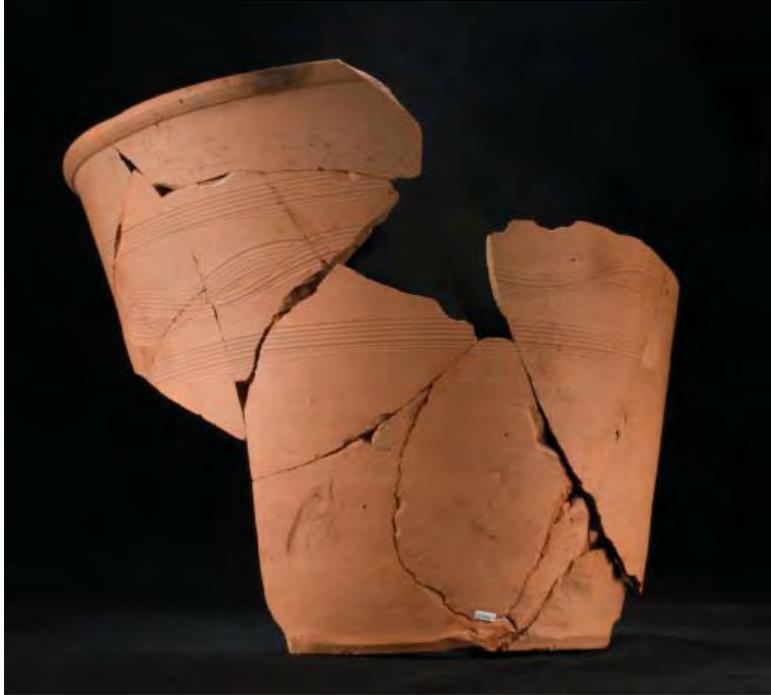
Figure 5.21. Detail of tooled decoration, vessel 39. Another style of tooling is visible on vessel 41 in Figure 5.18.

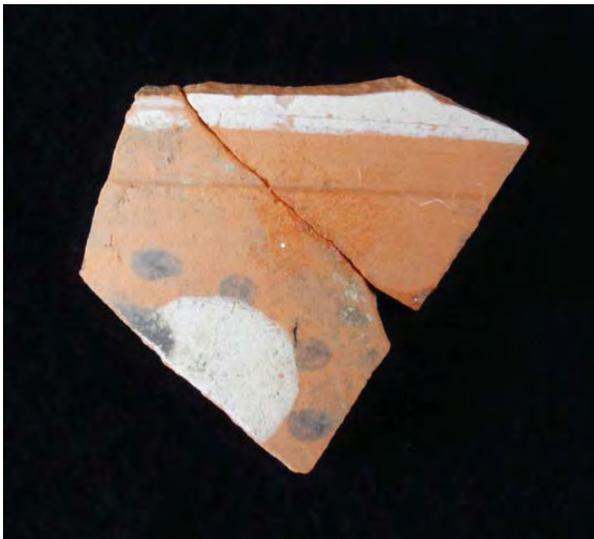
Figure 5.22. Slip decorated fragment. This piece is the sole example of this type of decoration in the collection.

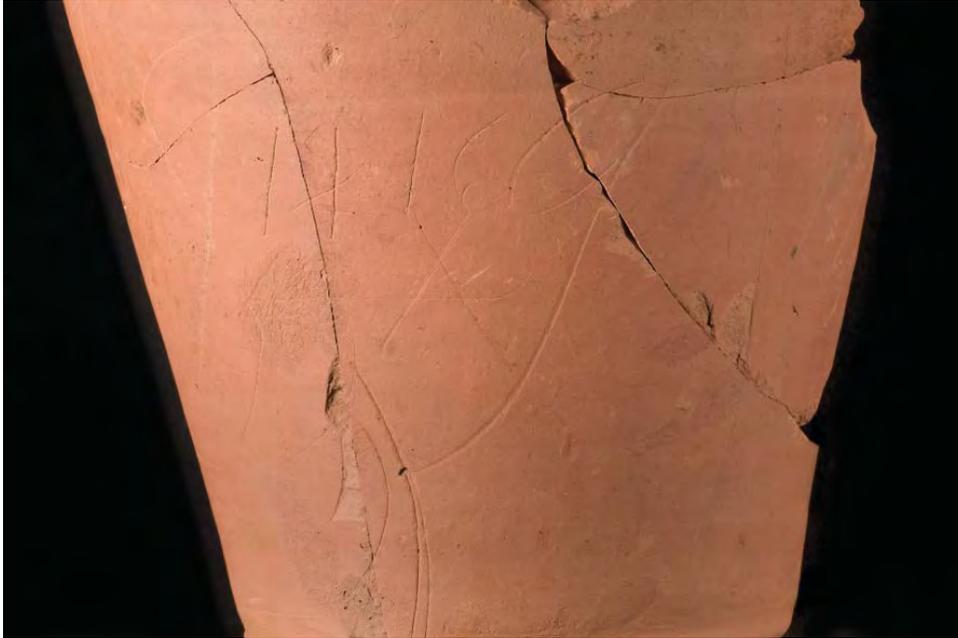
Figure 5.23. Scratched letters and numbers on vessel 35. The scratches include an X and a sequence which may read “1716g.”

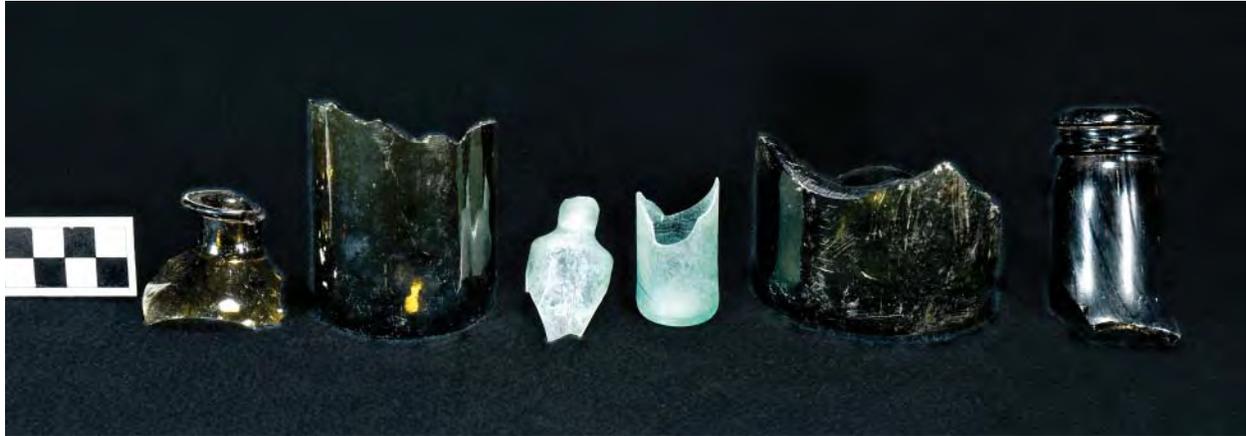
Figure 5.24. Glass bottle fragments from the northern French drain, Feature 2. These are the only large fragments of vessel glass recovered during the 2008 excavations.

Other than window glass, almost all of the glass from the greenhouse area is bottle glass, primarily necks and bases (Figure 5.24). There is one globe from a lamp represented, but no table glassware such as tumblers or stemware. Among the bottles are at least two small vials (base diameter = 2.5 cm) with flanged lips of the type that commonly held liquid medicines. Here,

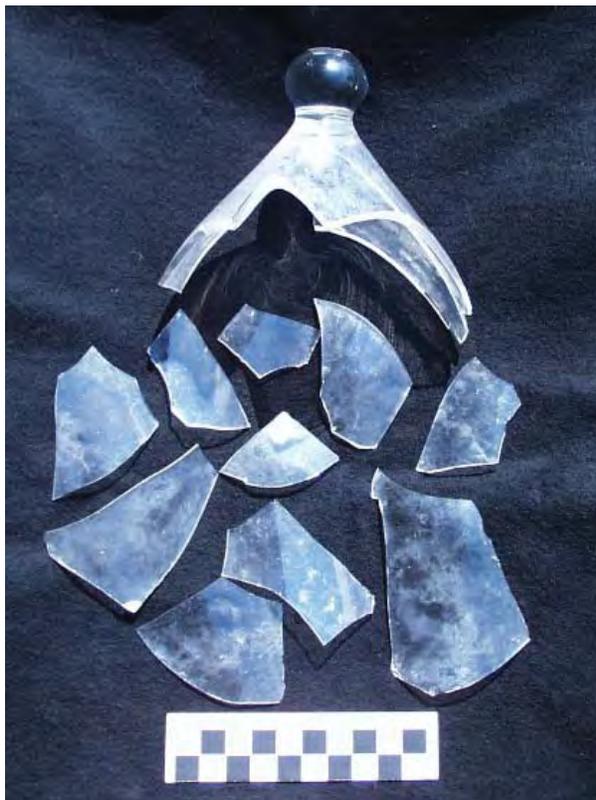
Figure 5.25. Glass bell jar fragments recovered in 2005. Photograph by Leith Smith.

postulate a greenhouse-related function for these because of the large pieces that are present; in the ceramic collection, only large pieces of planting pots (related to the greenhouse function) survived, while other vessels were much more fragmentary. In the 2005 text excavations, a fragmentary bell jar was recovered from the mouth of the stone lined drain (Figure 5.25). Bell jars protected delicate plants in pots or planted outside.

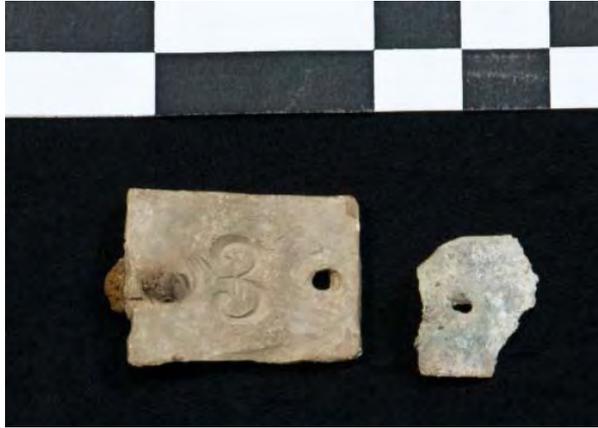
Figure 5.26. Lead tags from contexts 627 and 628.

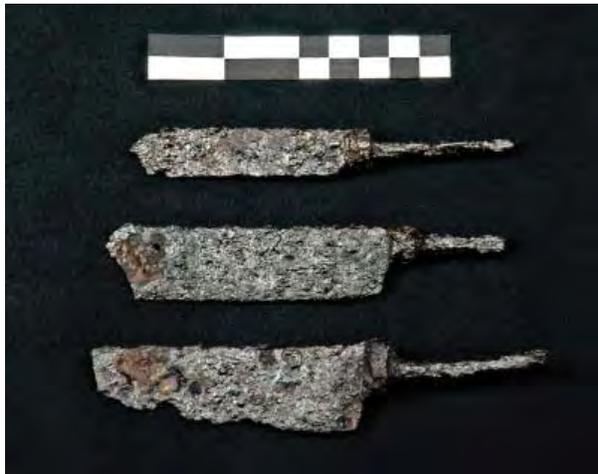
Figure 5.27. The three more complete knife blades; contexts 633, 634, and 799.

Four partial (Figure 5.27) knife blades were also recovered from the greenhouse area. One is represented only by a blade tip (and may in fact come from a pair of scissors or shears); three are comprised of a partial blade and tang. All of these would have had wooden or bone handles, now decomposed, surrounding the metal tang. Table knives of the early 19th century typically had broad, slightly curved blades with rounded ends. Unfortunately, these are not complete enough to determine their shape; the three that are most complete lack their tips, and the single tip fragment is pointed rather than rounded. They may have served as pruning knives, though they lack the distinctive backwards curve of the pruning knife (French: *serpette*) blade shown in Diderot's encyclopedia (Figure 5.28) and other period publications. No forks or spoons were recovered, which lends some support to the idea that the knives had a function in the greenhouse and were not simply domestic utensils redeposited here.

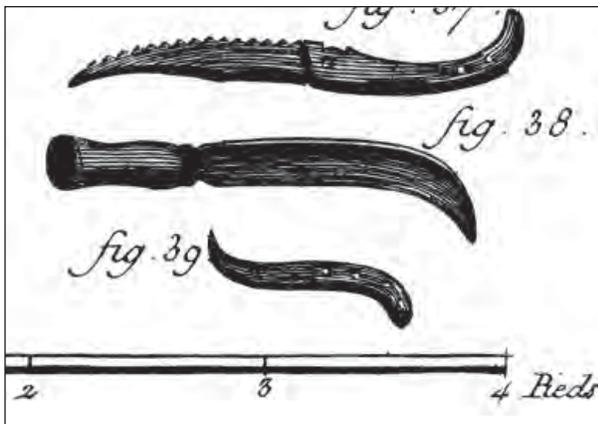
Figure 5.28. Pruning knives, illustrated in Diderot's late 18th-century *Encyclopedia*.
