**Data Recovery Excavations of the Carriage House,
Greenhouse, and Greenhouse/Carriage House Well at
Gore Place, Waltham, Massachusetts**

**Prepared by:
Christa M. Beranek, J.N. Leith Smith, and John M. Steinberg
With contributions by Michelle G. Styger, Heidi Krofft, and Rita A. DeForest
Fiske Center for Archaeological Research
University of Massachusetts Boston**

Cultural Resources Management Study No. 45

March 2011

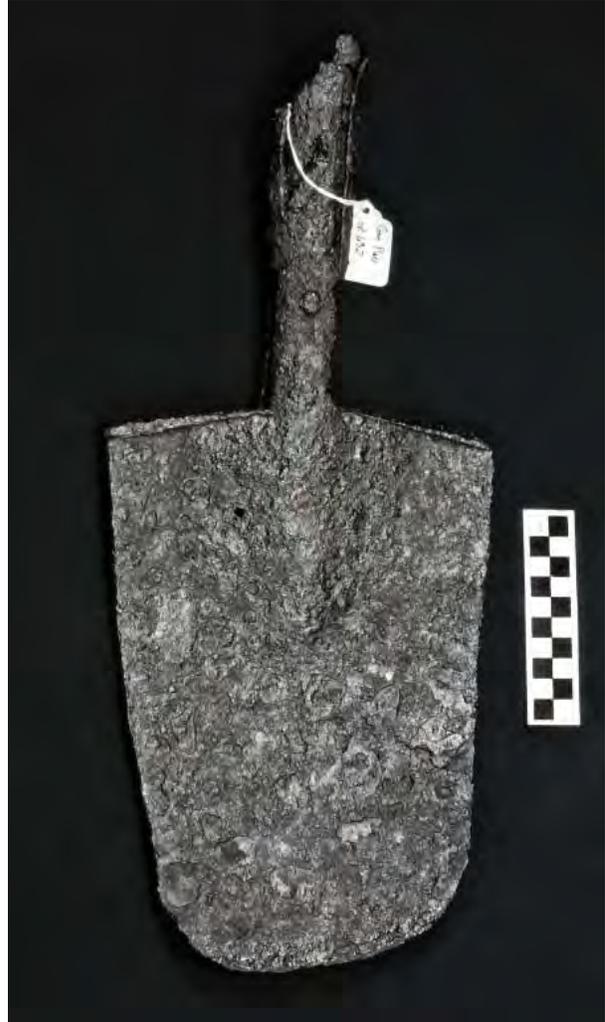
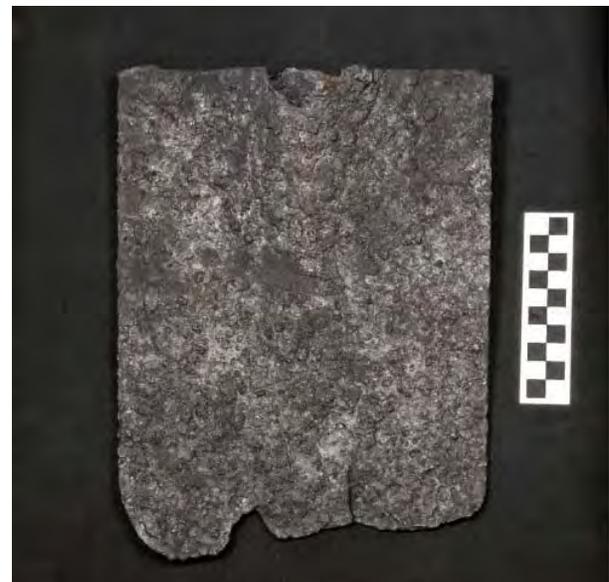
Figure 5.29. Iron spades from the northern French drain fill.

The fill of the northern French drain contained a number of large items, presumably placed there to promote drainage. In addition to several almost intact planting pots, there were three iron spades and a colander in the fill. These spades may not have been used in the greenhouse itself, but might have been used to turn soil or composting piles nearby. The greenhouse extension might have served as general purpose storage space for garden tools used in the area, though other general-purpose garden and farm tools such as hoes, rakes, and scythes were not found in the greenhouse area. Two of the spades were rectangular; one was rounded (Figure 5.29). The rounded example is the most complete and consists of two iron plates that are worked together for the blade of the spade, but which separate as they move towards the handle. The triangular iron plates that formed the top edge

of the shovel are intact, as is the beginning of the iron fitting that would have surrounded the wooden handle. The blade is 26 cm long and 19 cm wide at the top, tapering to a gently rounded point. Only the blades of the square spades survive. They are also both formed from two plates that separate near the handle. The top components are partially present on one example and missing on the other. Neither has a preserved handle attachment. These blades are 27 cm long, 21 cm wide at the top, and about 18 cm wide at the bottom.

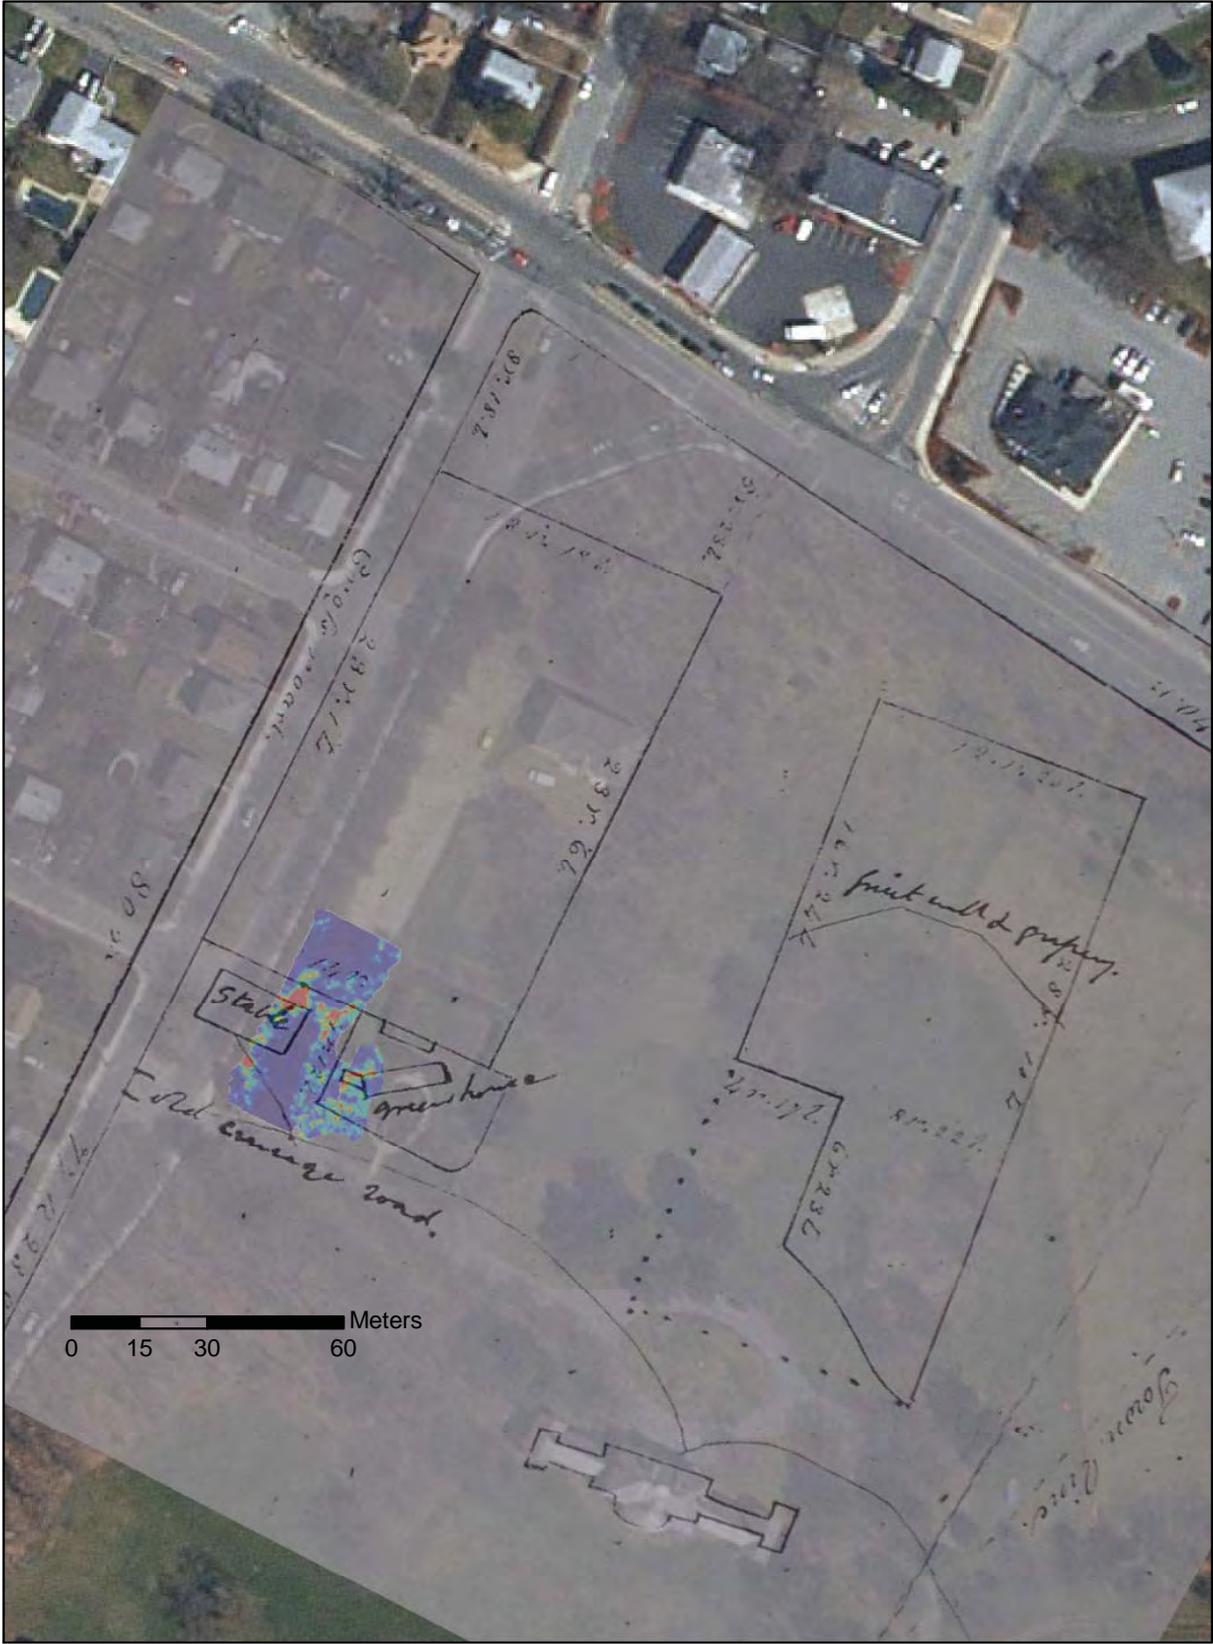
Figure 6.1. Property-wide georeference of the 1834 Lyman map. See Figure 2.3 for a detail.

While the 1834 Lyman map could be georeferenced to the whole property (Figure 6.1), with

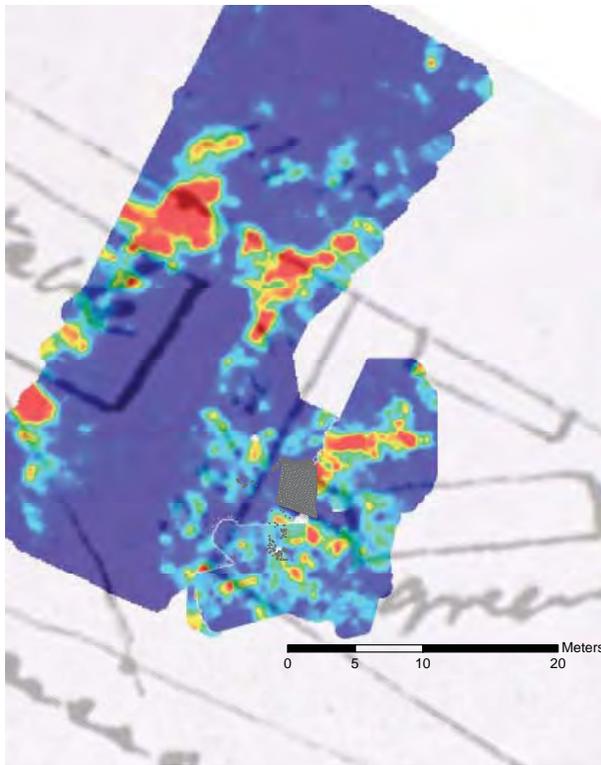
Figure 6.2. The 1834 Lyman map, GPR slice, and excavated brick floor.

In Figure 6.2, the Lyman map was georeferenced using the northeast corner of the carriage house and the southwest corner of the brick floor of the greenhouse addition. This projection shifts the greenhouse south of the east-west geophysical anomaly interpreted as the north wall. It does, however, have the fronts of the stable and greenhouse extension flush with each other. In Figure

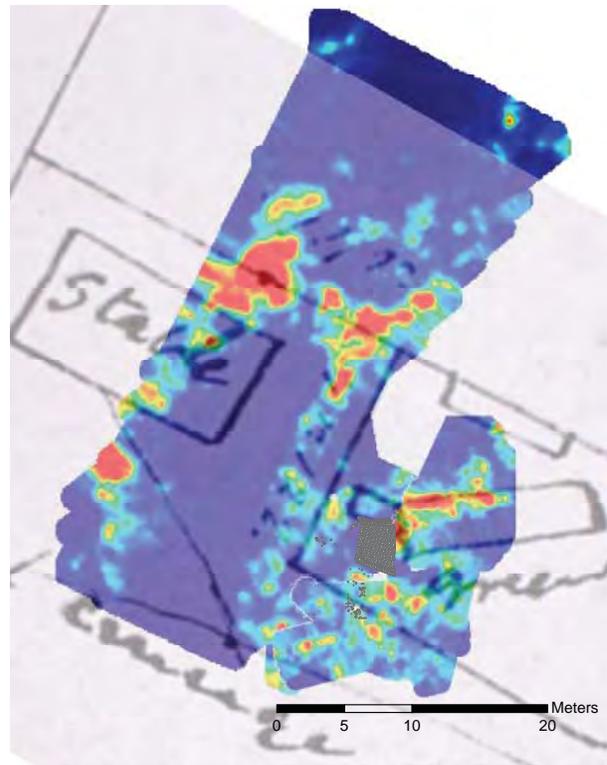
Figure 6.4. The 1834 Lyman map, GPR slice, and excavated brick floor.

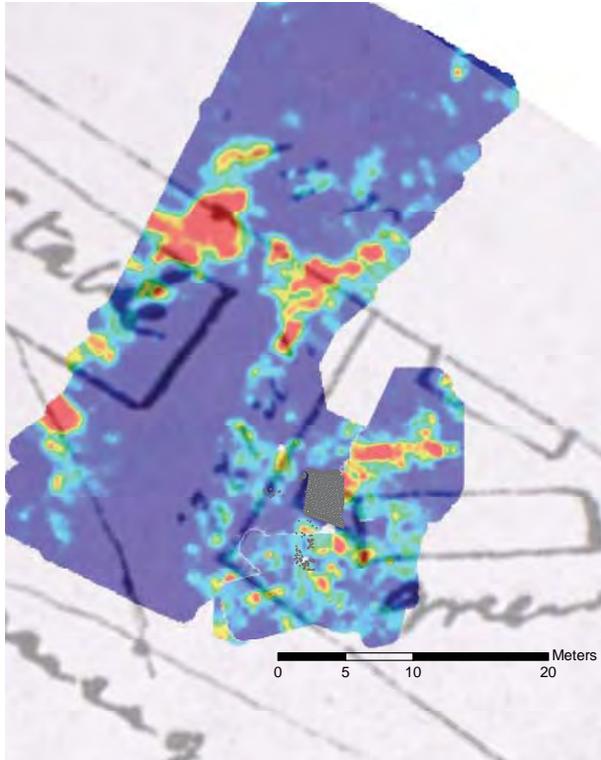
Figure 6.3. The 1834 Lyman map, GPR slice, and excavated brick floor.

6.3, the georeferencing used the northeast corner of the stable and the northwest corner of the brick floor. This projection again shifts the greenhouse south of the east-west geophysical anomaly interpreted as the north wall. It also shrinks the buildings so that they appear approximately 86% of their real size. (This is based on the known size of the carriage house, and assumes that rendering the buildings using a consistent scale was important to the map's author.) In Figure 6.4 the map was georeferenced using the northeast corner of the stable and aligning the east-west geophysical anomaly with the north wall of the greenhouse. This version also shrinks the buildings substantially, and it takes the fronts of the stable and the greenhouse extension out of flush alignment.

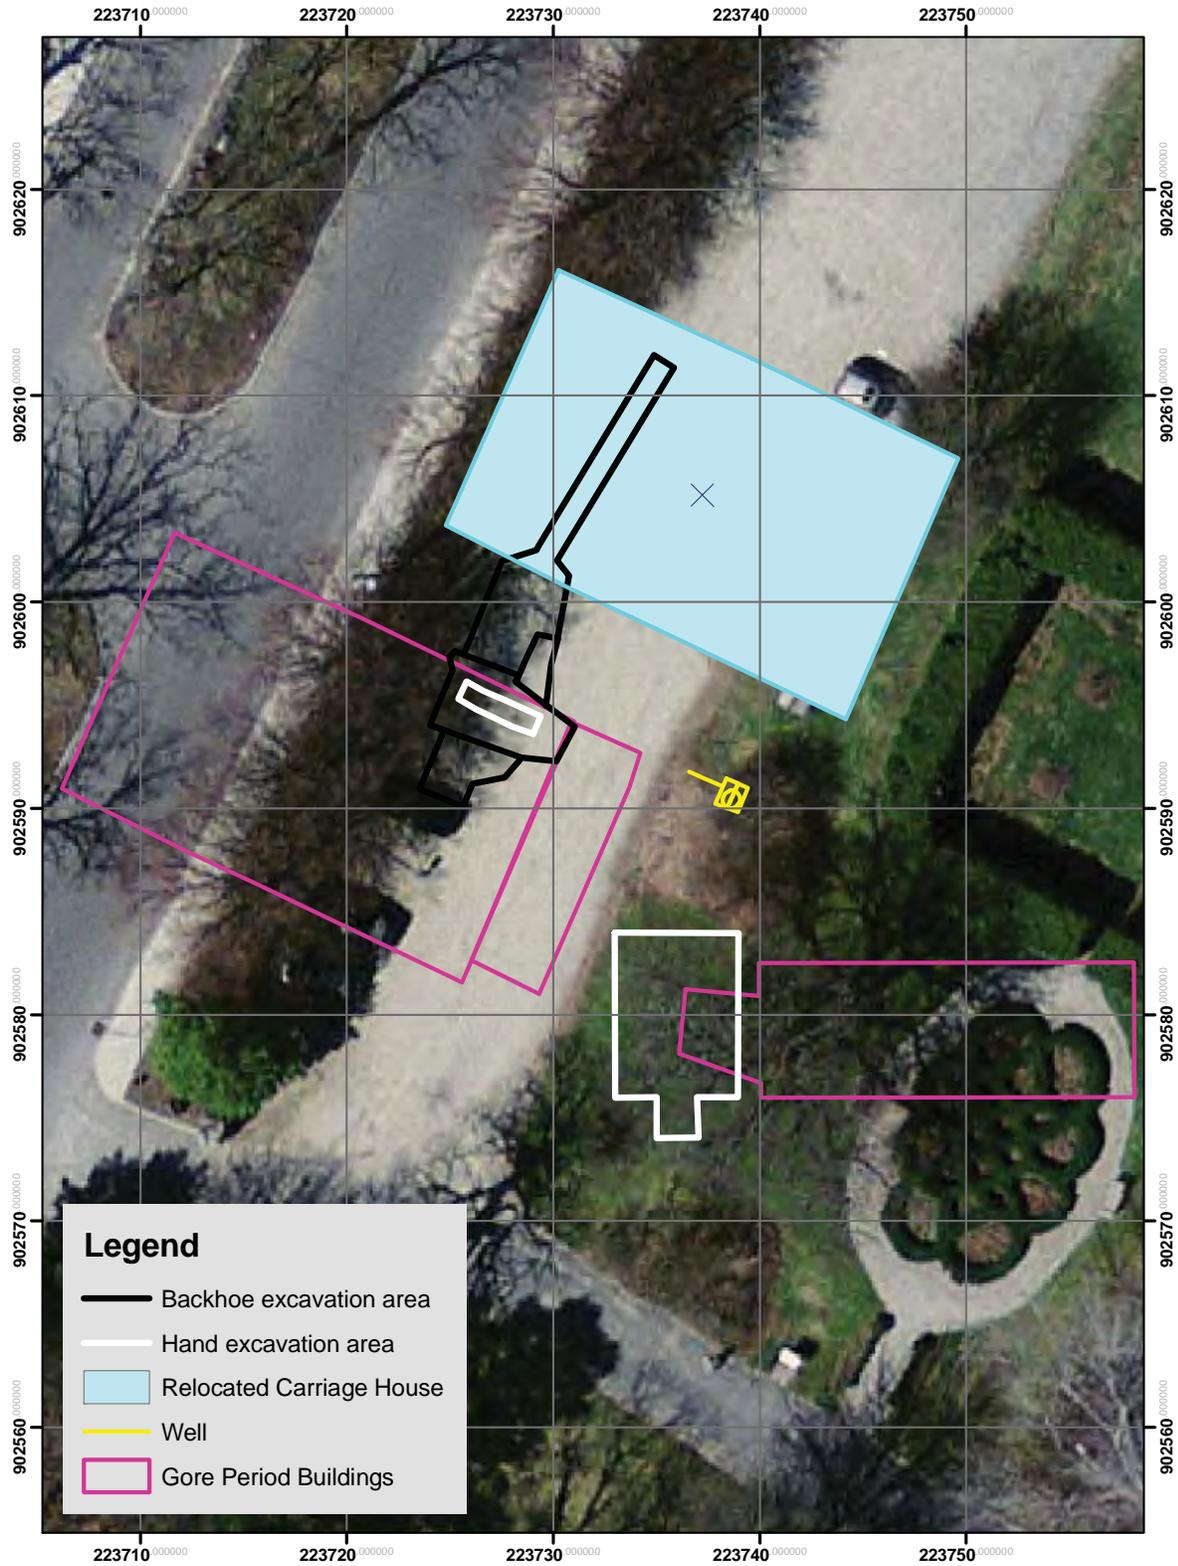
Figure 6.5. Reconstruction using elements of multiple georeferences. This figure also shows our proposed carriage house relocation that will minimize impacts to known Gore-period archaeological features.

Finally, we created a reconstruction using elements of multiple georeferences that represents our best estimate of the location of the carriage house and of the unexcavated portion of the greenhouse (Figure 6.5). It uses the true size of the carriage house, the geophysical void for placement of the carriage house ramp and basement, the brick

floor for the location of the greenhouse extension, and the east-west reflector as the north wall of the greenhouse. This model has the advantage of keeping the carriage house flush with the greenhouse extension, as the author of the Lyman map observed. Furthermore, it maintains the south-south-west orientation of the greenhouse extension, following the rest of the buildings on the lot, with the exception of the greenhouse which is oriented with one long face to the south, to maximize exposure to the sun. The combined result of these factors is that the greenhouse appears to be wider than depicted on the 1834 map. (Here, the main body of the structure is 18 m [59 ft] east-west by 6.5 m [21 ft] north-south, while on the Lyman map the east-west dimension is roughly the same (60 ft), but the north-south dimension is 15 feet.) This model produced the building orientations, sizes, and locations used in figures throughout the report.

Using information from the 1834 Lyman map, ground penetrating radar results, archaeological information, and comparative sources, we can reconstruct or postulate a good deal about the appearance of the greenhouse which was situated on the property's entrance drive between the street and the house (see Figure 6.5). The main body of the greenhouse, which has not been excavated, was a rectangular structure measuring 60 by 15 to 21 feet (or 18 by up to 6.5 m) oriented to face south and, therefore, not aligned with the other buildings on the property. It had a small (roughly 3 by 3 meter or almost 10 by 10 foot) trapezoidal extension on the west end, most of which has been excavated. The extension was aligned so that it was oriented with the carriage house and the entrance drive, and the south face of the extension may have been flush with the south face of the carriage house. The extension had a brick floor, while white marble tiles recovered from the destruction debris suggest that the floor of the main greenhouse was marble or white marble and black slate. The GPR investigations did not detect a uniform reflection from the floor of the main body of the greenhouse, although some reflections from closer to the center of the floor are visible in Figure 4.13 (at the far right). Is this because the floor, which may have been elevated above the ground surface, was completely removed when the greenhouse was demolished? Or were there beds or bark pits around the edges of the greenhouse that limited the floor surface?

We recommend that the carriage house be sited approximately 20 ft north of its original location and as close to Gore Street as is feasible (see Figure 6.5). This location would place the north wall of the carriage house roughly even with the north edge of the yew hedge, and the southwest corner just east of the information kiosk bordering the parking lot. This placement ensures preservation of the archaeological remains of Gore's early greenhouse, yard and possible hot bed, features that one day may figure prominently in the restoration and interpretation of the estate. It also preserves the carriage house/greenhouse well that was

body of the greenhouse. In any event, the area that comprised the former greenhouse enclosure should be protected from any construction or other subsurface impacts since it has a high potential of containing important greenhouse-related deposits. This area includes the knot garden, the area between the knot garden and the yew hedge, and the southern part of the area enclosed by the yew hedge (see Figure 6.5).

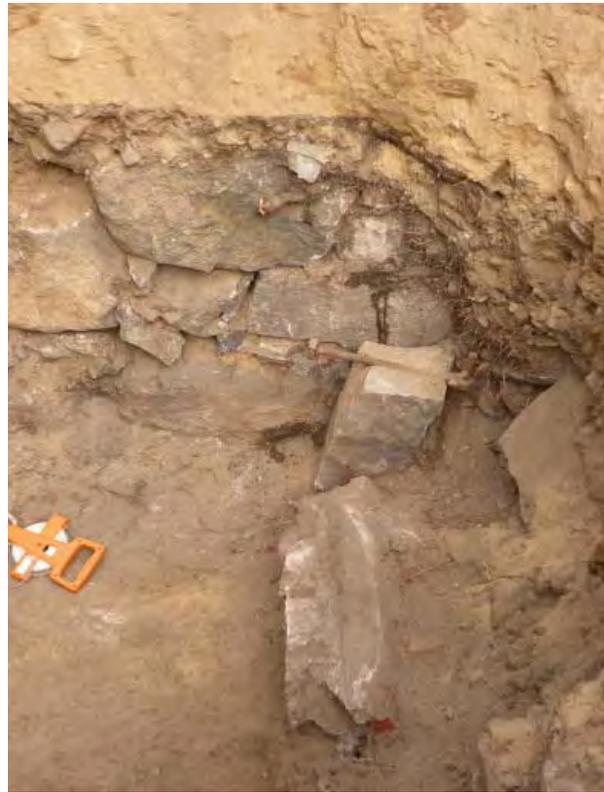
Figure 6.6. Granite door post for carriage house cellar entrance

Excavation of a portion of the carriage house cellar revealed the lower portion of at least the rear (north) foundation wall to be well preserved along with the cellar floor. The wall is constructed of large and small rubble or field stones mortared in place. Wall height ranged between 55 and 85 cm above the floor surface, indicating that at least 80 cm of wall was missing from the highest preserved portion. The rear wall is approximately 60 cm (2 ft) in thickness and probably extended eastward past the granite door support post to form the north and east walls of the entrance ramp. The opening for the cellar entrance was defined by the split granite post directly against the stone wall (Figure 6.6). Although the top half of the post was missing, the lower portion was dug into the cellar floor and retained an iron pintle that passed through the post. The exterior portion of the pintle would have held the door hinge, while the interior portion was fitted with a nut and washer that indicated a wooden post was once present against the interior side of the granite post, and probably served as part of the door framework. The door sill consisted of concrete with fragmented brick that appeared to fill the space of a former wooden sill. Below the concrete was fieldstone that the wood sill would have rested on. The presence of the brick
